Arboricultural Impact Assessment

76 Lawn Road, Camden NW3 2XB

Project Number: P3430.1.3

Date: 25 August 2021

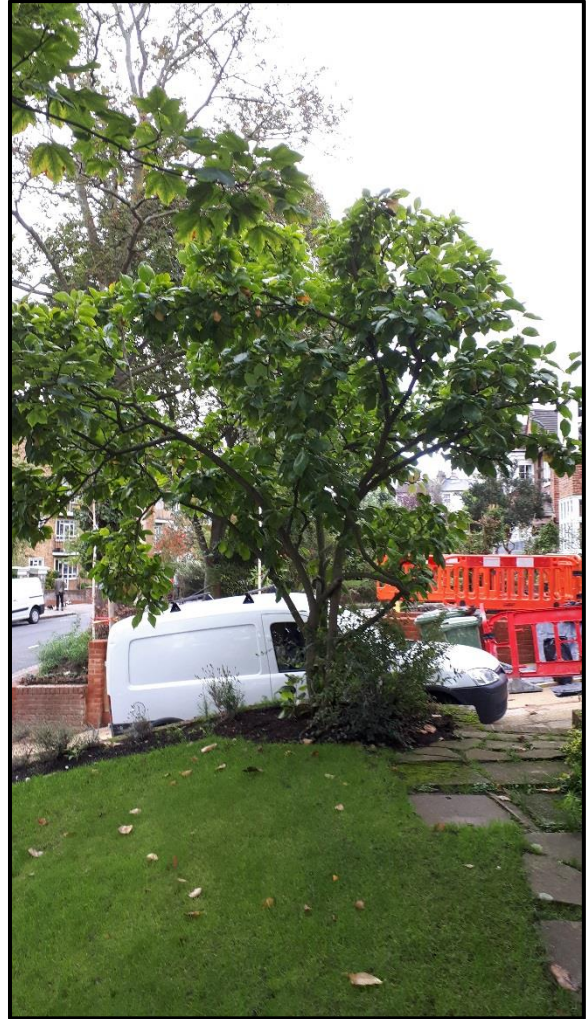
Photograph 4. T3, magnolia, located to the south of the front garden. Viewed looking towards the south.

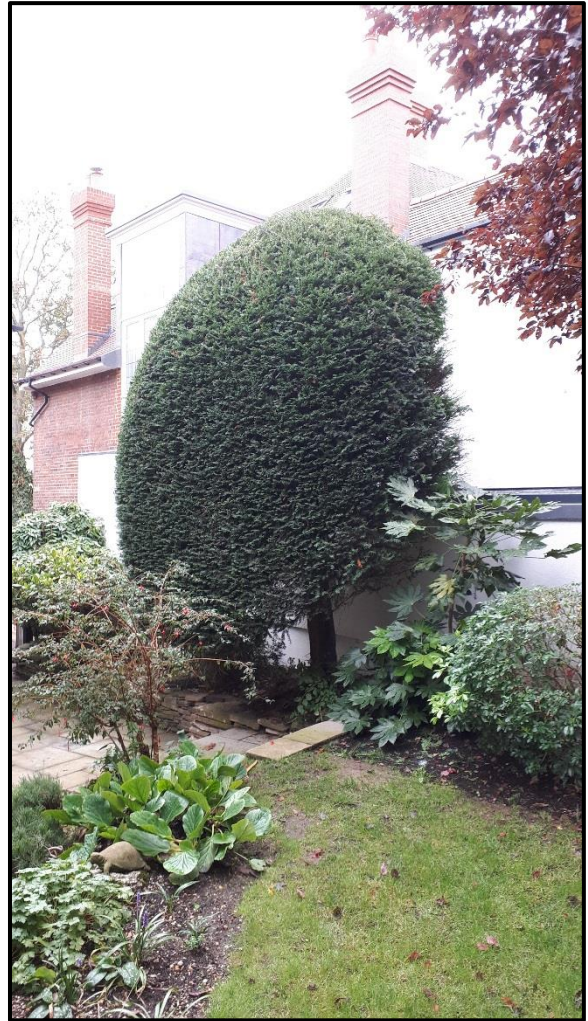
Photograph 6. T5, yew. Viewed looking towards the south-east.

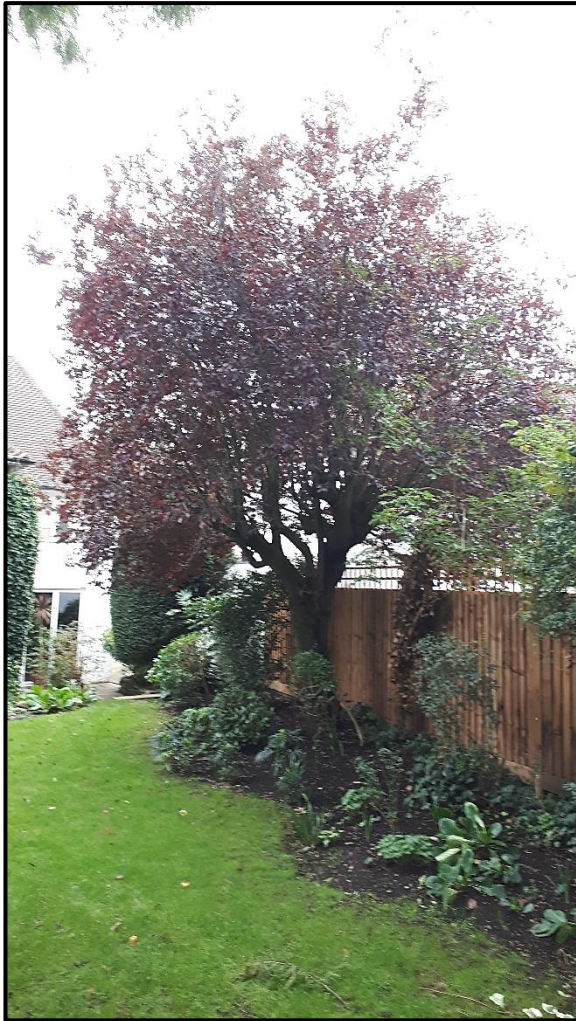
Photograph 7. T6, cherry, located centrally in the rear garden along the southern boundary. Viewed looking towards the south-east.

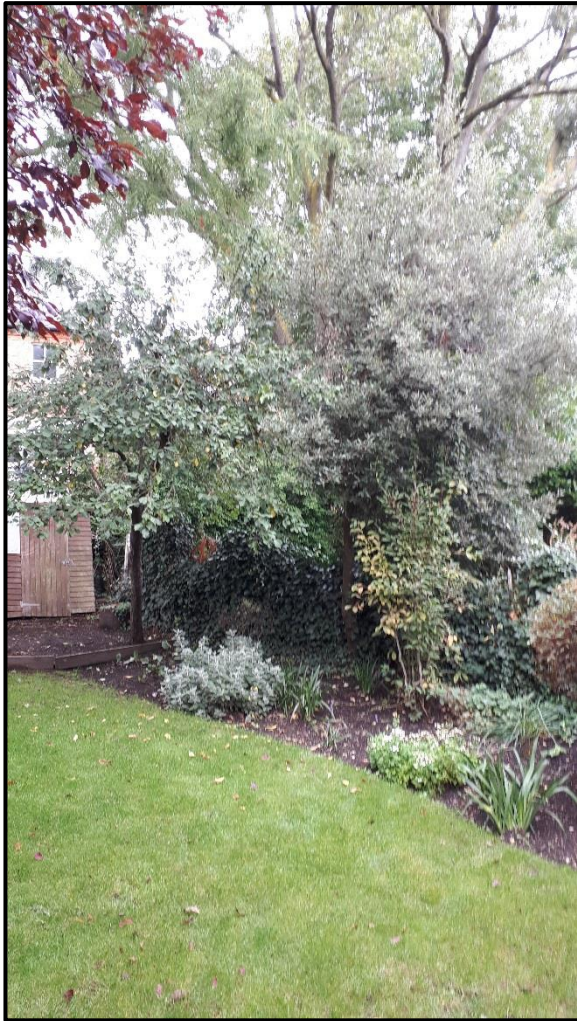
Photograph 9. G1, cherry (centre-left) and holm oak (centre-right), with mutual crown formation. Viewed looking towards the north-west.

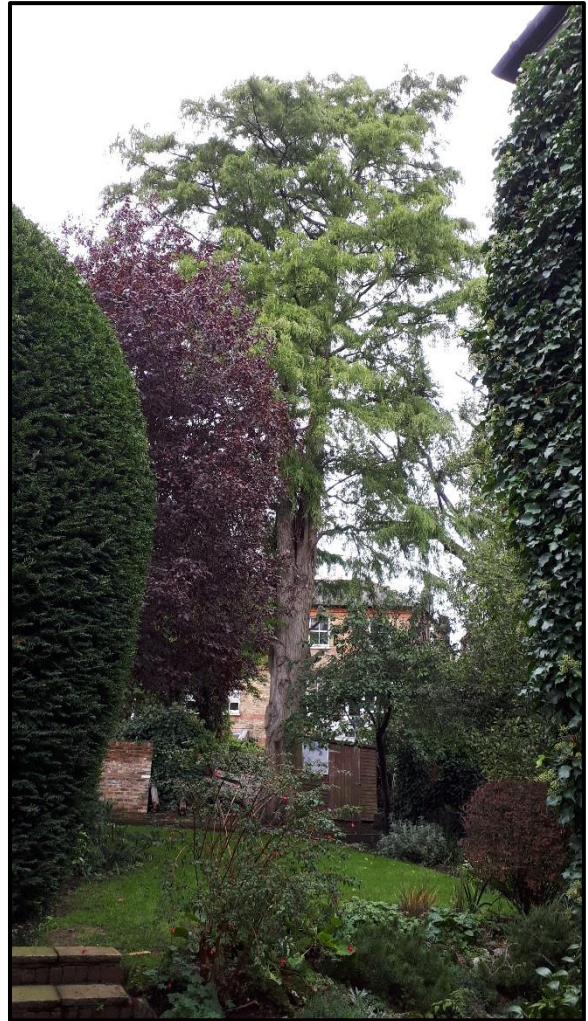
Photograph 10. T7, swamp cypress, located to the far west of the rear garden. A high quality and dominant tree in the surrounding environment. Viewed looking towards the north-west.
