ARBORICULTURAL IMPACT ASSESSMENT

St Paul's CE Primary School, Elsworthy Road, NW3 3DS

Reference: MDJAC-22.137-AIA-01A

Revision: A – 16 January 2023

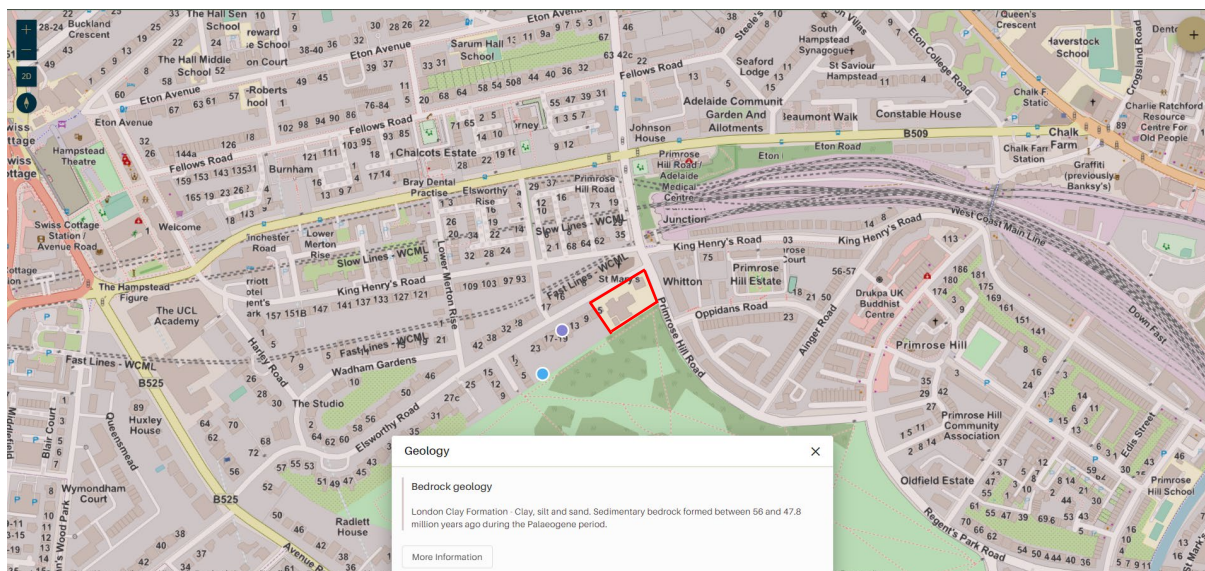
5.1.7 As part of my assessment I have considered the likely soil properties underlying the site. The site is located atop an area of London Clay Formation (British Geology Society, 2022), which is highly susceptible to volumetric changes as a result of moisture extraction, particularly from tree roots. This is further corroborated by the number of insurance claims made for such damages throughout the Greater London area, and in particular, within the London Borough of Camden (Dobson, 2022).

Figure 1: extract showing the location of the site (bounded in red) within an area of London Clay Formation (mauve hatching) (British Geology Society, 2022).

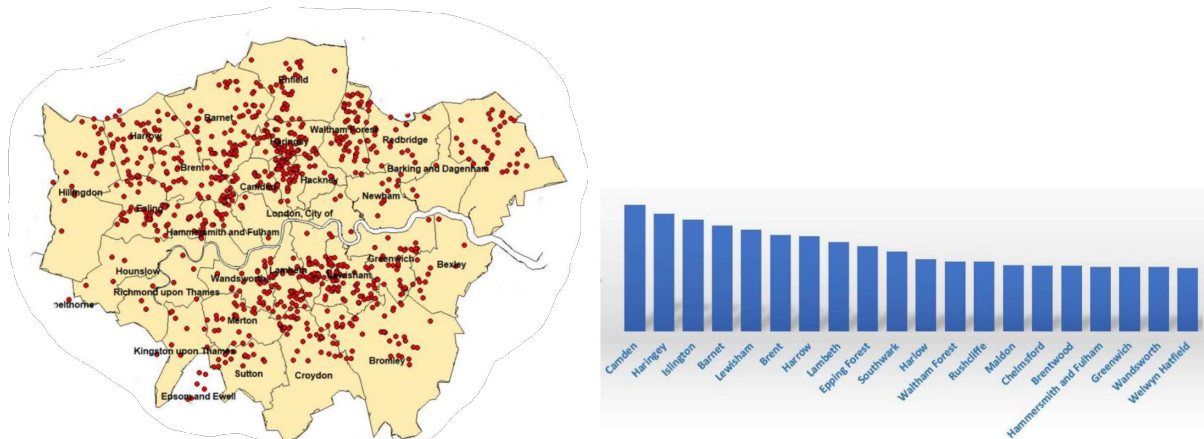
Figure 2: showing the location of tree-related subsidence and damage 'hot spots' throughout Greater London (above left) and the insurance claims frequency by area across the UK (Dobson, 2022).
