## Engineers Report

**Risk Address** 75 Albert Street  
Camden Town  
London  
NW1 7LX

**360 Reference** DLG-SN-22-004445

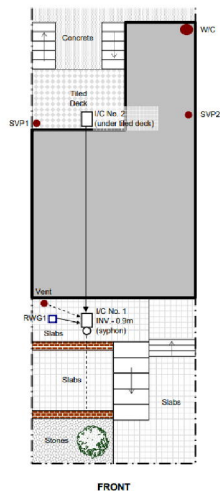
The property is served by a domestic drainage system. This was surveyed as part of the previous claim, and it is understood that the few minor defects found were repaired.
