Issue date: 19/01/2023

Monitoring visit 3 of 4

### Monitoring Plus Report

| <b>Address</b><br>75 Albert Street<br>Campden Town<br>London<br><br>NW1 7LX | | <b>Suspected reason</b><br>to be advised | <b>Monitoring type</b><br>levels & cracks |

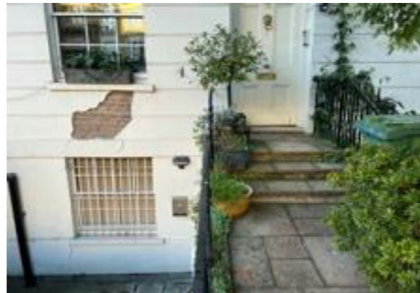
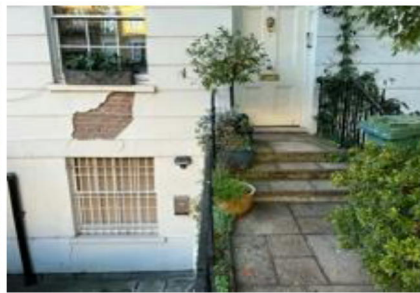
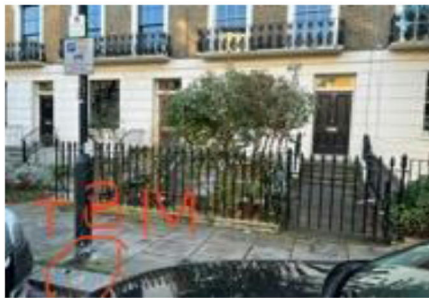
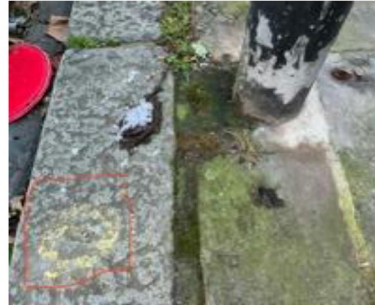
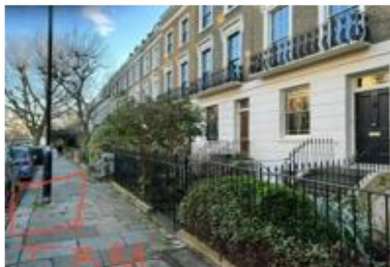
**Photos from visit on 19/01/2023**

| Crack A n/a too high . See photo attached | | <b>Sketch showing location of monitoring points</b><br><p>FRONT ELEVATION</p> <p>TBM: front of No.73, next to the lamp post on footpath</p> | |

Crack A-too high and not safe
