Existing Internal Elevations
Window Stack 01

BW125 - BW - ## - XX - DR - E3001

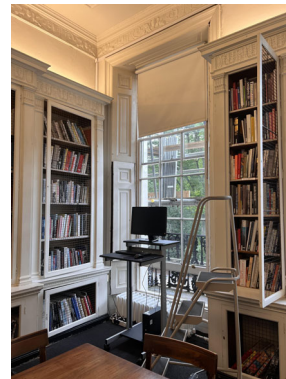
W.03.06

Modern casement
Poor condition
Studwall cuts across

Modern casement window.
Lowest significance.
No related detail of interest.
Non original dormer (widened pre-existing).

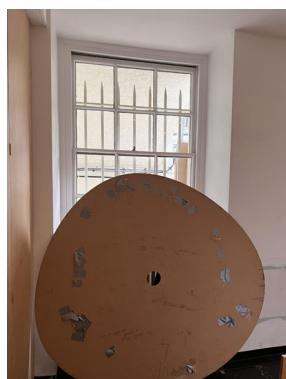
W.01.09

Weighted sash
6 over 9 panel sashes
Shutters historic and original
Painted sash
Manually operated blinds
Pipework through panels
Panels damaged and in bad condition

Chamfered reveals and shutters original although in a poor condition. Left hand side shutter one of few openable shutters. High significance.
Windows have no horns and appear to be original to the building although the glazing is later and sources record that the windows of the first floor were blown out (including glazing bars) during WWII. In addition, it has been reported that the windows to no. 34 were replaced in the 1920s to match those at no. 35 (the windows to no. 34 having been replaced in the 19th century). Given the importance of the first floor windows and appropriate detailing these are considered to be of the highest Significance.
