The Cottage, Hilltop Road Structural Survey Report For Planning

PROJECT NO.	2150		
PROJECT NAME	The Cottage, Hilltop Road		
CLIENT	John Weidner		
PROJECT ADDRESS	The Cottage, Hilltop Road, NW6 2QA		
DOCUMENT TITLE	Structural Survey Report		
DOCUMENT REV.	D		
DATE	03.07.21		
PREPARED BY	Adam Harrison MEng CEng FICE	TITLE	Director
CHECKED BY	Alex Clifton BEng	TITLE	Senior Engineer
<p>This report has been prepared by Constructure Limited with reasonable skill, care and diligence (taking account of the resources devoted to it by agreement with the Client); under the terms and conditions agreed with the Client (incorporating Constructure Limited's General Terms and Conditions of Business); for the sole use and benefit of the Client and for the sole purpose agreed with the Client.</p> <p>The benefit of this report shall not be assigned by the Client to any third party, without the express prior written consent of Constructure Limited.</p> <p>This report shall not be relied upon by any third party without the express prior written consent of Constructure Limited and Constructure Limited accepts no liability to any third party to whom this report (or any part thereof) is disclosed without

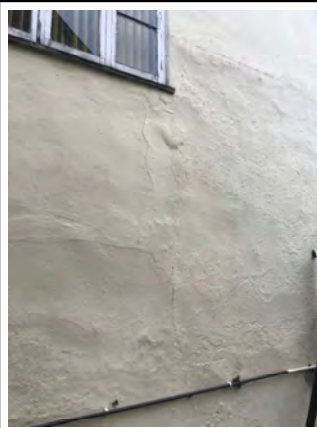
[4] South facade wall

The boundary wall to the west is seen to be in poor condition, with cracking visible through the painted brickwork [6]. To the south facade wall, cracking was visible to a number of locations, with render flaking/crumbling away from the masonry. This is reflected by internal damp, suggesting that the render is both letting water in, and holding this against the masonry creating damp internally [11].

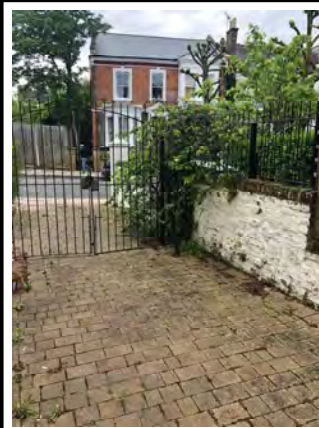
[5] Driveway

The paving forming the driveway to the south of the property has visibly settled, and there is a dip which we understand creates standing water during wet weather. It was noted that there is a height difference between the neighbouring property to the south, and this driveway, with the adjoining property being founded at a lower level.
