Design and Access Statement

In support of Planning and Listed Building Application Reference:
PP-11210537, submitted to Camden Council on 22nd April 2022

Address: 1, Charrington Street, London NW1 1RS

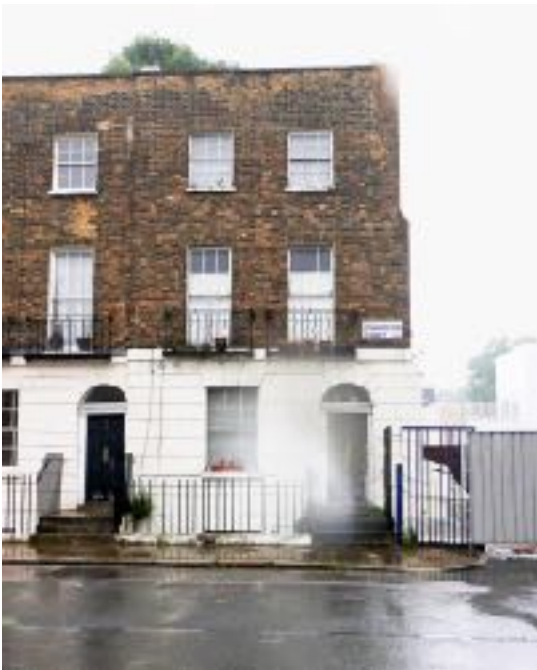
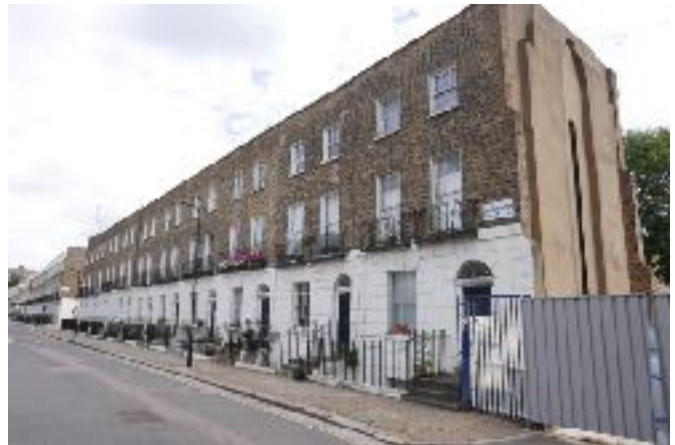
The building is a 4 storey, (including basement), Grade 2 listed, end of terrace house, from the late 19th century, occupied by one tenant at present, renting the property. It was probably reinforced with buttresses, etc, on the end gable. Details of when and why are unknown.

Photographs of Front elevation and Gable end, November 2021
