Design note

Project	Date	By	Reference
Ambassadors Theatre, London	2 Mar 2023	RR	5208_DN_001

Title
Structural design philosophy, remedial works overhead pavement support

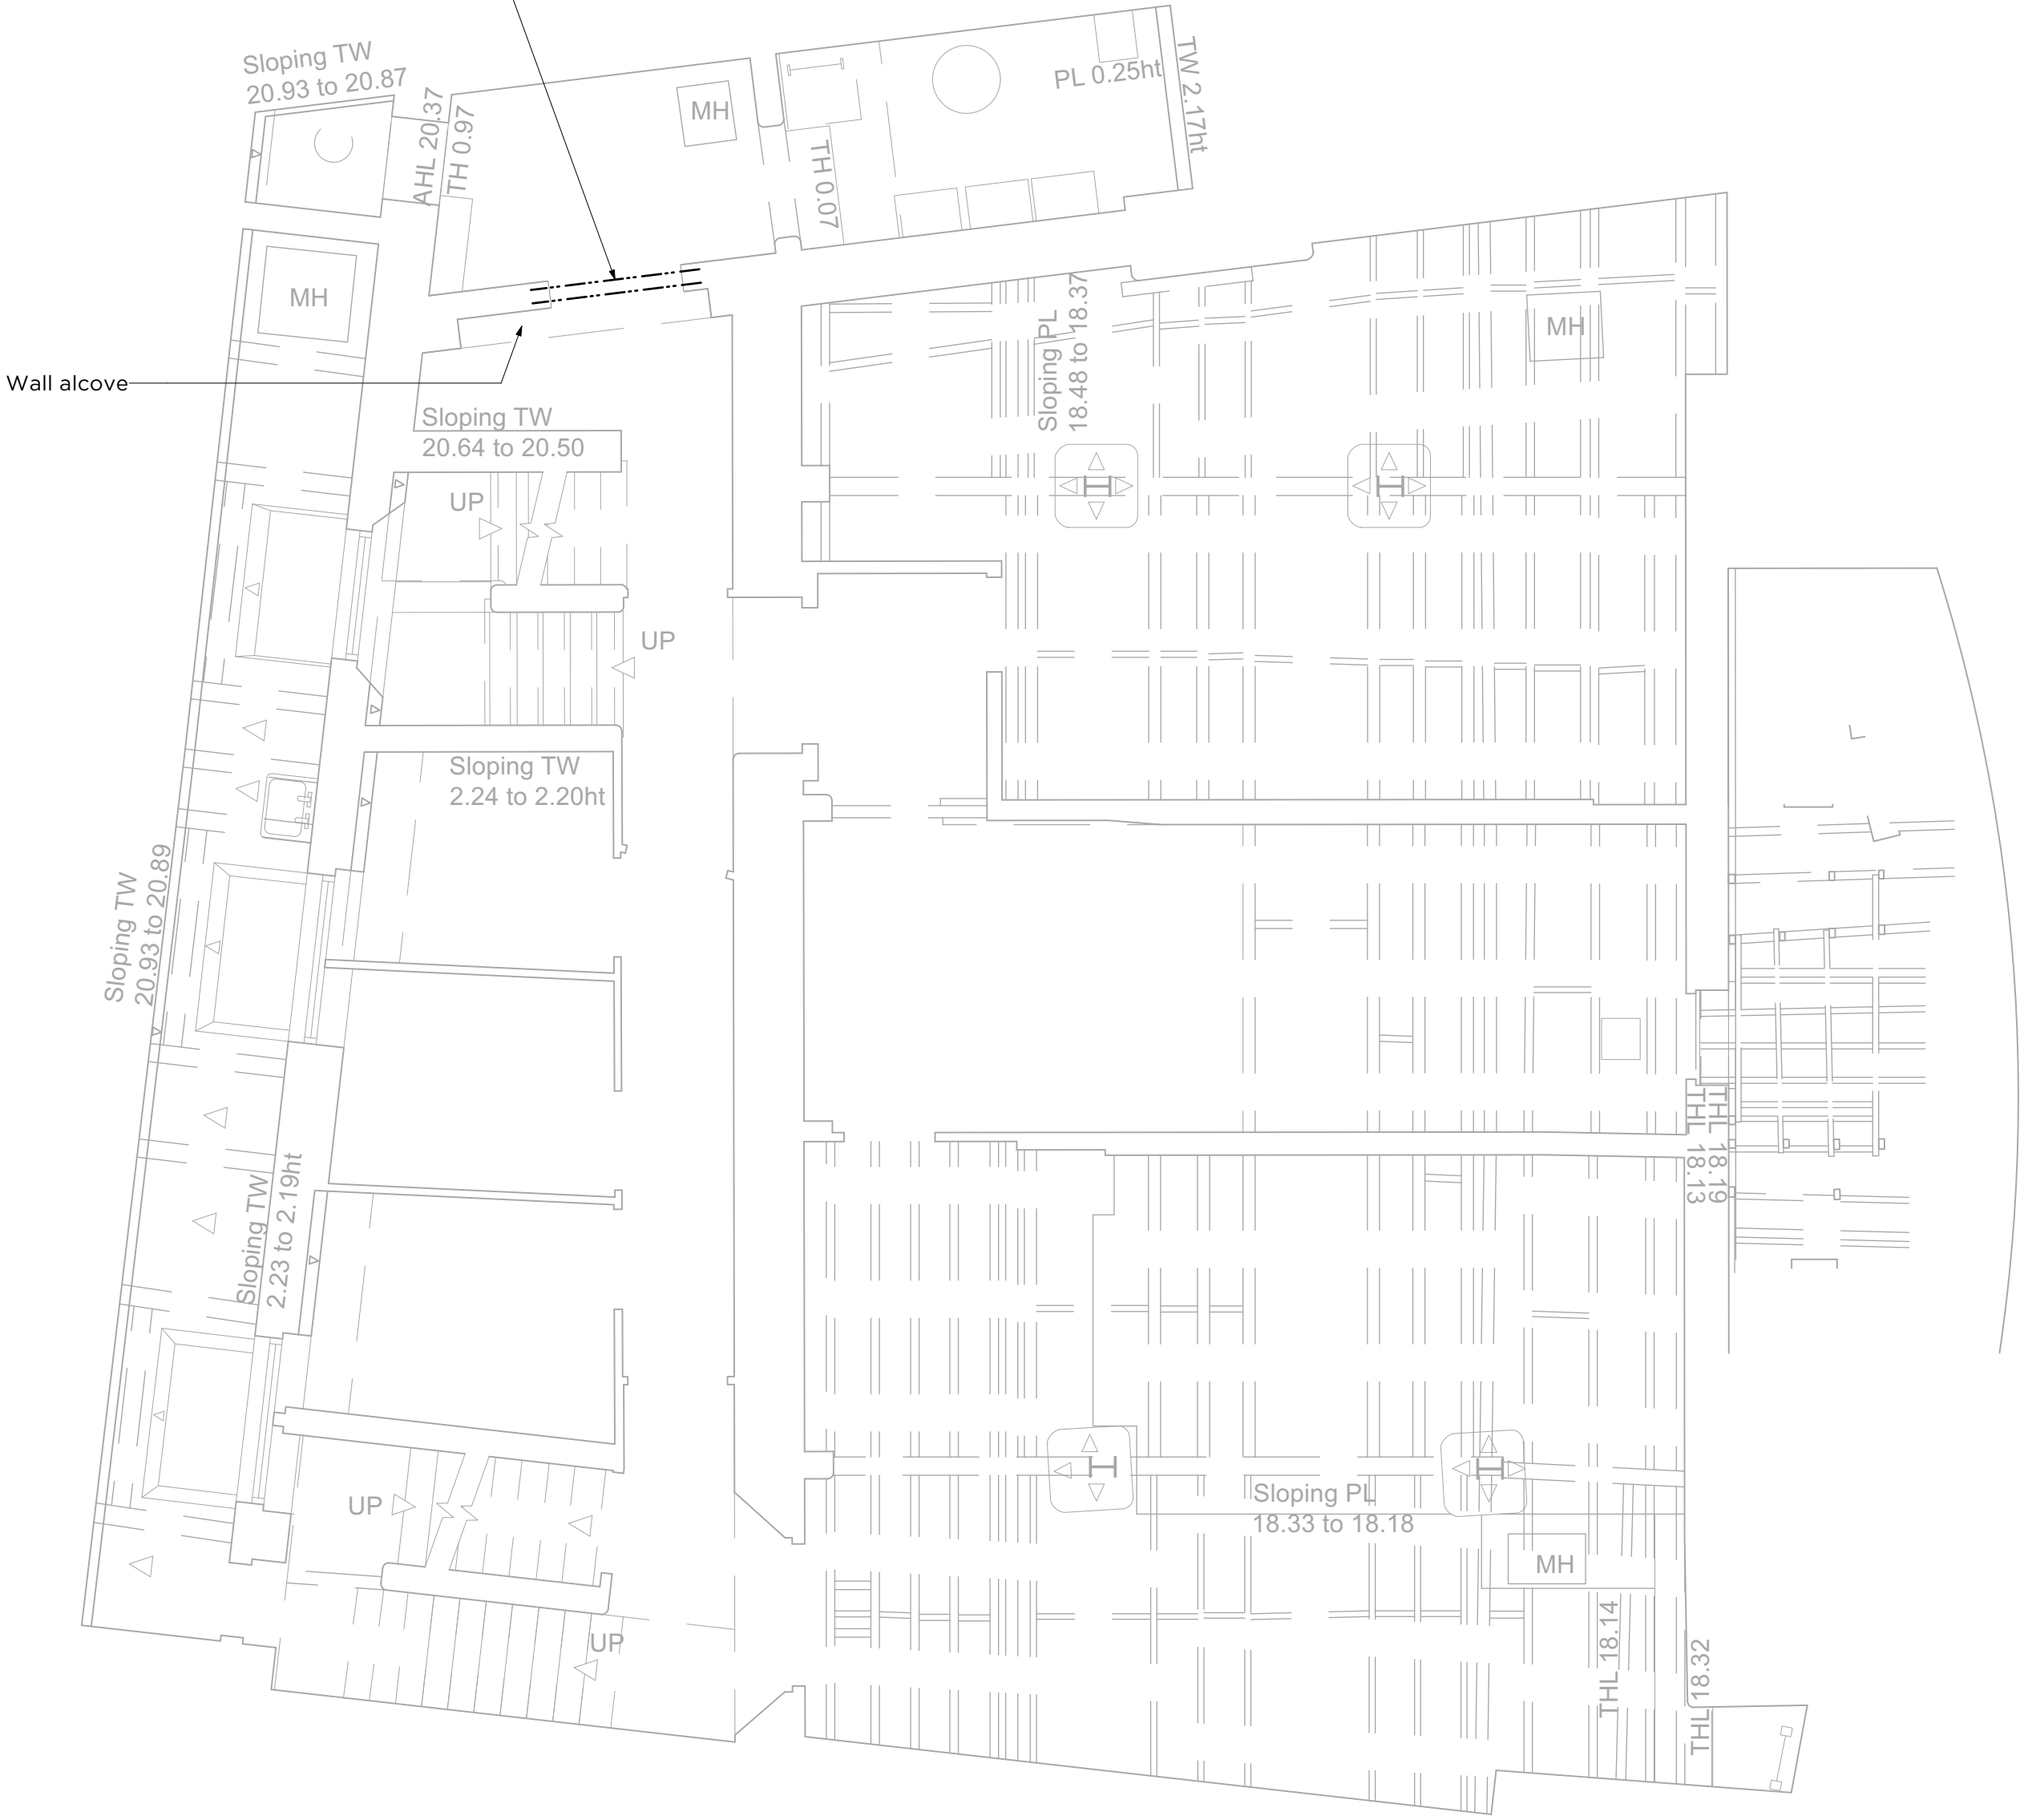
New opening in existing masonry wall:
- 2no precast plank lintels over 100w x 140dp, with 150mm bearing at each end.
- Opening to be created in two stages: one half leaf removed & lintel installed first, followed by the other half leaf
