## ARBORICULTURAL ASSESSMENT REPORT

<b>For:</b>	<b>Client:</b>	Sedgwick International UK
	<b>Insurer:</b>	Covea
<b>Site:</b>	<b>Policyholder:</b>	Aberdare Gardens Ltd
	<b>Risk Address:</b>	57 Aberdare Gardens, London, NW6 3AL
<b>Refs:</b>	<b>PRI Ref:</b>	
	<b>Client Ref:</b>	
	<b>Insurer Ref:</b>

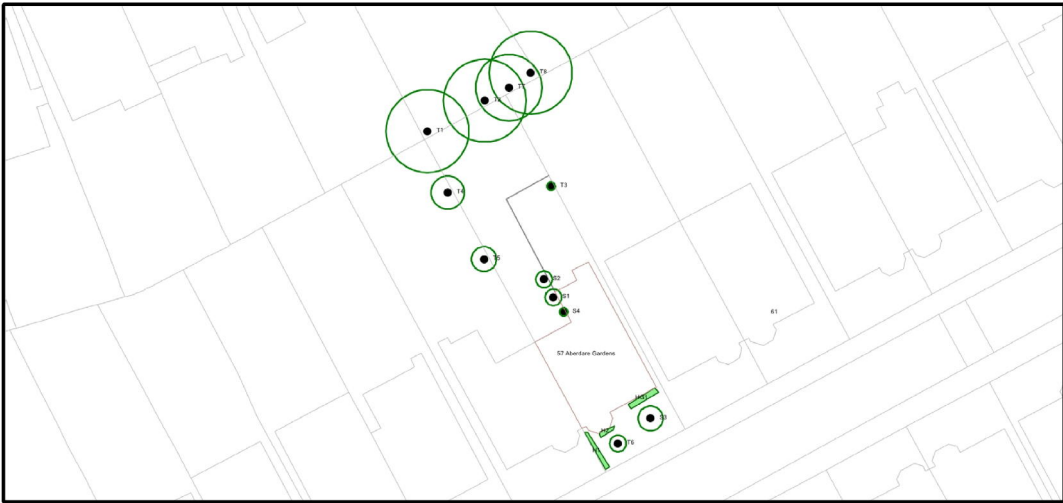
Location:	57 Aberdare Gardens, London, NW6 3AL
Job Ref:	[REDACTED]
Survey Date:	- NTS
By Property Risk Inspection - Insurance Services
