**Subject:** CEPC Balustrades

The provisional report by Andy Maskell was extremely useful.

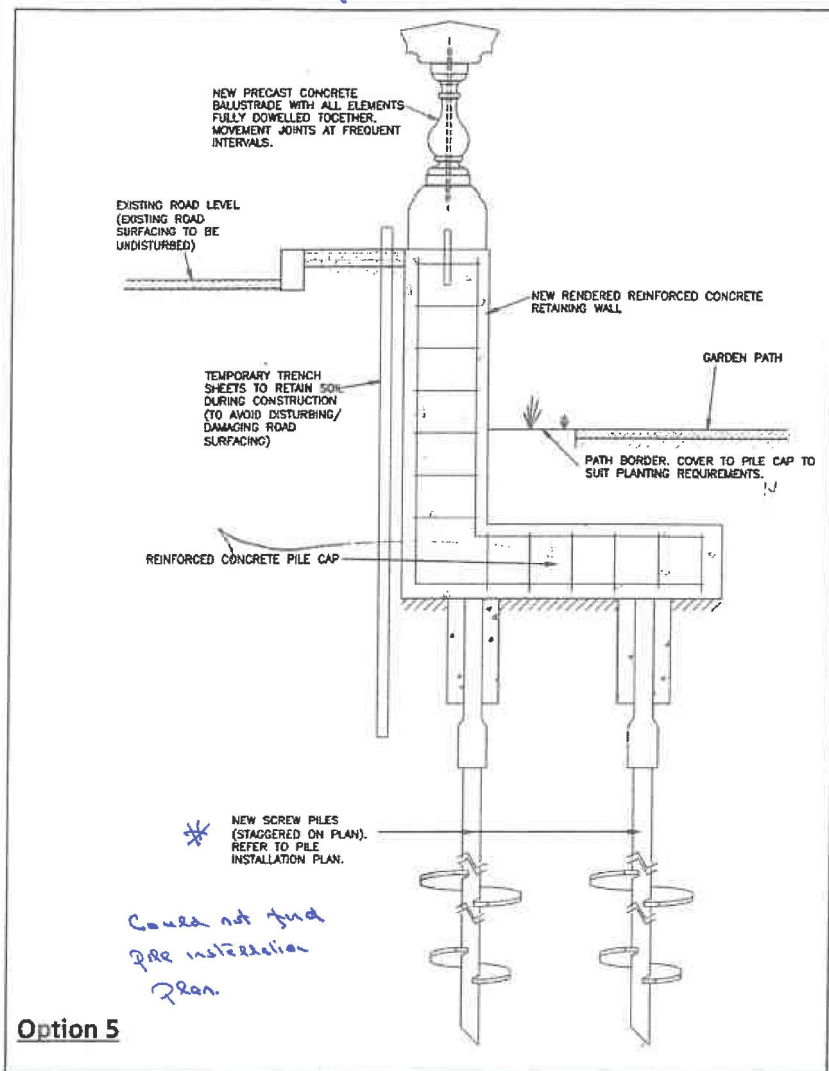
Indicative piling arrangement.

Note depth of excavation for concrete pile cap varies

Attached please find two copies of his drawing.

On the first one, I show a yellow shading at approximately 2.5m from the garden side of the balustrade.

On the second drawing, I show a blue shading approximately 4m from the balustrade.

As you can see from the drawing prepared by our consultant, the reinforced concrete pile cap is itself approximately 1.5m from the balustrade, so I believe it is self evident that extensive disturbance will occur within 2.5m of the boundary wall.

As you will see, I have marked in red the trees that are likely to be lost on each of the plans.
