—The British Museum
Low Level Roofs
Design & Access Statement
Rev 1

The British Museum
Low Level Roofs
Design & Access Statement

This Design and Access Statement has been prepared by Nex on behalf of The British Museum to illustrate proposals for the proposed roof refurbishments to five small roofs at the south east of the Museum.

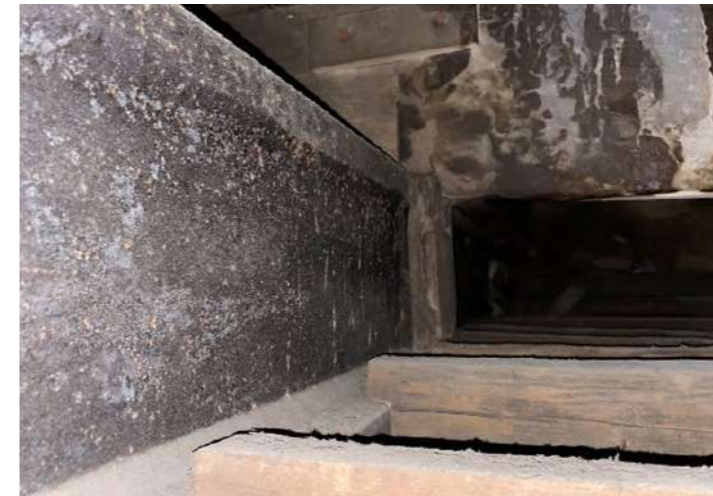
01. Water ingress to slate joist within roof void of B/3/X03
02. Water damaged joist and deck within B/2/X03
03. Flaking paintwork within Contractor's WC
04. Flaking paintwork within Contractor's corridor
05. Life expired mechanical plant on gantry over B/3/X04
06. Electrical cabling running next to B2/X01

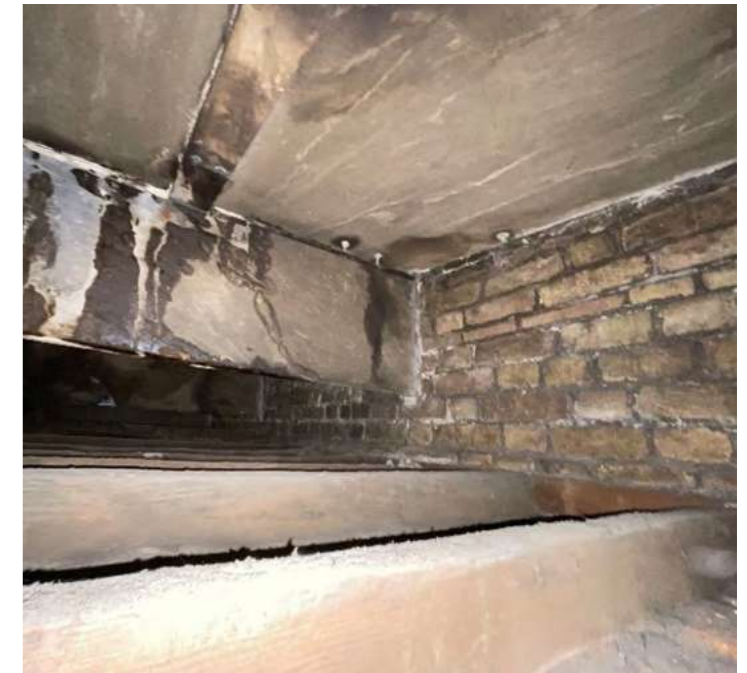
01. Photo showing B/3/X03, highlighted in blue
 02. Slate panels and joists over lath and plaster ceiling on timber joists
 03. Structural Engineer's sketch of existing roof structure of B/3/X02

B/3/X03 has slate weathering strips below the seams of the panels, sat over a slate ridge beam and slate purlins. The slate purlins are supported by a cast iron beam which seems to be original to the construction. Timber ceiling joists are tied into the underside of the cast iron beam, and support a lath and plaster ceiling.

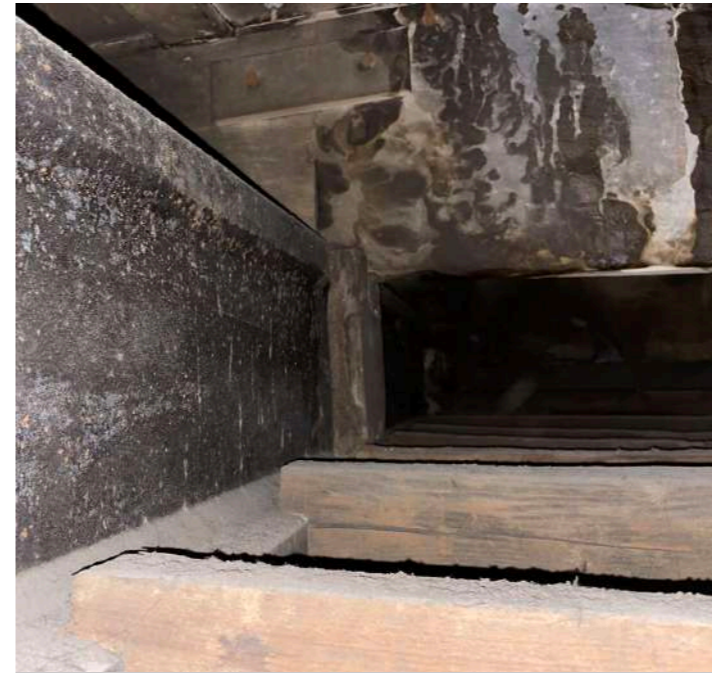
- 01. Slate joist supported by cast iron beam within roof void of B/3/X03
- 02. Flaking bitumen and disused pipe over B/3/X03
- 03. Brick piers within roof void of B/3/X04
- 04. Core through B/3/X04 down to patent slate panel

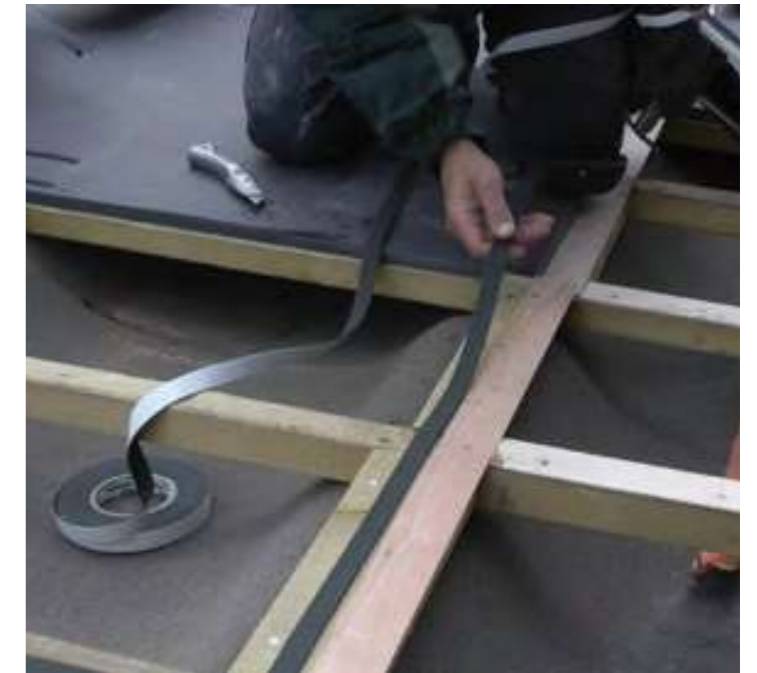
01. Installation of Compriband over new timber structure at St. George's Church, Everton
02. Finished patent slate roof at St. George's Church, Everton

Both of these projects employed a similar methodology in repairing the roofs, where the original slates were lifted and the substructure - in these cases formed from timber and iron - were inspected and repaired. In the project at St. George's, it was estimated that around 40% of the slates were cracked and damaged as part of this process, and needed to be replaced. Following repair to the structure, a contemporary sarking felt was laid and ventilation

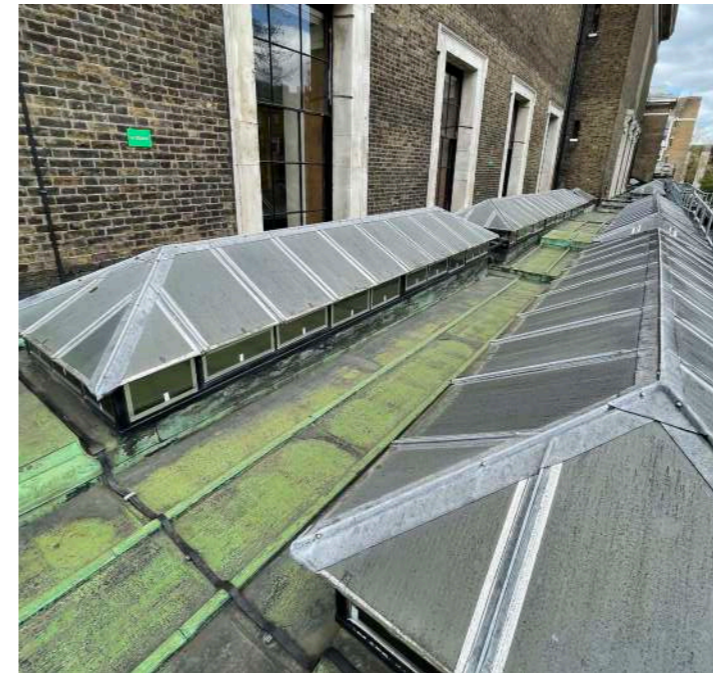
- 01. Copper roofing on the Sector A roofs at the east of the British Museum
- 02. Copper roofing of the dome over the Round Reading Room at the British Museum
- 03. Existing skylight

A further option explored by Nex was to remove and replace the existing slate roof coverings and structure, and replace with new steel and timber structure and a new copper roof, retaining the original ceilings. This option has the benefit of leaving the lath and plaster and stone/slate ceilings in place, and introducing a roof in keeping with other areas of the Sydney Smirke design at the Museum, which would both be a robust covering to prevent water ingress and a more visually attractive and appropriate covering than a contemporary membrane.
