DESIGN STATEMENT

4.2 HERITAGE APPROACH

4.5 SUSTAINABILITY STRATEGY

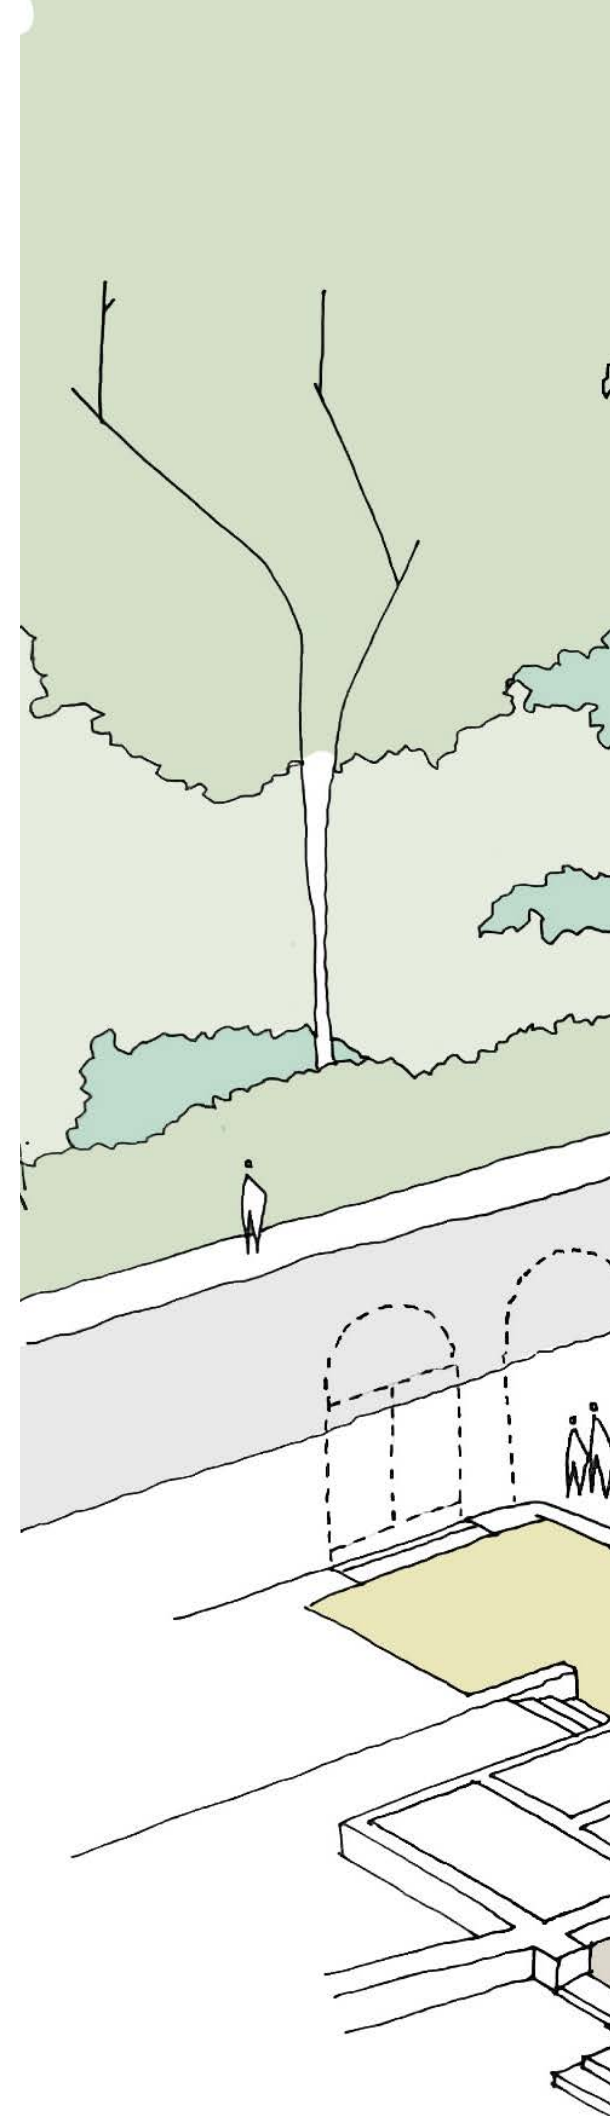
- ① **Wall and roof upgrades** - All external walls and roof to be insulated to improve the thermal efficiency of the houses.
- ② **Window upgrades** - Majority of window glazing to be upgraded to provide thermal efficiency and support the heating strategy.

- ③ **Airtightness** - Perimeter seals introduced to all windows and doors. Chimneys to be sensitively sealed to prevent draughts.
- ④ **Fire and acoustic upgrades** - All separating floor and walls to be upgraded to meet high levels of fire safety and offer improved acoustic comfort.

- ⑤ **Energy** - Gas boilers to be removed and replaced with an Air Source Heat Pump system located in the garden of house 46.
- ⑥ **Biodiversity** - Gardens to be replanted to improve the biodiversity of the site and to create an enhanced outlook for all residents.

- ⑦ **Wellbeing** - Internal arrangements of houses adjusted to provide garden access to all residents.

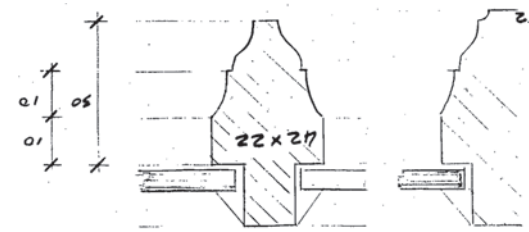
Example of window bar record drawings

A sensitive approach will be taken to the replacements, ensuring that existing window panel arrangements, sash frame sizes and window bar profiles are followed. Record drawings from the 1980s works list profiles which can be utilised - see MICA conservation buildings report for more information.

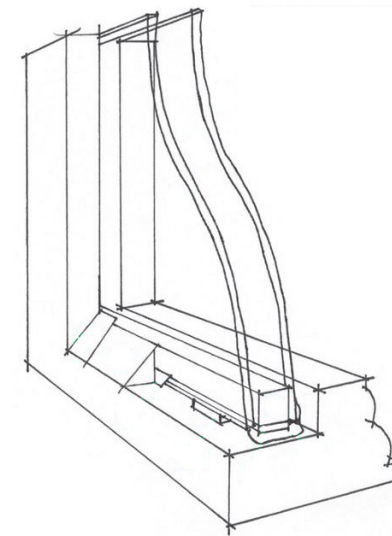
Sketch showing thin profile double glazing installation

As part of the sustainability strategy, to improve the thermal efficiency of the buildings, it is proposed that the sash windows are fully replaced, incorporating thin profile double glazing to improve the U-Value to 1.8 W/m²K, an improvement of 65%. In addition, new draught seals will be added, increasing air-tightness and further reducing heat loss.

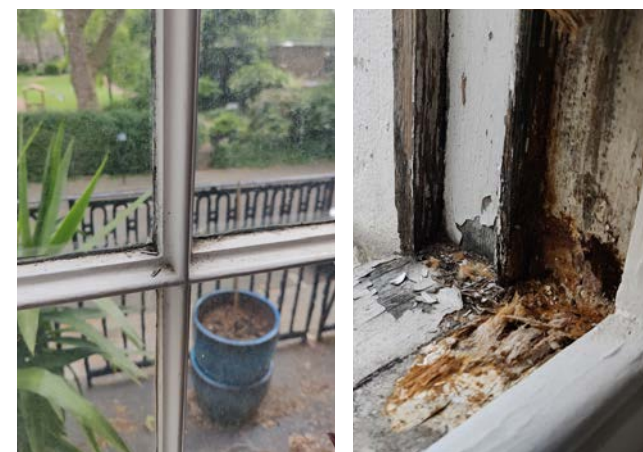
Existing window bars and visible frame deterioration

The windows are a significant feature of the facade and add to the heritage value of the houses although they are later additions - replaced in the 1980s works. The single glazed units offer a U-Value of 5.1 W/m²K. Lack of maintenance has also led to high levels of deterioration throughout.

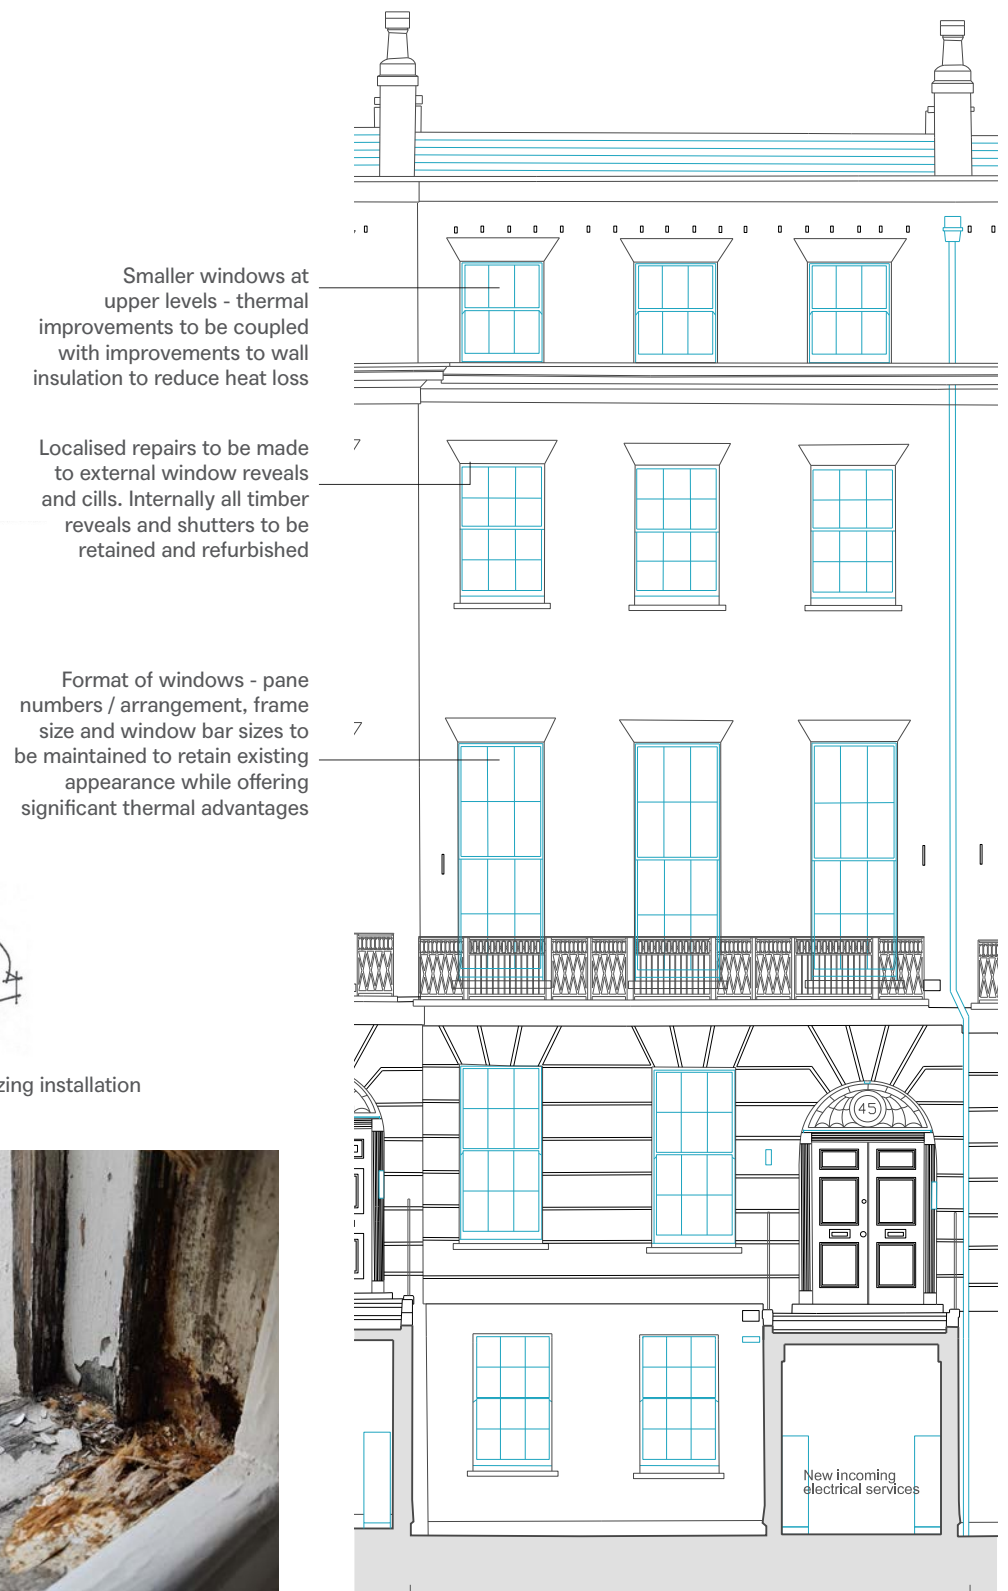
Excerpt from proposed South elevation

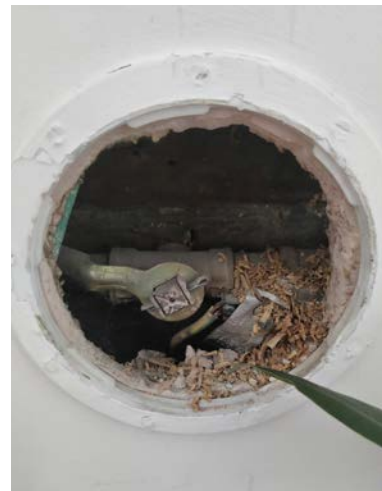
Existing wall cavity

Where an existing cavity is present, insulation will be installed behind the plasterboard, maintaining the existing wall line and ensuring decorative features including cornicing, picture rails, dado rails and skirting are conserved.

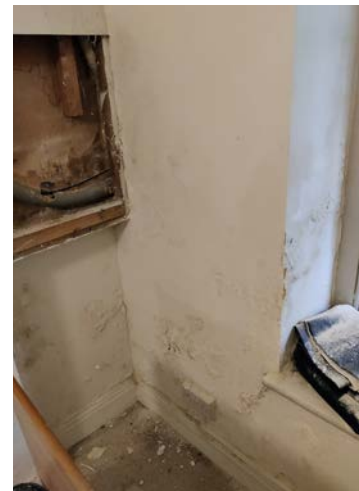
Basement damp walls

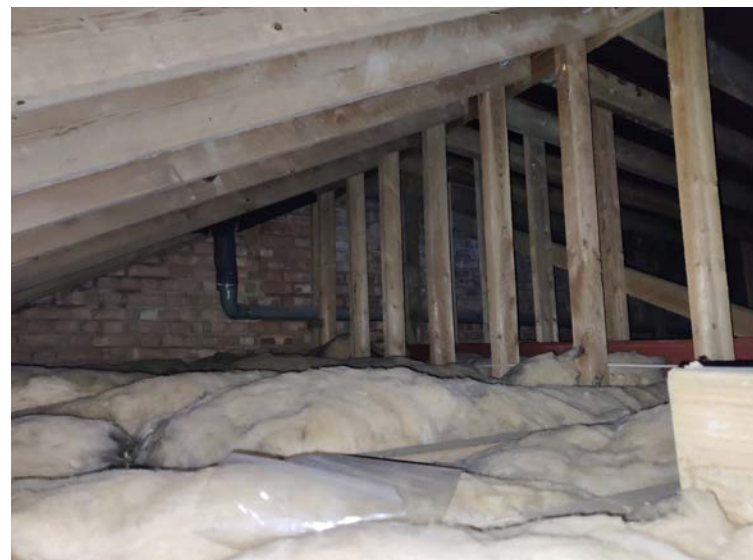
Existing insulation at ceiling level - no insulation between joists

Currently, there is some insulation in the roof voids at ceiling level. In the proposed works to refinish the roofs, additional insulation is proposed between the roof joists, improving the thermal efficiency of this element of the buildings. The level of the roofs will be unaltered.

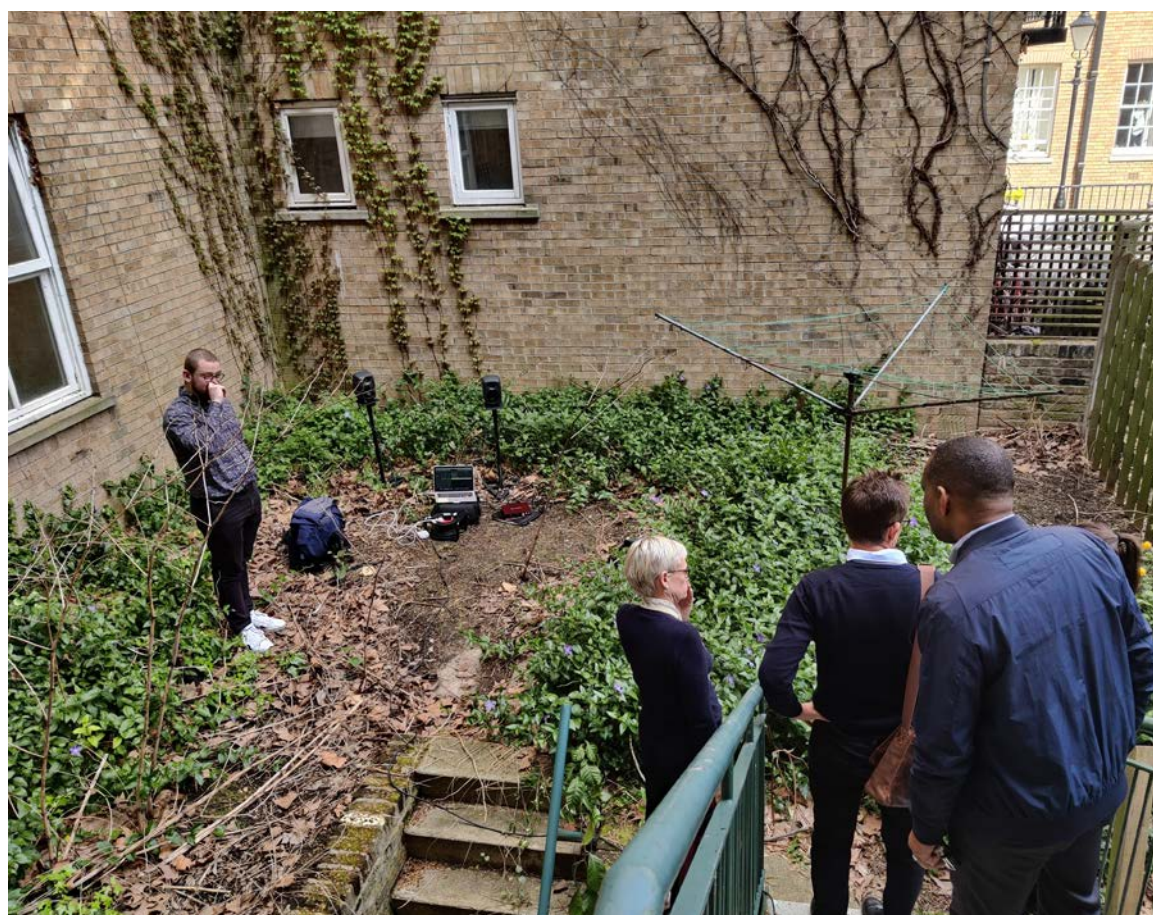
Acoustic demonstrations carried out by acoustic consultant to present the level of attenuated noise from the ASHP units within the gardens of House 46. Noise levels were also checked in the adjacent corridors where the sound was inaudible.

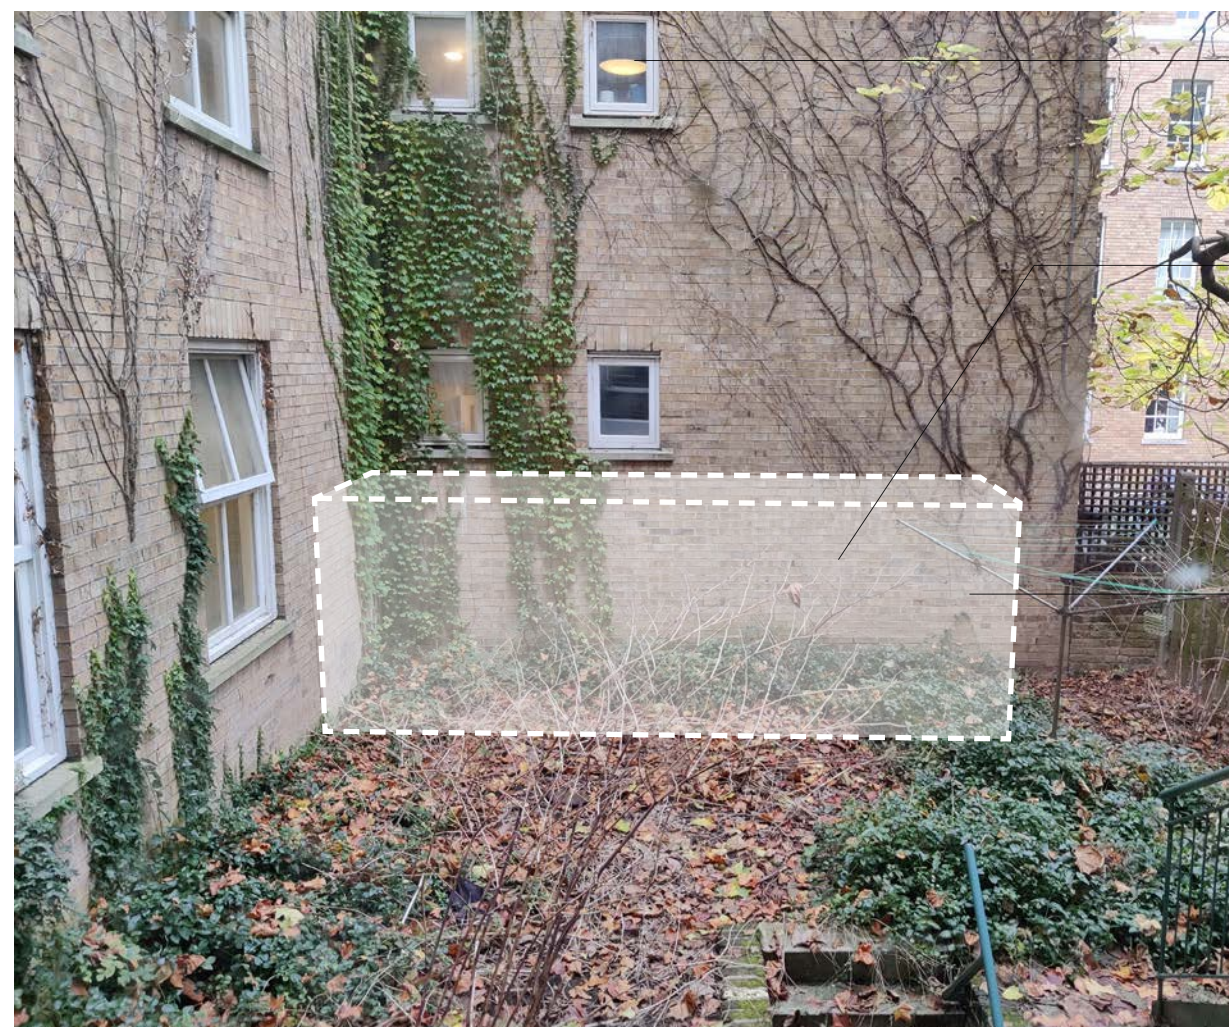
Proposed location of ASHP acoustic enclosure in garden of House 46

Secondary windows to kitchens in William Goodenough House - primary windows on east facade (not visible in photo) and away from ASHP enclosure

Existing plant room of William Goodenough House in basement directly behind proposed ASHP location

Located in corner, below windows the impact of the ASHP enclosure is minimised

Acoustic enclosure powder coated to minimise impact. Acoustic rating defined by acoustic consultant to meet Part E requirements

East facade of William Goodenough House facing garden and acoustic enclosure occupied by circulation corridors on all levels

The location of the ASHP units has been carefully considered to minimise impact on the surrounding environment and occupants. It is proposed that they be located in the garden of House 46, adjacent to communal areas of William Goodenough House and housed within an acoustic enclosure to limit noise transfer.

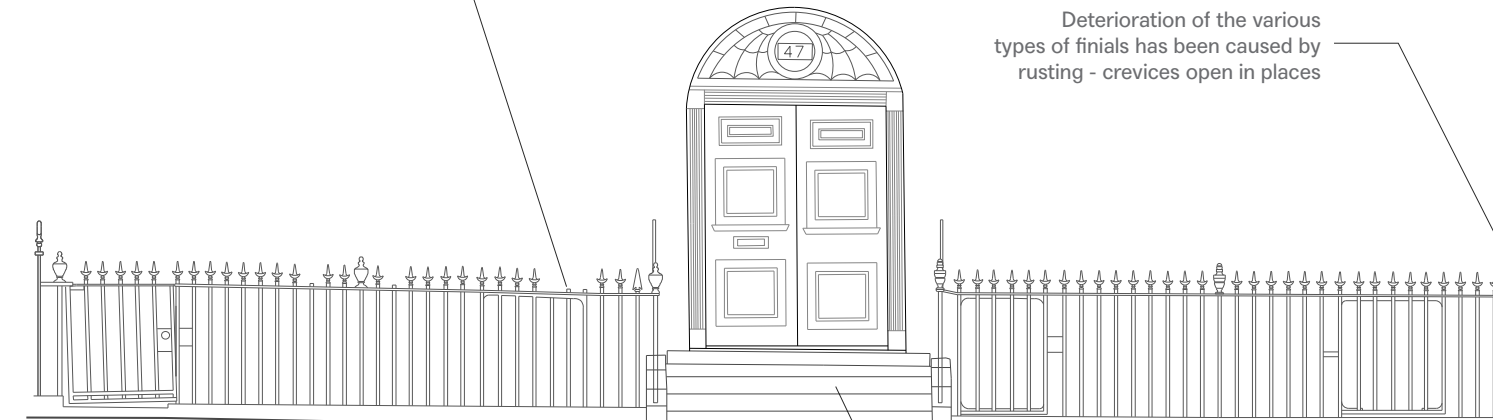
Missing railing heads have left the top of posts exposed and vulnerable to further rust damage

Layers of paint on fan-light timbers and cracks in glazing. Unsightly bird deterrent spikes located on top of door frame

Deterioration of the various types of finials has been caused by rusting - crevices open in places

Existing south elevation railings and entrances to houses 43-47

Small tiles have been used to cover the original finishes of the steps to house 47. No drainage channel in place

Key to the overall appearance of the houses and their place on the streetscape are the railings and gates surrounding the lower ground floor front yards and vaults and the entrance steps up to the front doors. As with the houses there are differing conditions across the length with some missing railing heads and finials with significant rust deterioration.

The steps of house 47 have been covered in small tiles, not in keeping with the age of the buildings and the top landing of the steps of house 44 has been covered over with asphalt.

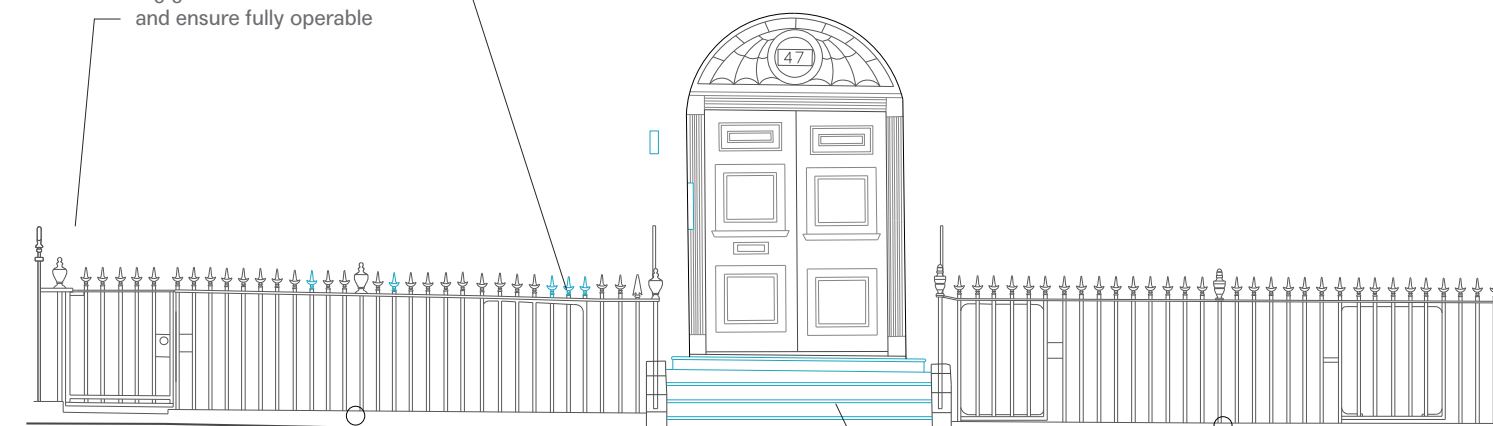
Replacement railing heads to be made to match existing design and fixed to bottom railings.

Re-hang gates to make secure and ensure fully operable

Proposed south elevation railings and entrances to houses 43-47

Small tiles to be removed to determine if original yorkstone paving in place. Repair / replace yorkstone to match adjacent as required.

- Repair damaged railings and replace missing sections.
- Re-hang gates that are not securely on hinges.
- Sand back and refinish railings.
- Repair stonework at base of railings as needed.
- Introduce drainage channels between landing and entrance doors to reduce water damage.
- Remove later finishes to steps and repair / replace stone to match adjacent.
- Repair front doors and fan-lights over.
- Install new discreet bird deterrent wires.

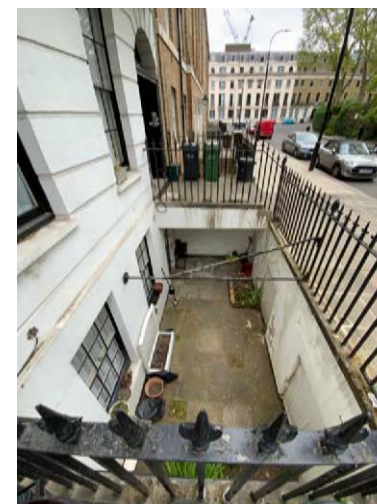
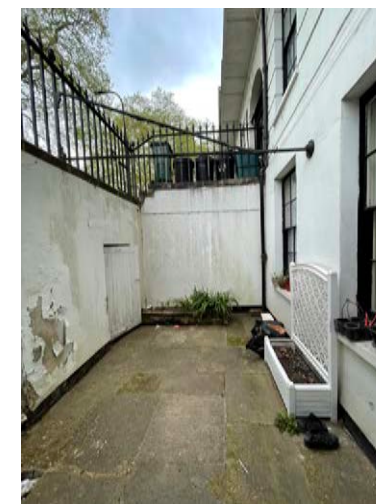
Front yard of House 43

House 43 ground surface is yorkstone pavers whereas the other houses have been concreted over in previous works. Existing drainage points remain.

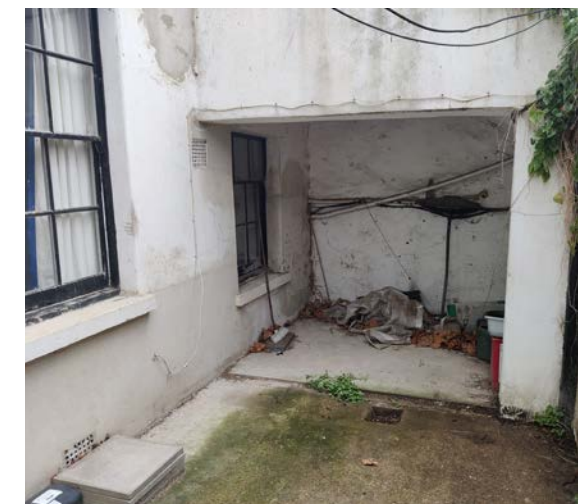
Front yard of House 47

Finishes have deteriorated with some of the render blown. House 47 has had some areas repaired along with the balcony repairs.
