5.0 Heritage Areas

5.1 Internal Heritage Areas

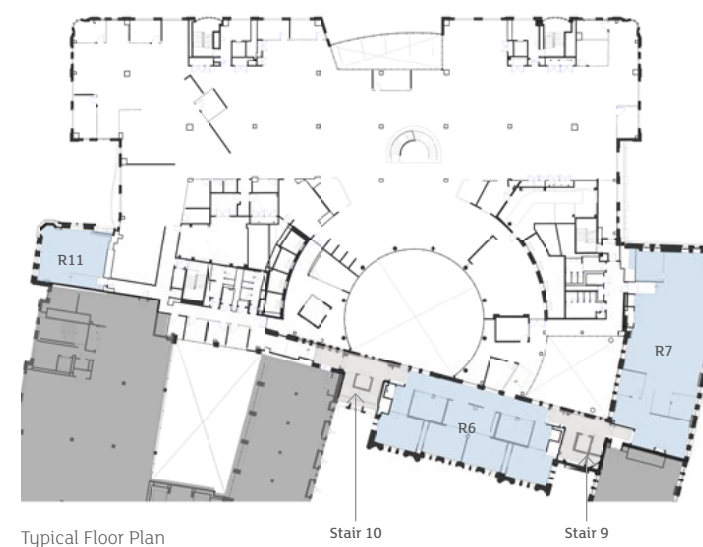
Typical Floor Plan

There are two stairs adjacent R6.

- Stair 9 - is a contemporary intervention, where historically no stair was present. Faience brickwork is visible on the north of the landings and is historically significant. Heritage style doors provide access into the stair from the lobbies. Secondary glazing has been introduced to the windows at the storey landings.
- Stair 10 - is an original stair with faience brickwork throughout. The stair has been historically adapted extending the core up to the fifth floor, with landings adjusted throughout. Secondary glazing has been introduced to the windows at the storey landings.

There are two original Waterhouse facades forming the south and west facade of the existing atria, which have been added to and adapted over time.

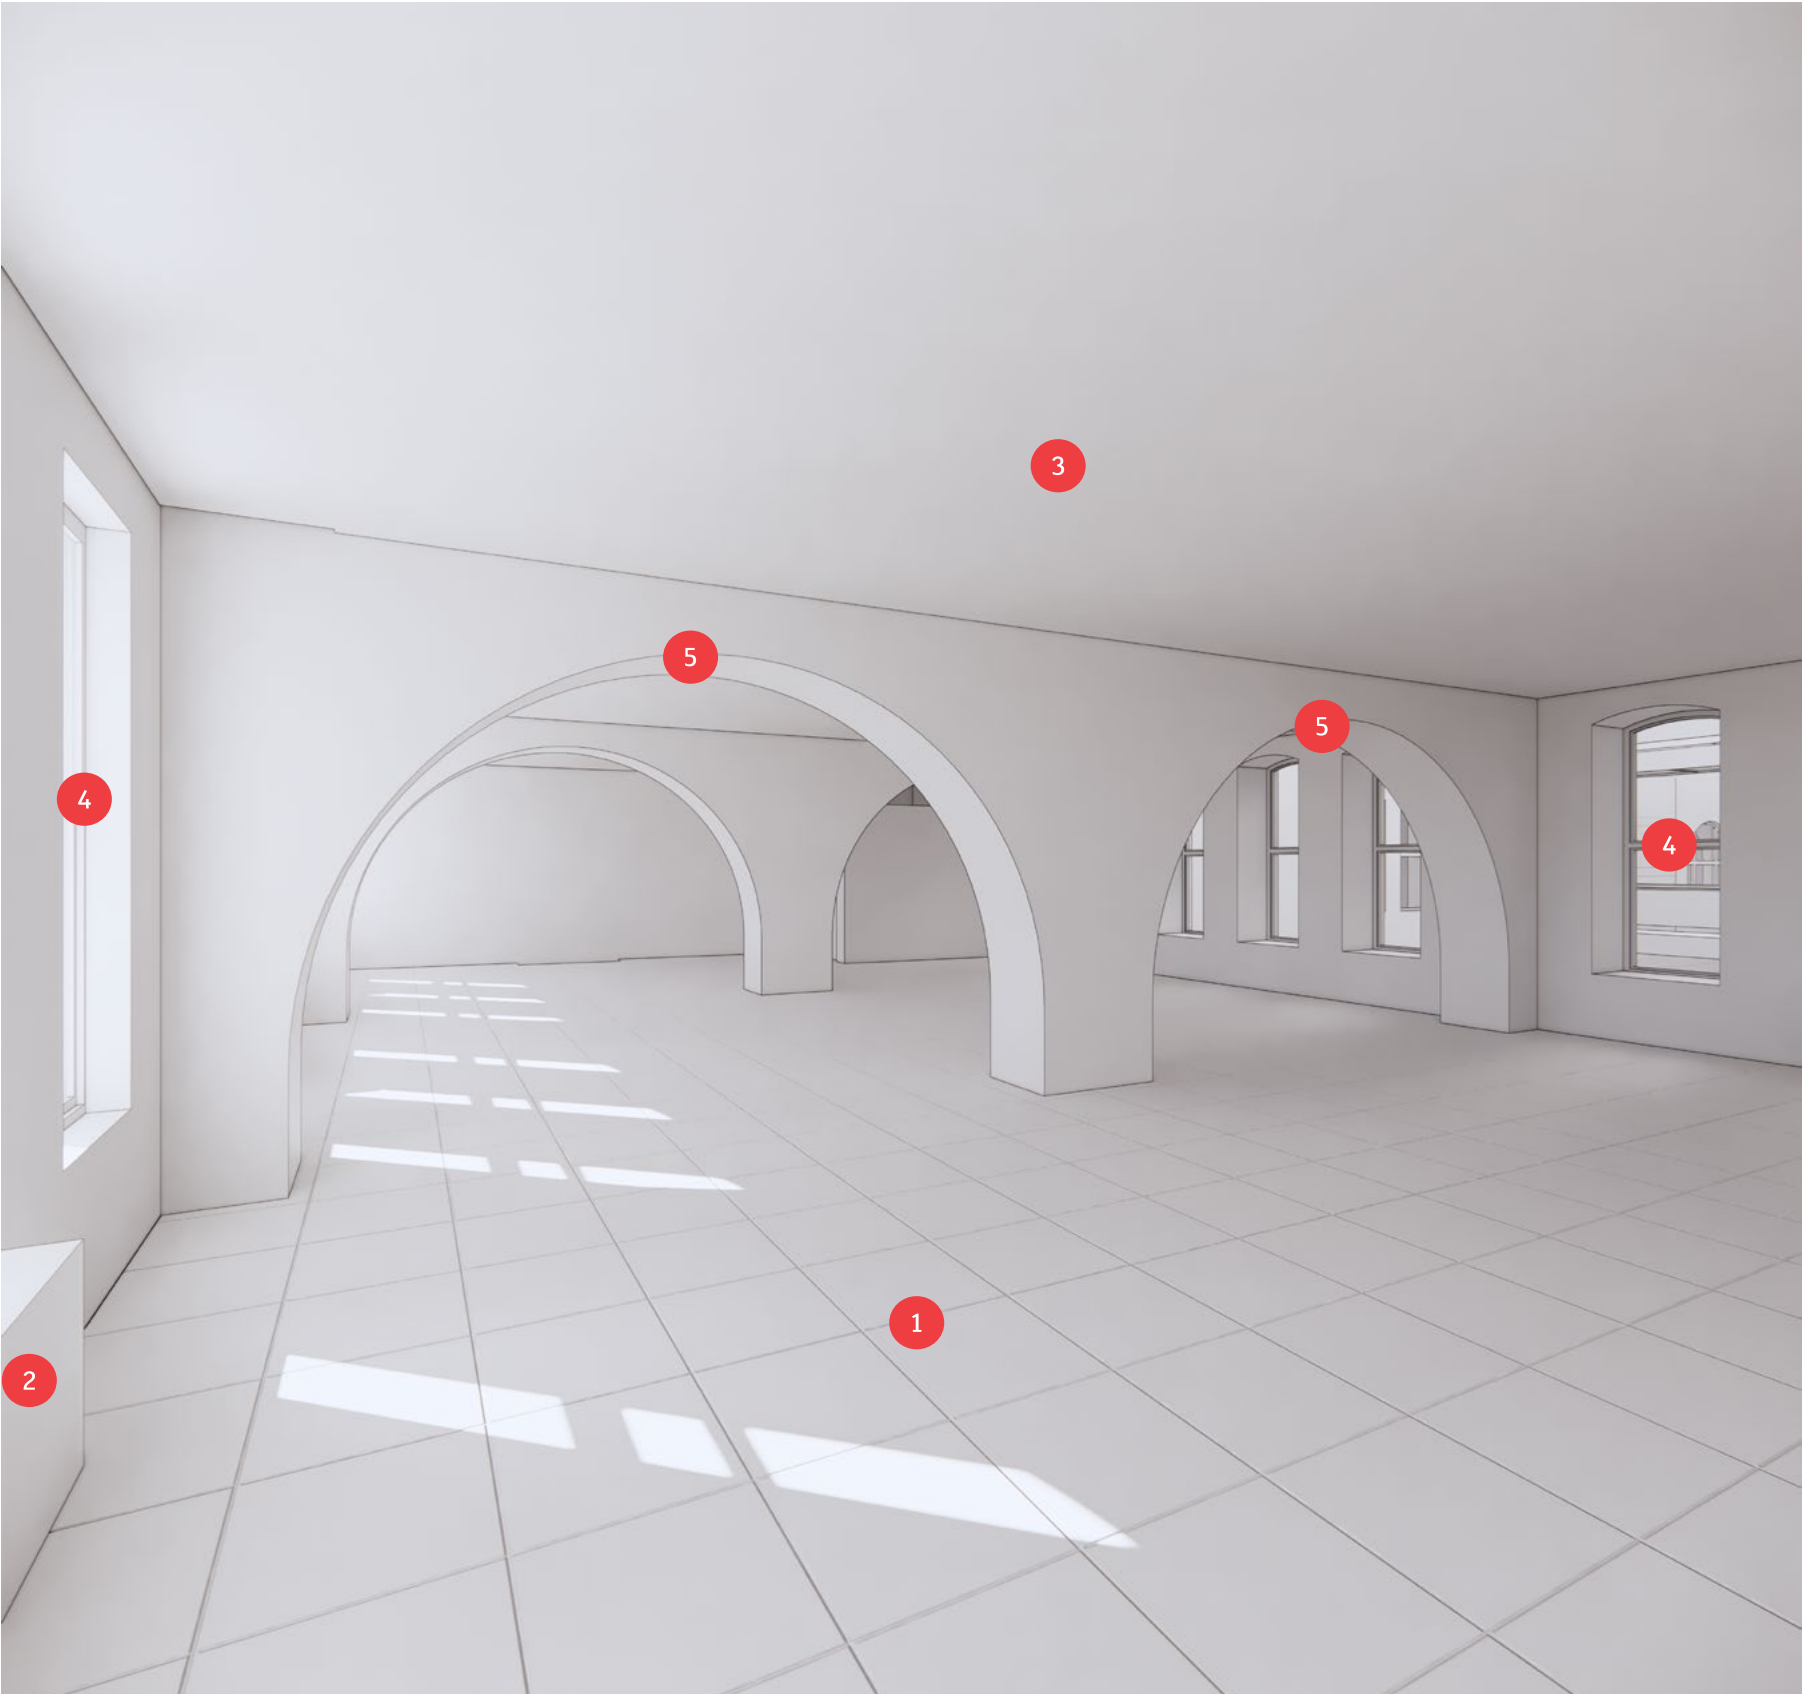
R7 - Typical Floor - Proposed Condition

R7 - Proposed typical floor.

Summary

The proposals provide a betterment to the existing heritage areas by maximising the volume. This is achieved by:

- 1. Raising the RAF system to provide air supply within the floor void.
- 2. Providing wall mounted FCU's to reduce high level services.
- 3. Reducing ceiling void to expose window heads

Alongside the above, the heritage areas are enhanced by:

- 4. Replacing the existing secondary sash windows with single pane secondary glazing, removing the existing 'double' sight lines
- 5. Maximising the existing arched openings by removing the existing plasterboard lining and exposing the arches true profile and materiality,

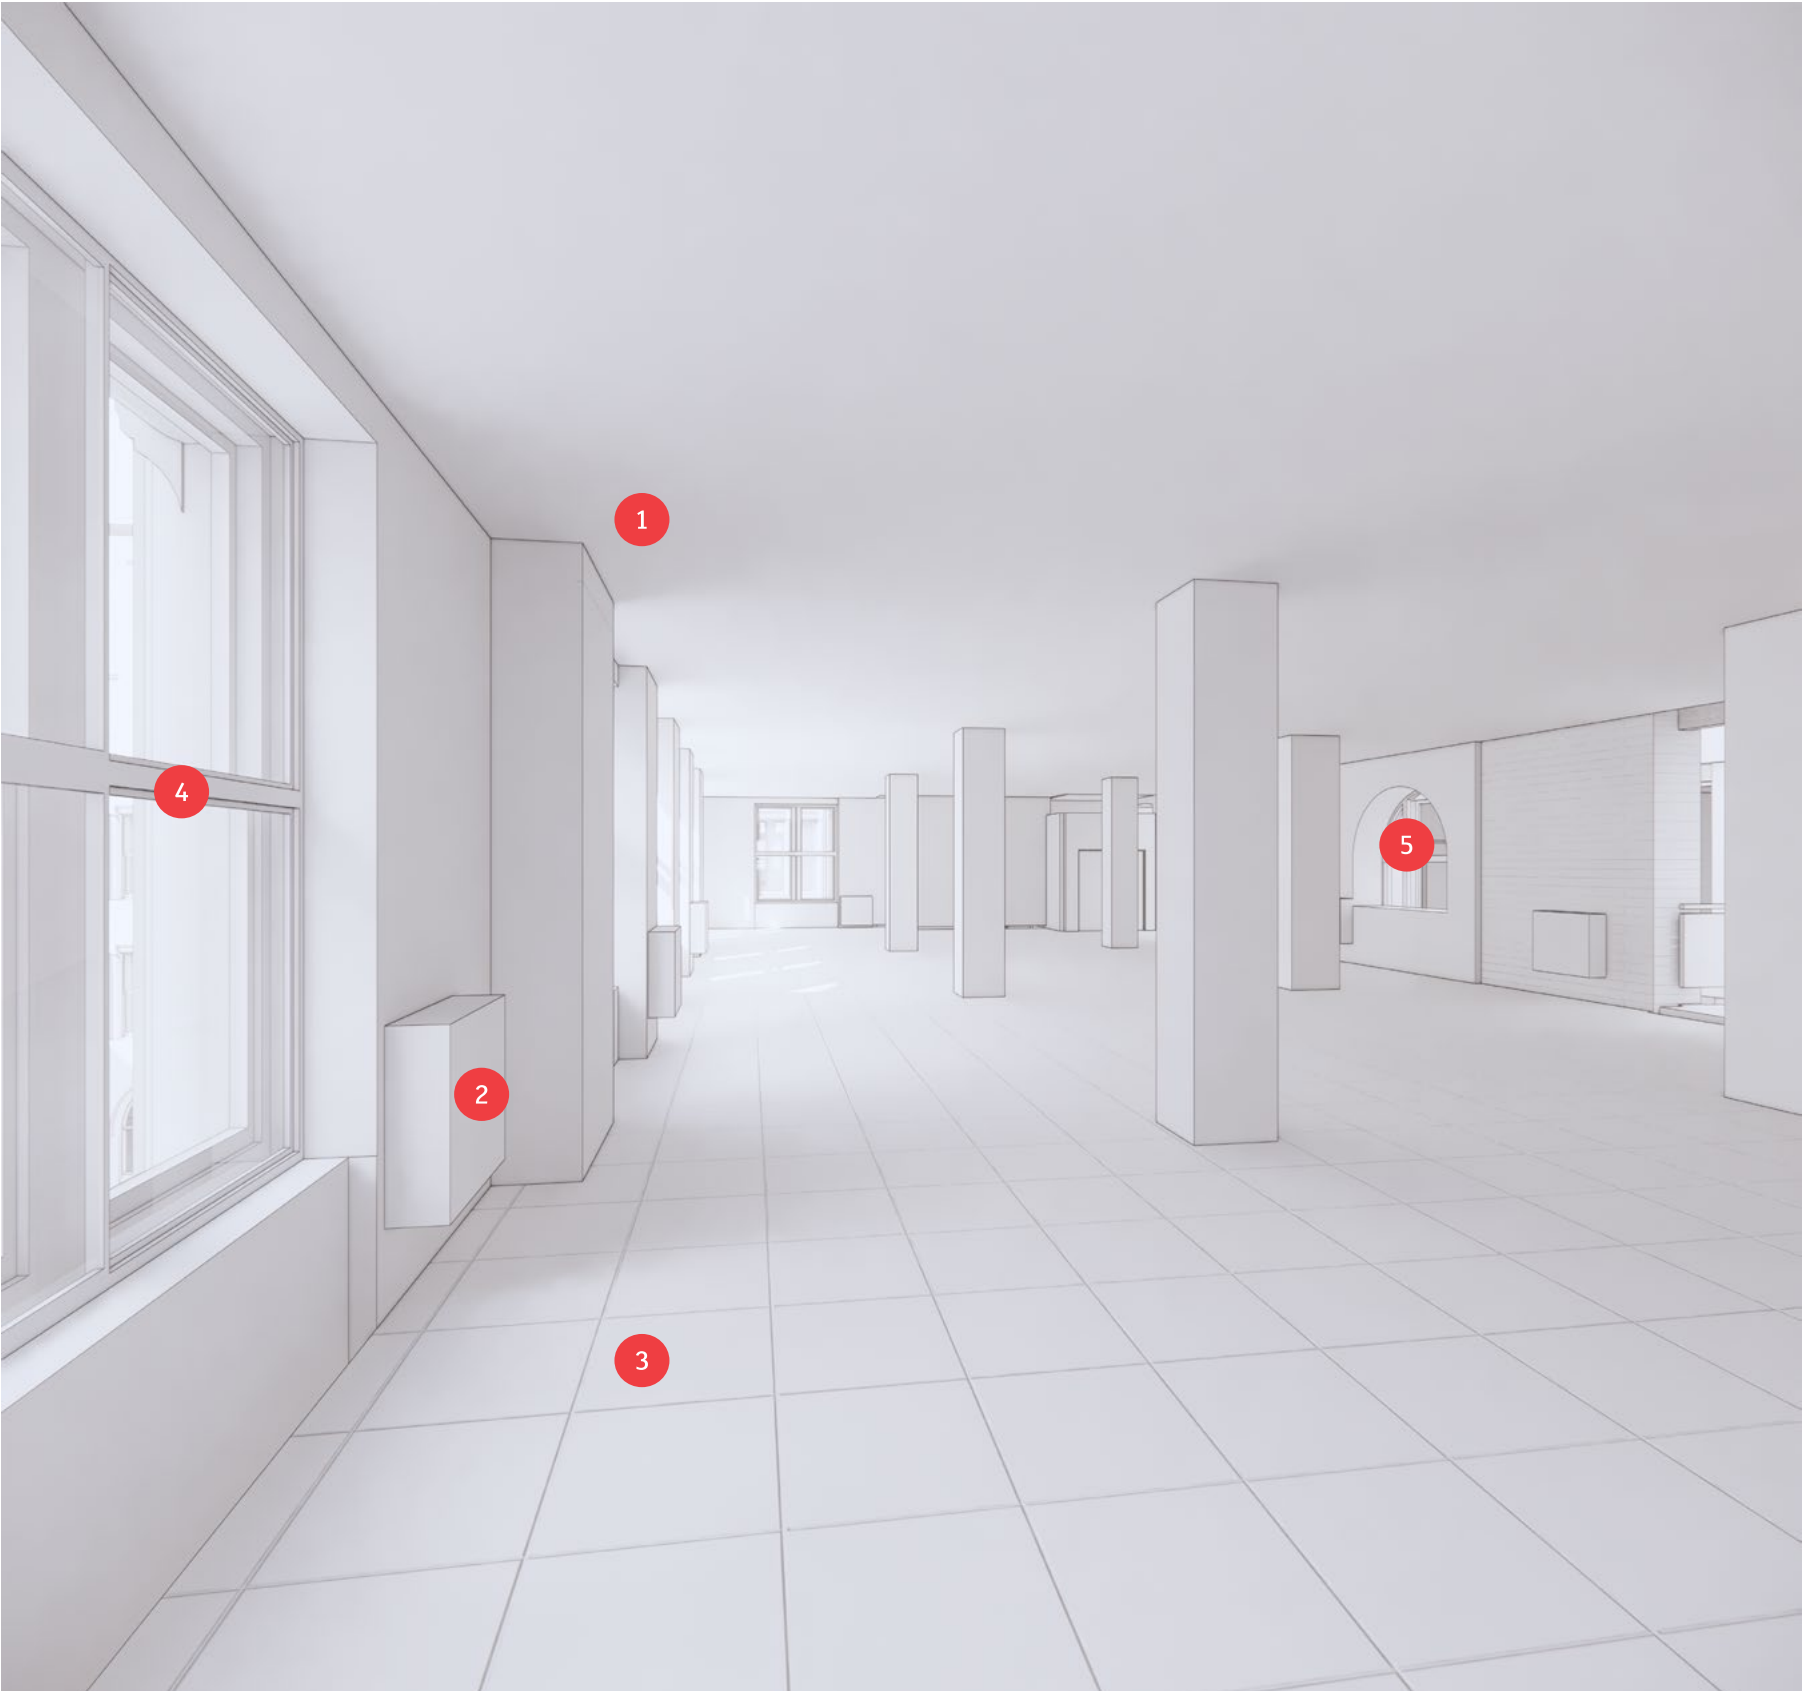
R6 - Typical Floor - Proposed Condition

R6 - Proposed typical floor.

Summary

The proposals provide a betterment to the existing heritage areas by maximising the volume. This is achieved by:

- 1. Raising the RAF system to provide air supply within the floor void.
- 2. Providing wall mounted FCU's to reduce high level services.
- 3. Reducing ceiling void to expose window heads

Alongside the above, the heritage areas are enhanced by:

- 4. Replacing the existing secondary sash windows with single pane secondary glazing, removing the existing 'double' sight lines
- 5. Replacement of primary contemporary glazing with more in keeping window type

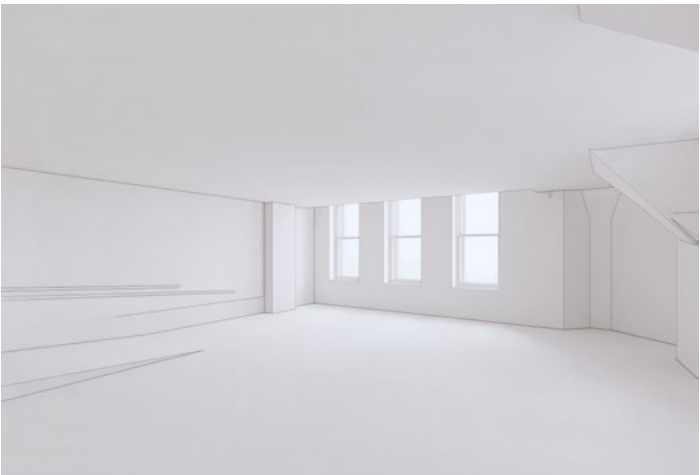
R11 - Typical Floor - Existing Condition

R11 - Existing summary

Summary

Other than the second floor, the existing office floors have no remaining heritage features visible, and have been fit out for contemporary office use.

Due to the presence of high level services providing ventilation, cooling and heating to the office spaces, the ceiling levels are lower than the heritage window heads.

Sash secondary glazing has been installed and generally throughout. The sash secondary glazing results in double site lines when viewed internally and externally.

Due to variation between the heritage areas and EPR extension, ramped access or stepped access is provided between the spaces.

A non-original stair has been introduced linking lower ground floor to the first floor.

There is presence of historic timber panelling to the second floor. The panelling is not original Waterhouse and has been adapted over time.

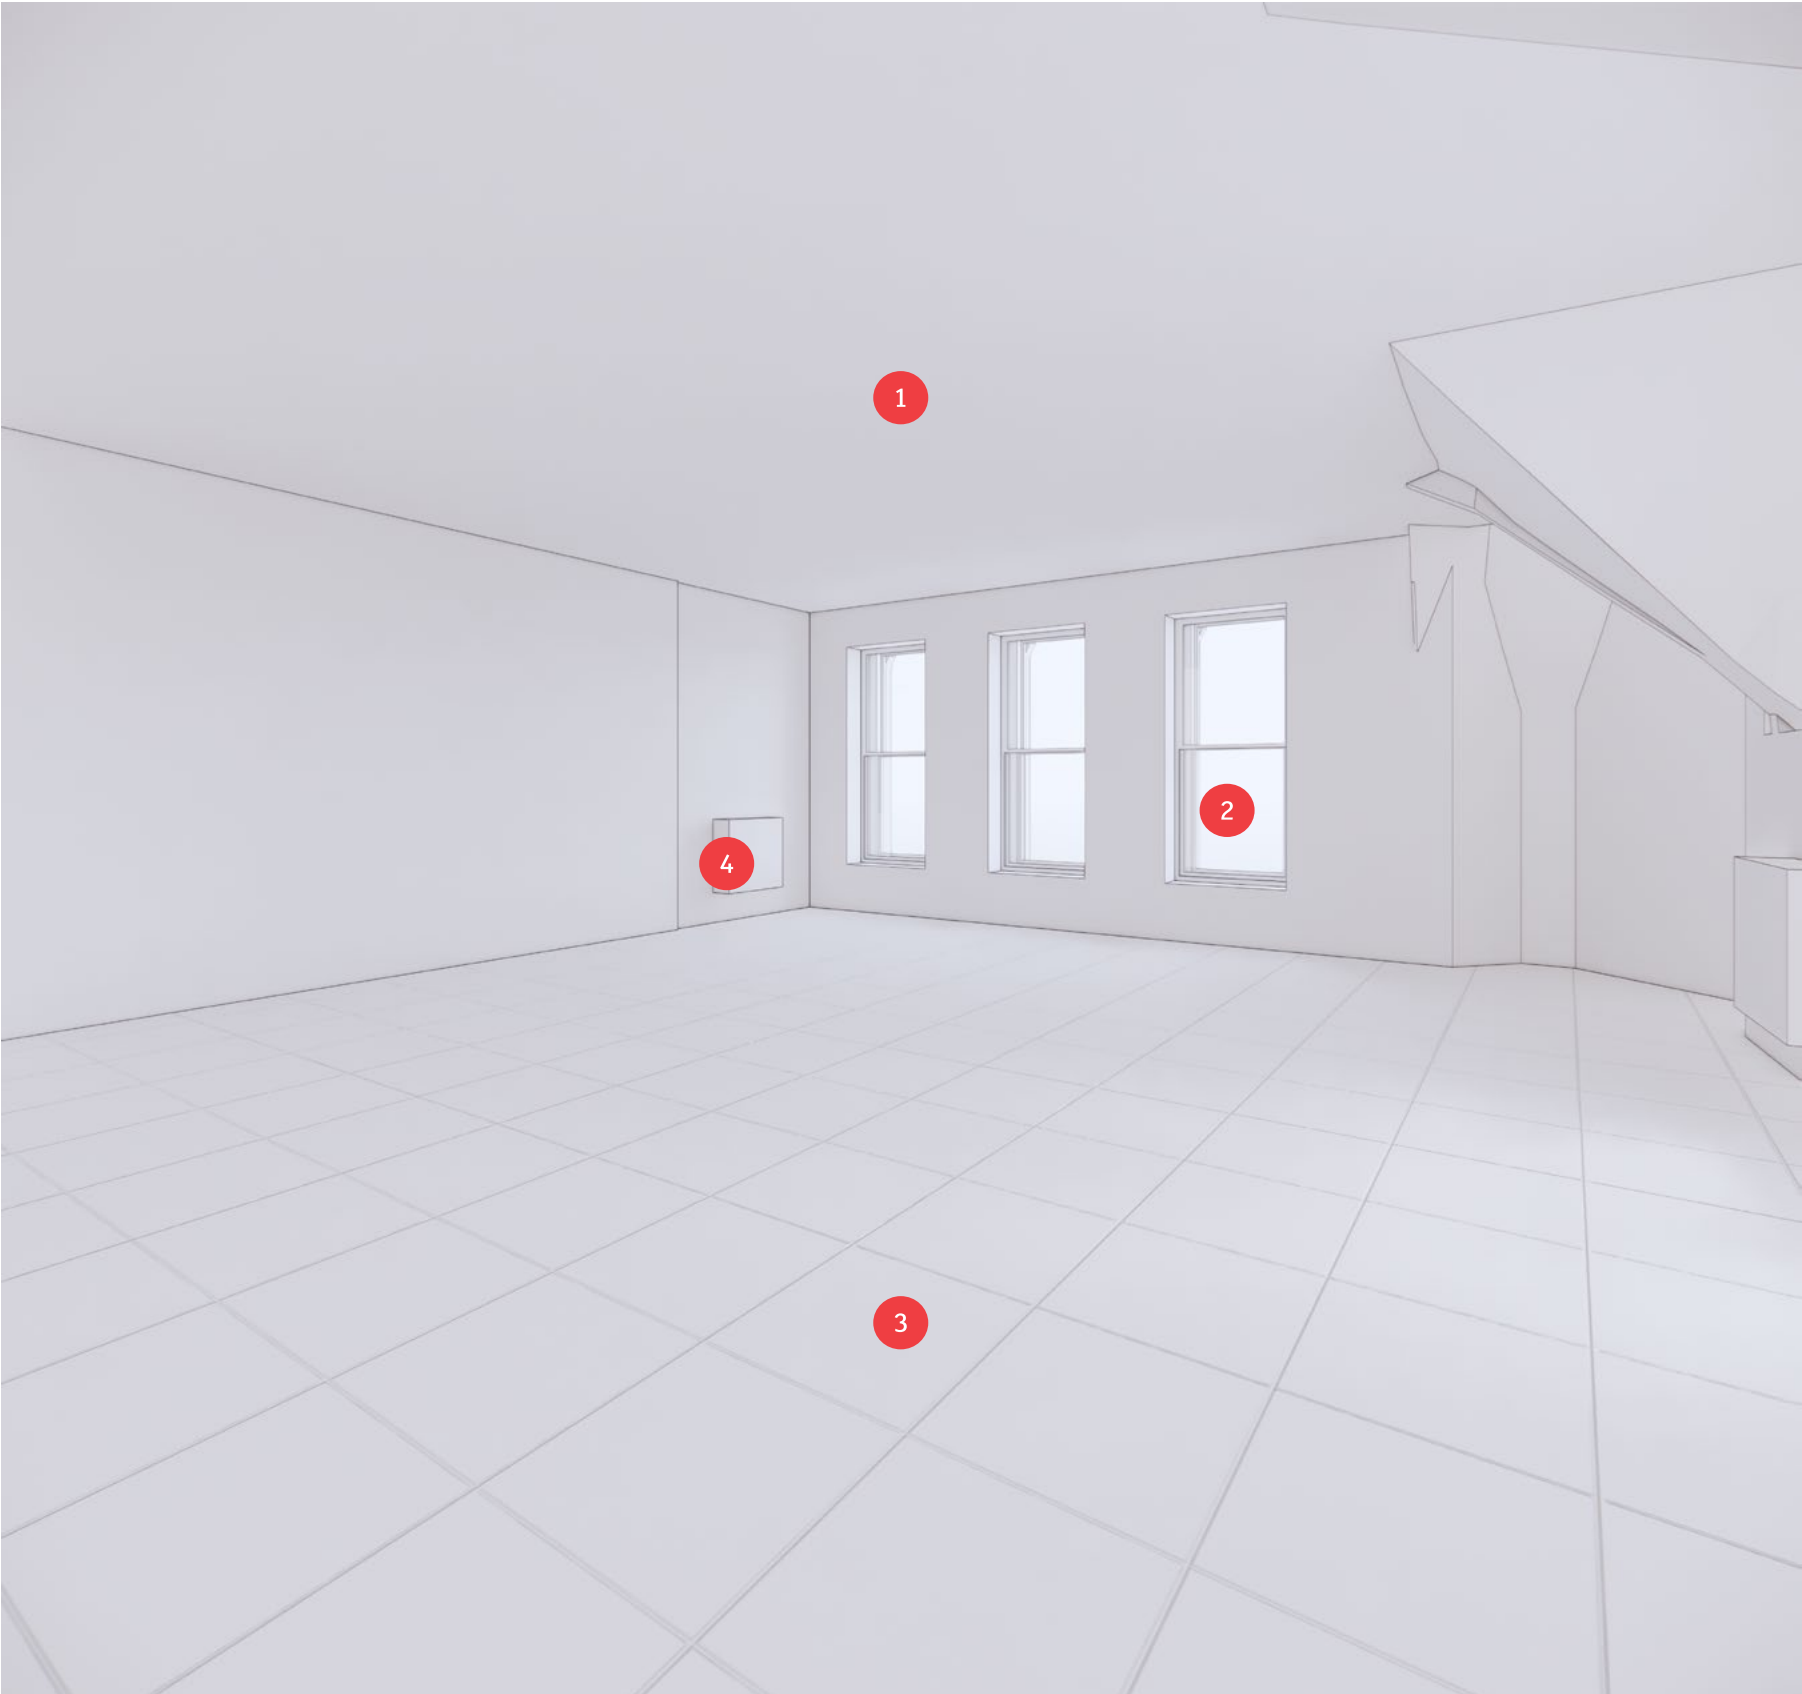
R11 - Typical Floor - Proposed Condition

R11 - Proposed typical floor.

Summary

The proposals provide a betterment to the existing heritage areas by maximising the volume. This is achieved by:

- 1. Raising the RAF system to provide air supply within the floor void.
- 2. Providing wall mounted FCU's to reduce high level services.
- 3. Reducing ceiling void to expose window heads

Alongside the above, the heritage areas are enhanced by:

- 4. Replacing the existing secondary sash windows with single pane secondary glazing, removing the existing 'double' sight lines

The existing timber panelling is to be retained, repaired and sensitively adapted to allow for the installation of wall mounted FCU's and the slight increase of the Raised Access Floor, which allows the increase of the ceiling level.

The contemporary stair at first floor is to be infilled to restore the original floorplate.

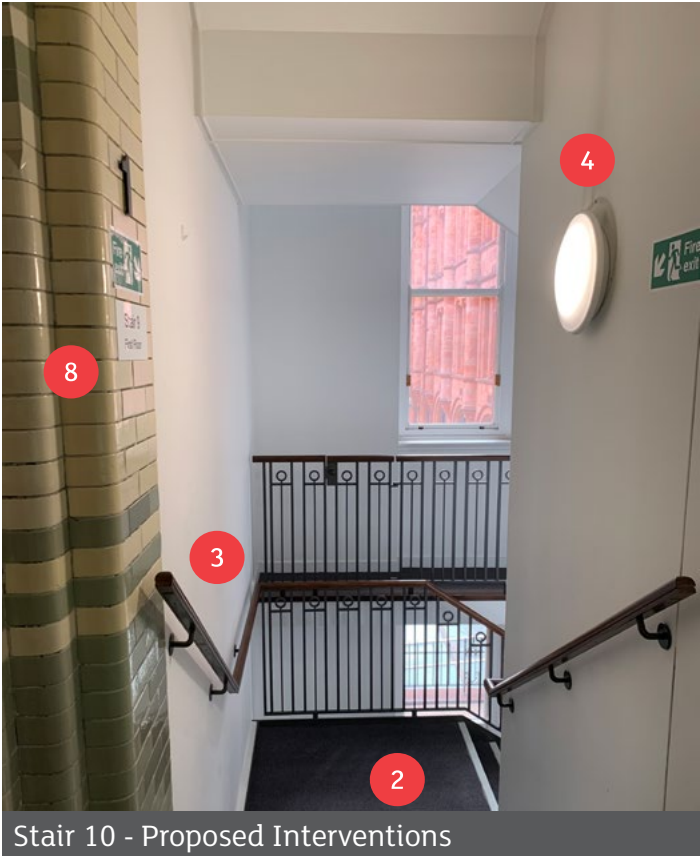
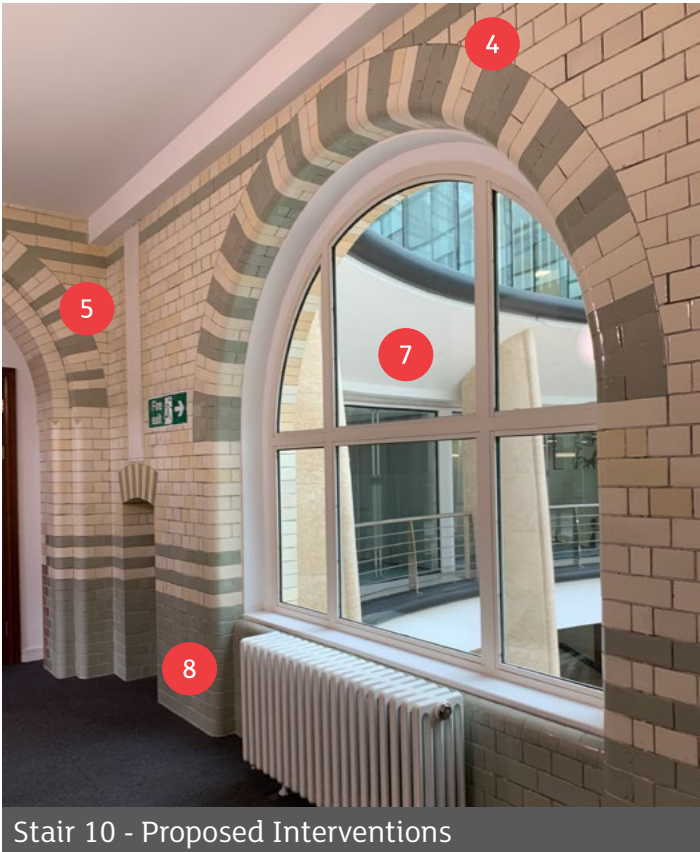
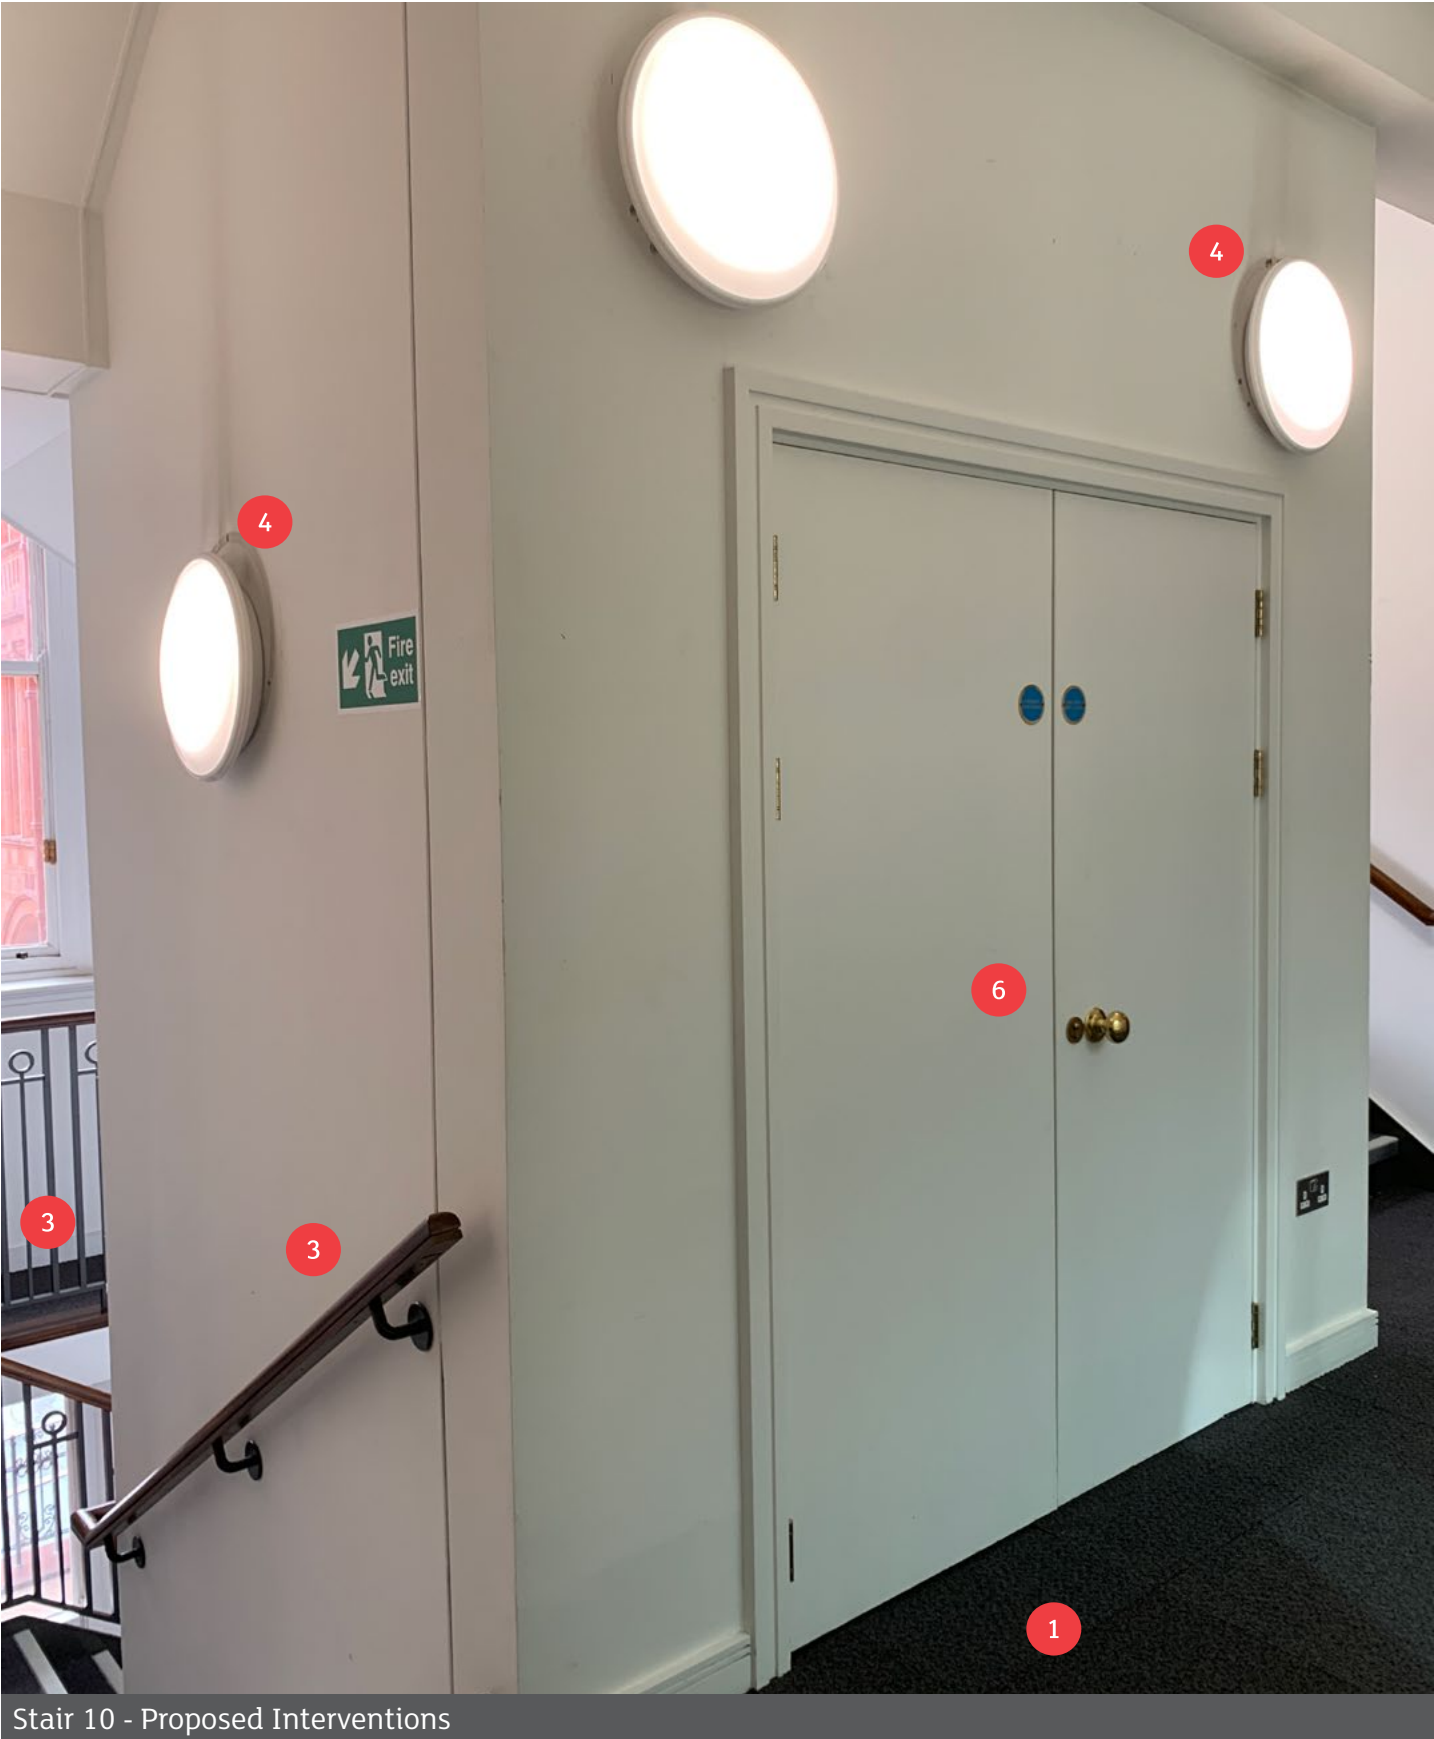
Stair 10 - Proposed Interventions

Stair 10

Interventions:

Stair 10 has many features perceived to be of high heritage significance. The stair core was adapted by EPR as part of the 1990's works and included.

- Raising of the main landing and amendments to the stairs.
- Removal of lift within central well.
- New lighting, radiators and signage.
- Introduction of secondary glazing.

Our proposals seek to retain elements of high heritage significance.

- 1 Replace floor finishes
- 2 Replace nosings and tread/riser finishes
- 3 Refurbish handrail
- 4 Replace light fittings
- 5 Refurbish faience brickwork
- 6 Refurbish doors
- 7 Replace/remove secondary glazing
- 8 Refurbish/replace radiators

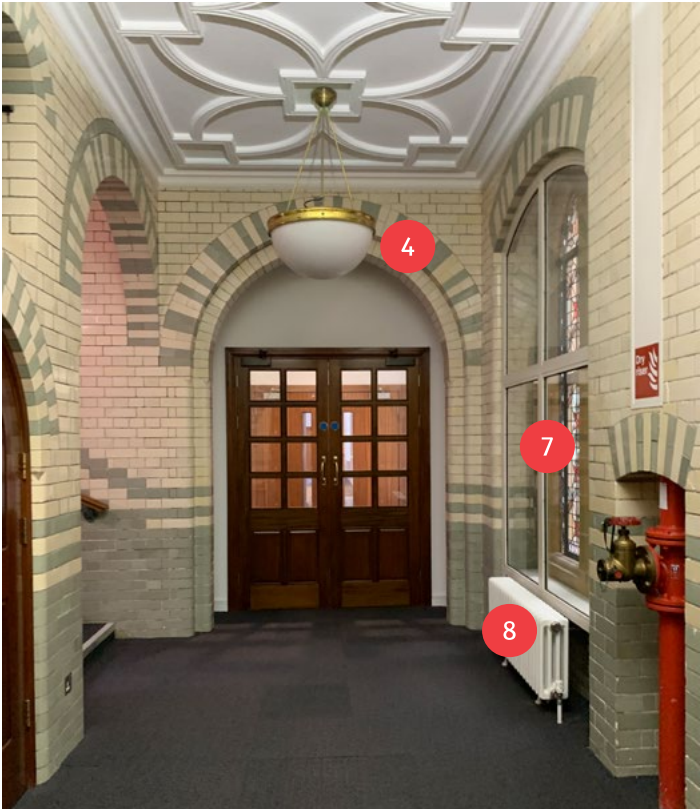
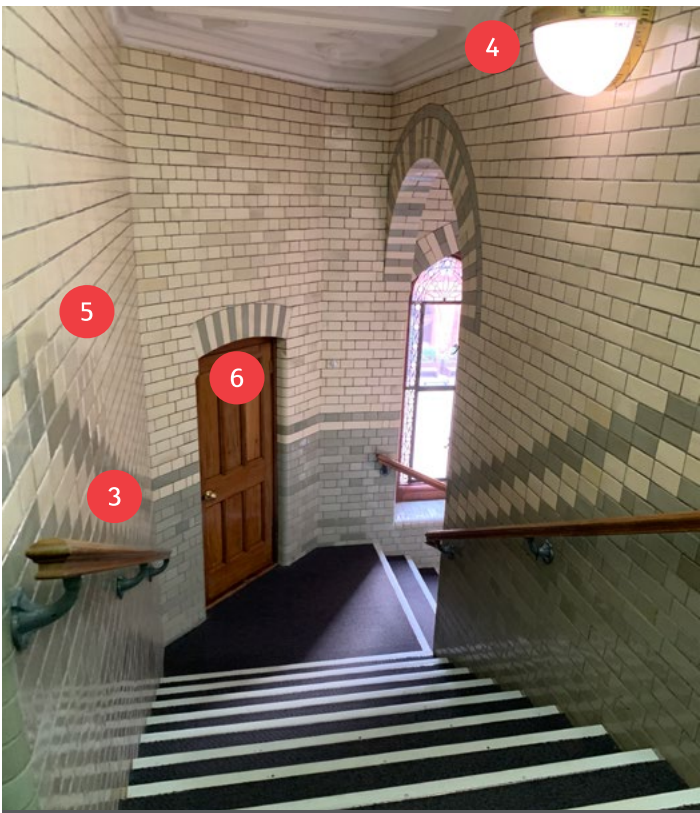
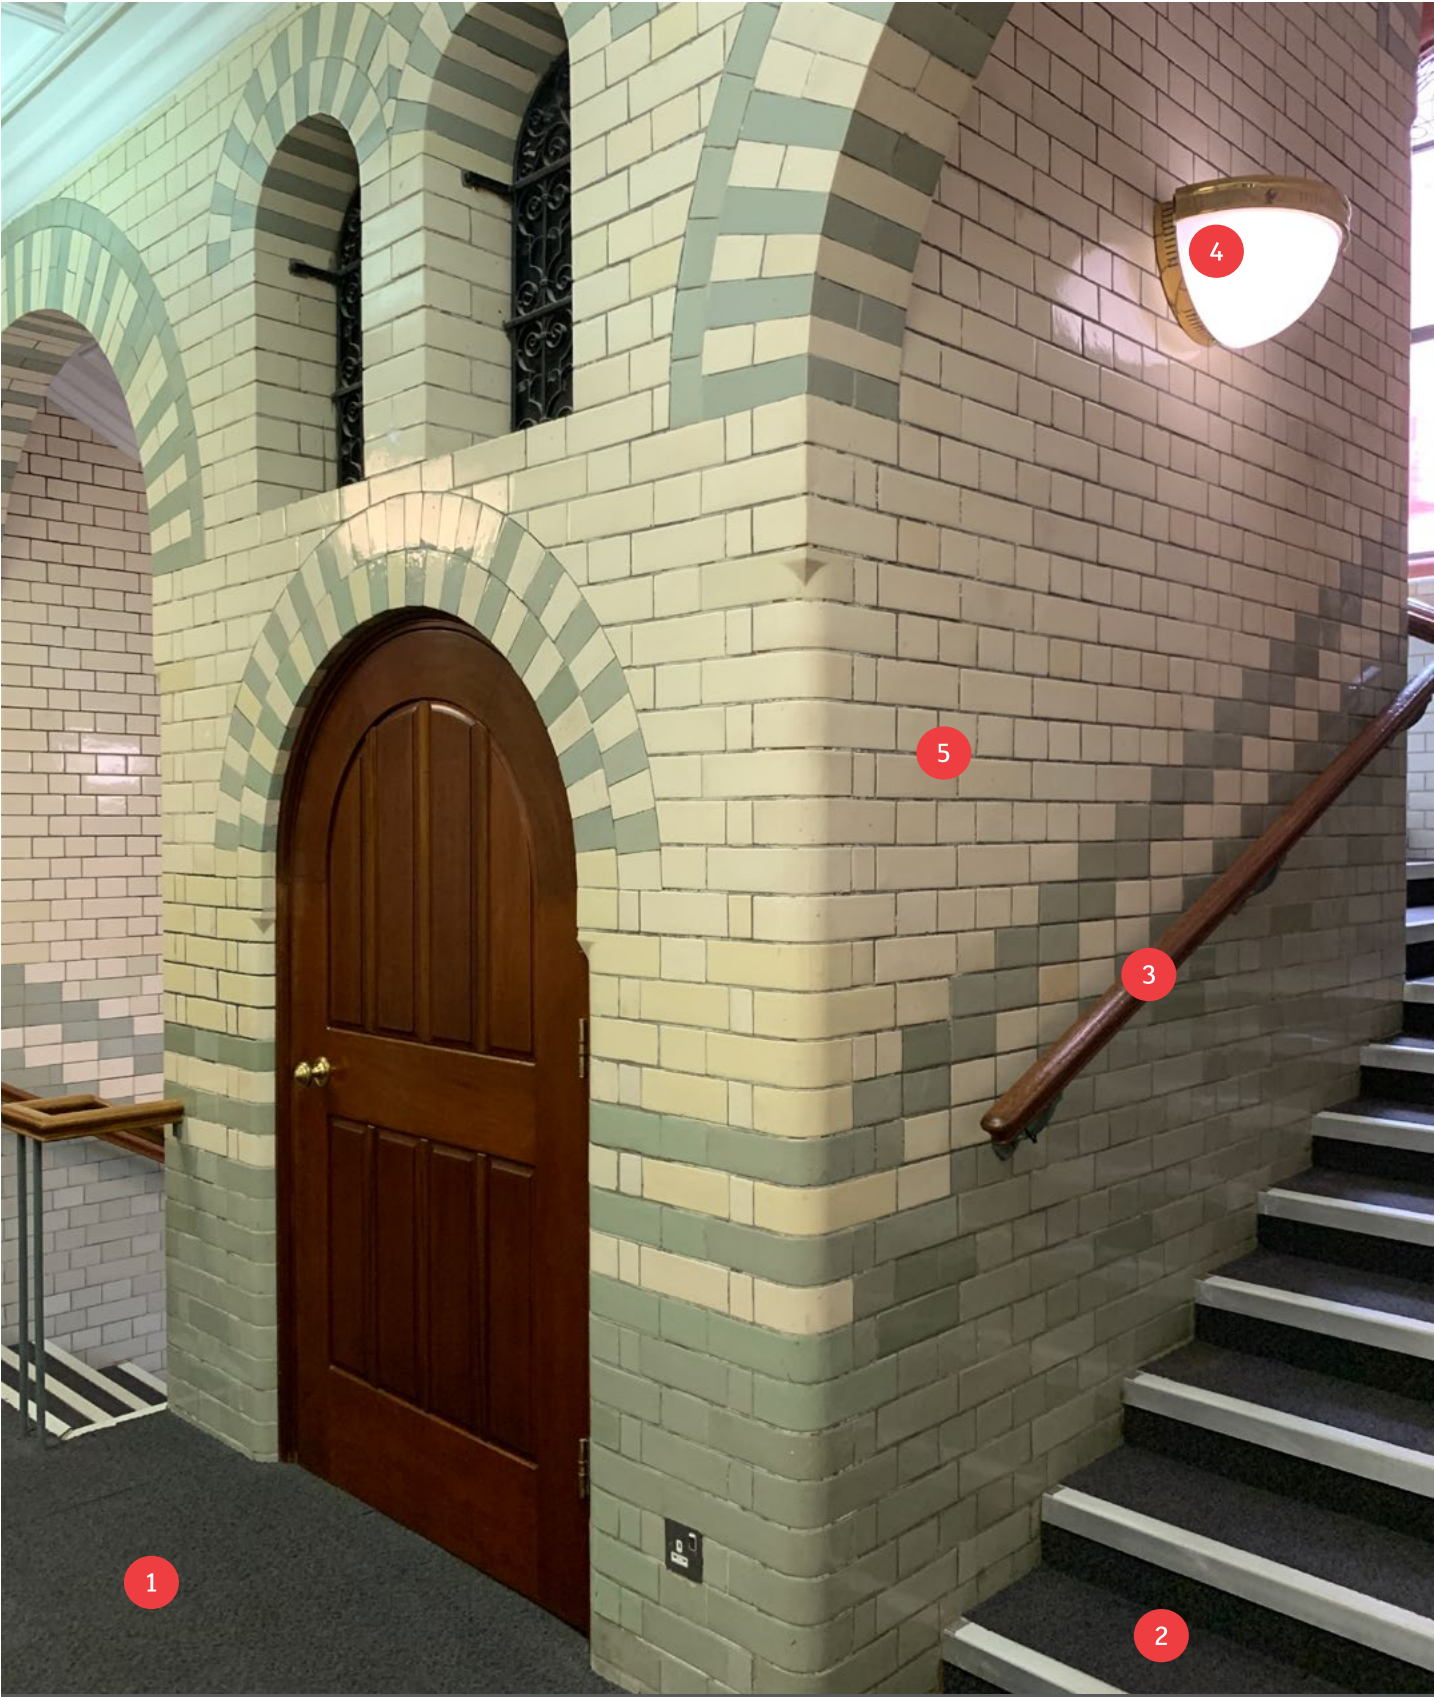
Stair 9 - Proposed Interventions

Stair 9

Interventions:

Stair 9 was introduced as part of the 1990's EPR works. No stair was in this location previously. There is faience brickwork to the main landings.

Our proposals seek to retain elements of high heritage significance, whilst retaining the stairs.

- 1 Replace floor finishes
- 2 Replace nosings and tread/riser finishes
- 3 Refurbish/replace handrail & balustrade
- 4 Replace light fittings
- 5 Refurbish faience brickwork
- 6 Introduce lift to central well
- 7 Replace windows
- 8 Refurbish/replace radiators

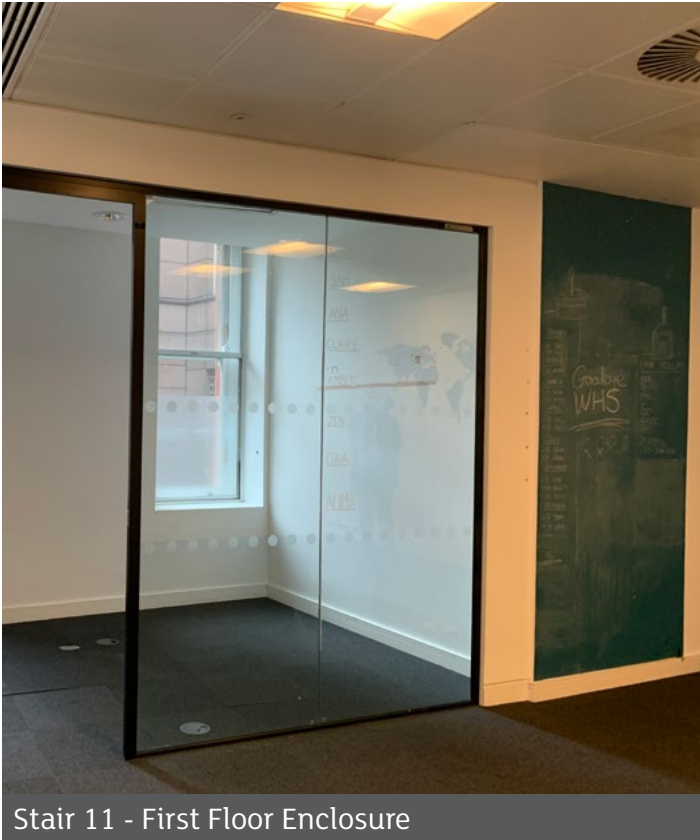
Stair 11 - First Floor Enclosure

The stair is required to be maintained from LG to GF for fire purposes.

The proposed see's the demolition of the stair from GF to 1F and reinstatement of floor slab to reinstate the original floorplate.

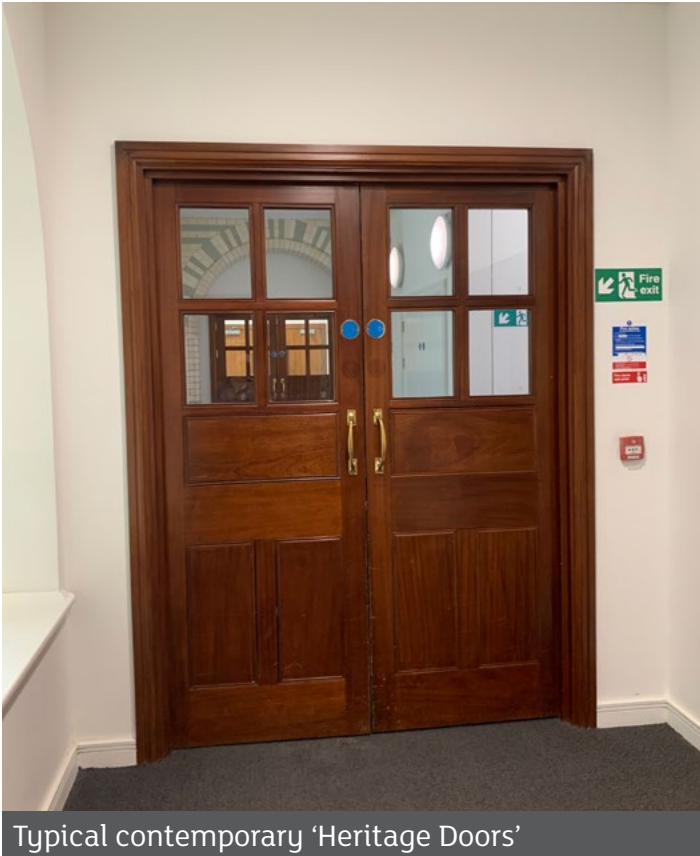
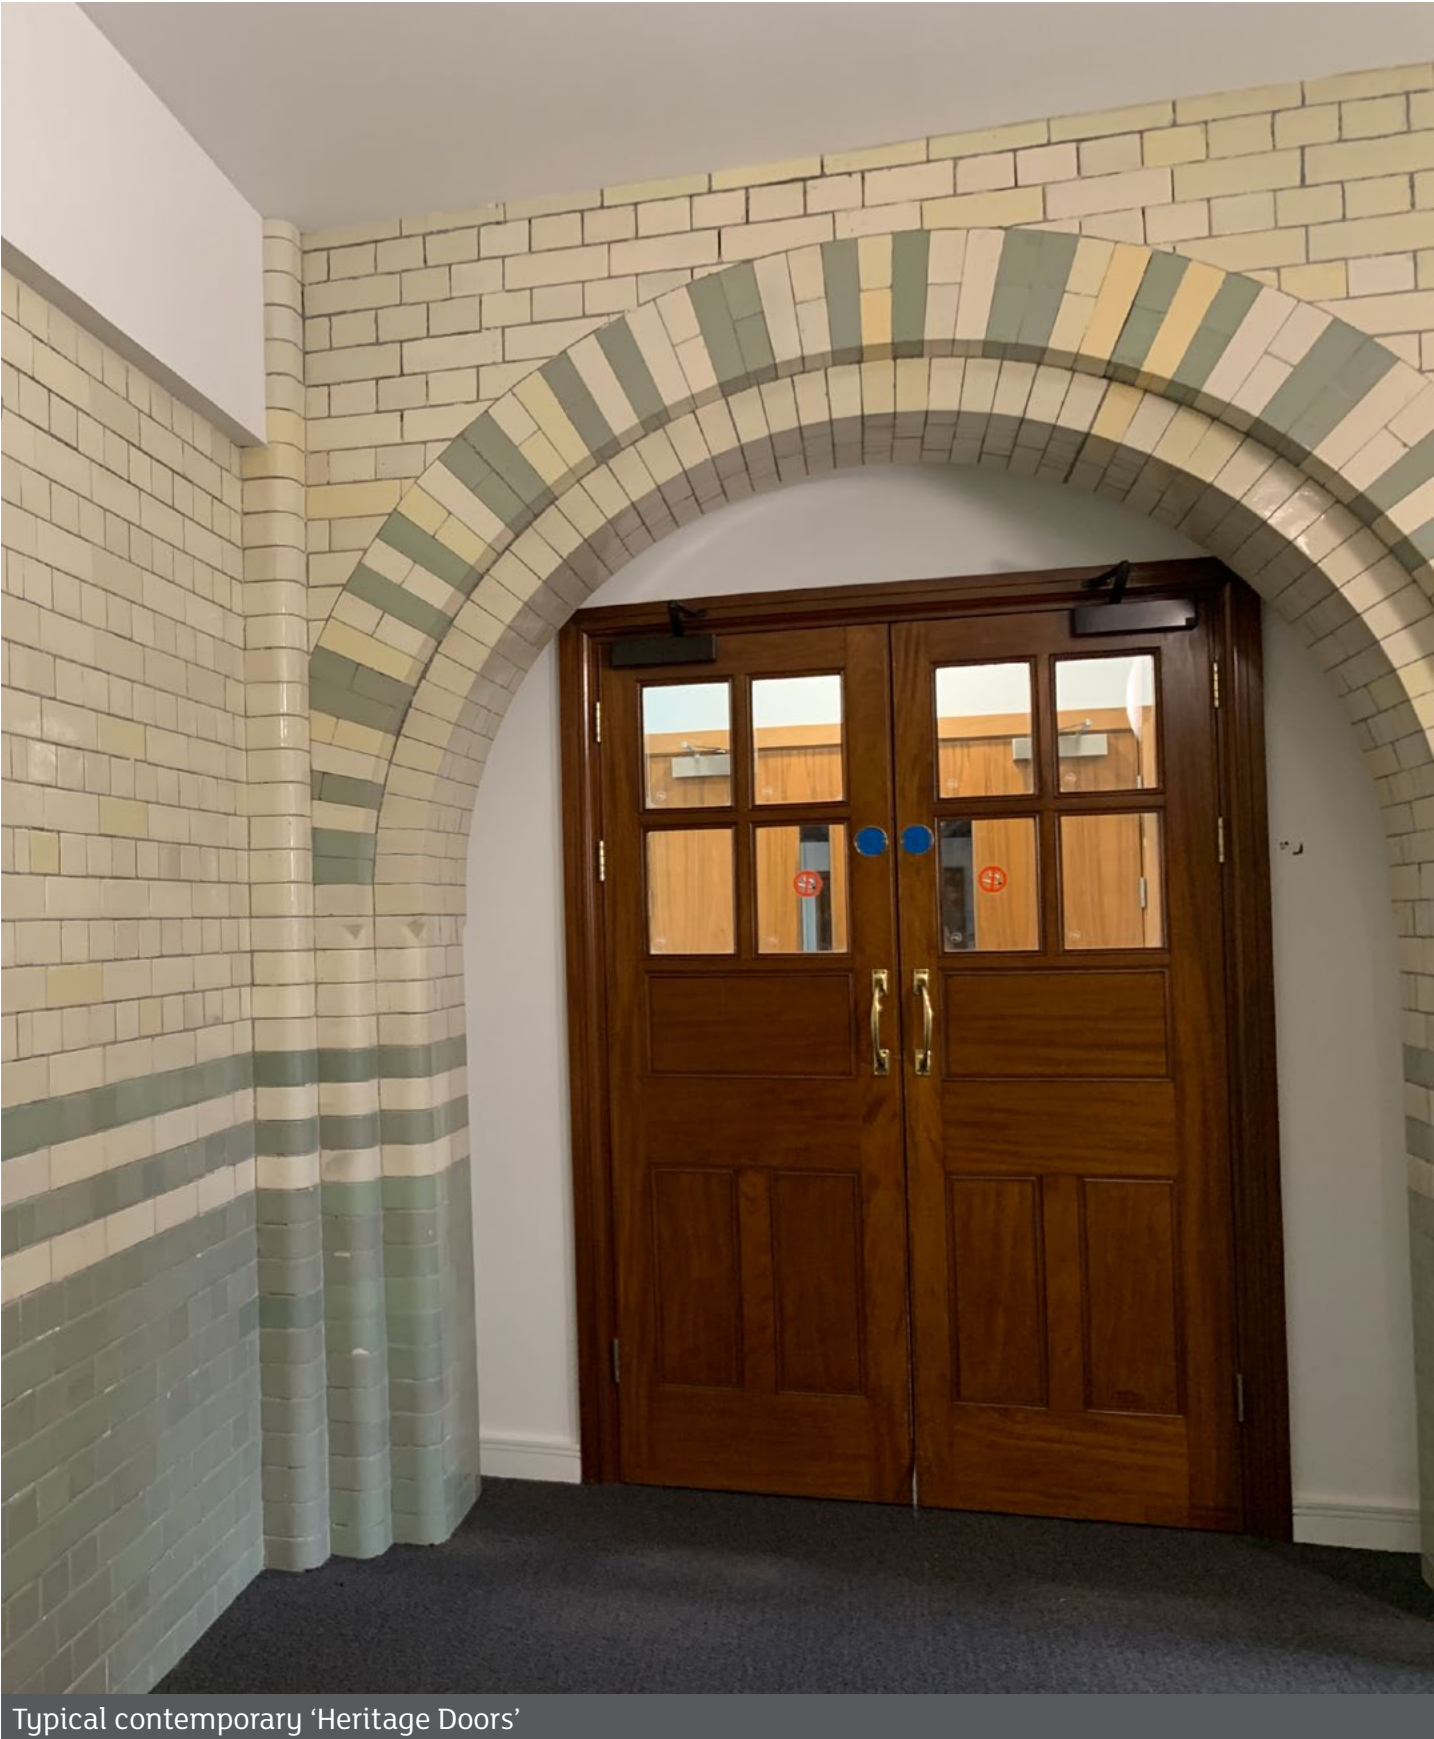
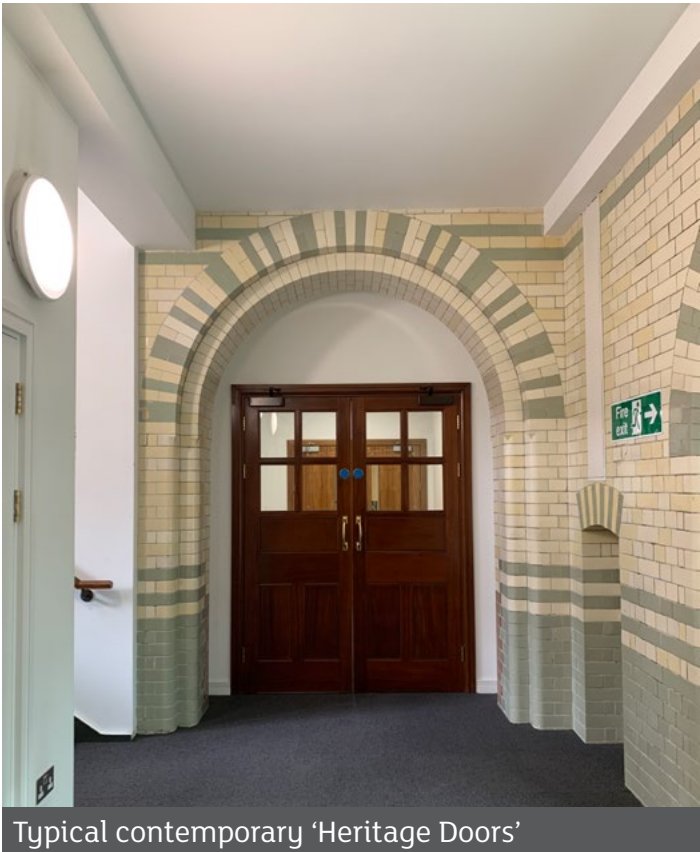
Typical contemporary 'Heritage Doors'

Heritage style fire doors have been installed to Stairs 9 & 10 respectively.

These are non original doors and may require upgrading to modern standards & DDA requirements.

Replacement doors are proposed to be in a similar heritage style. Adjacent lobby forming contemporary style doors to be replaced with heritage style doors, to provide a consistent reading within the heritage areas of the site,
