5.0 Heritage Areas

5.1 Internal Heritage Areas

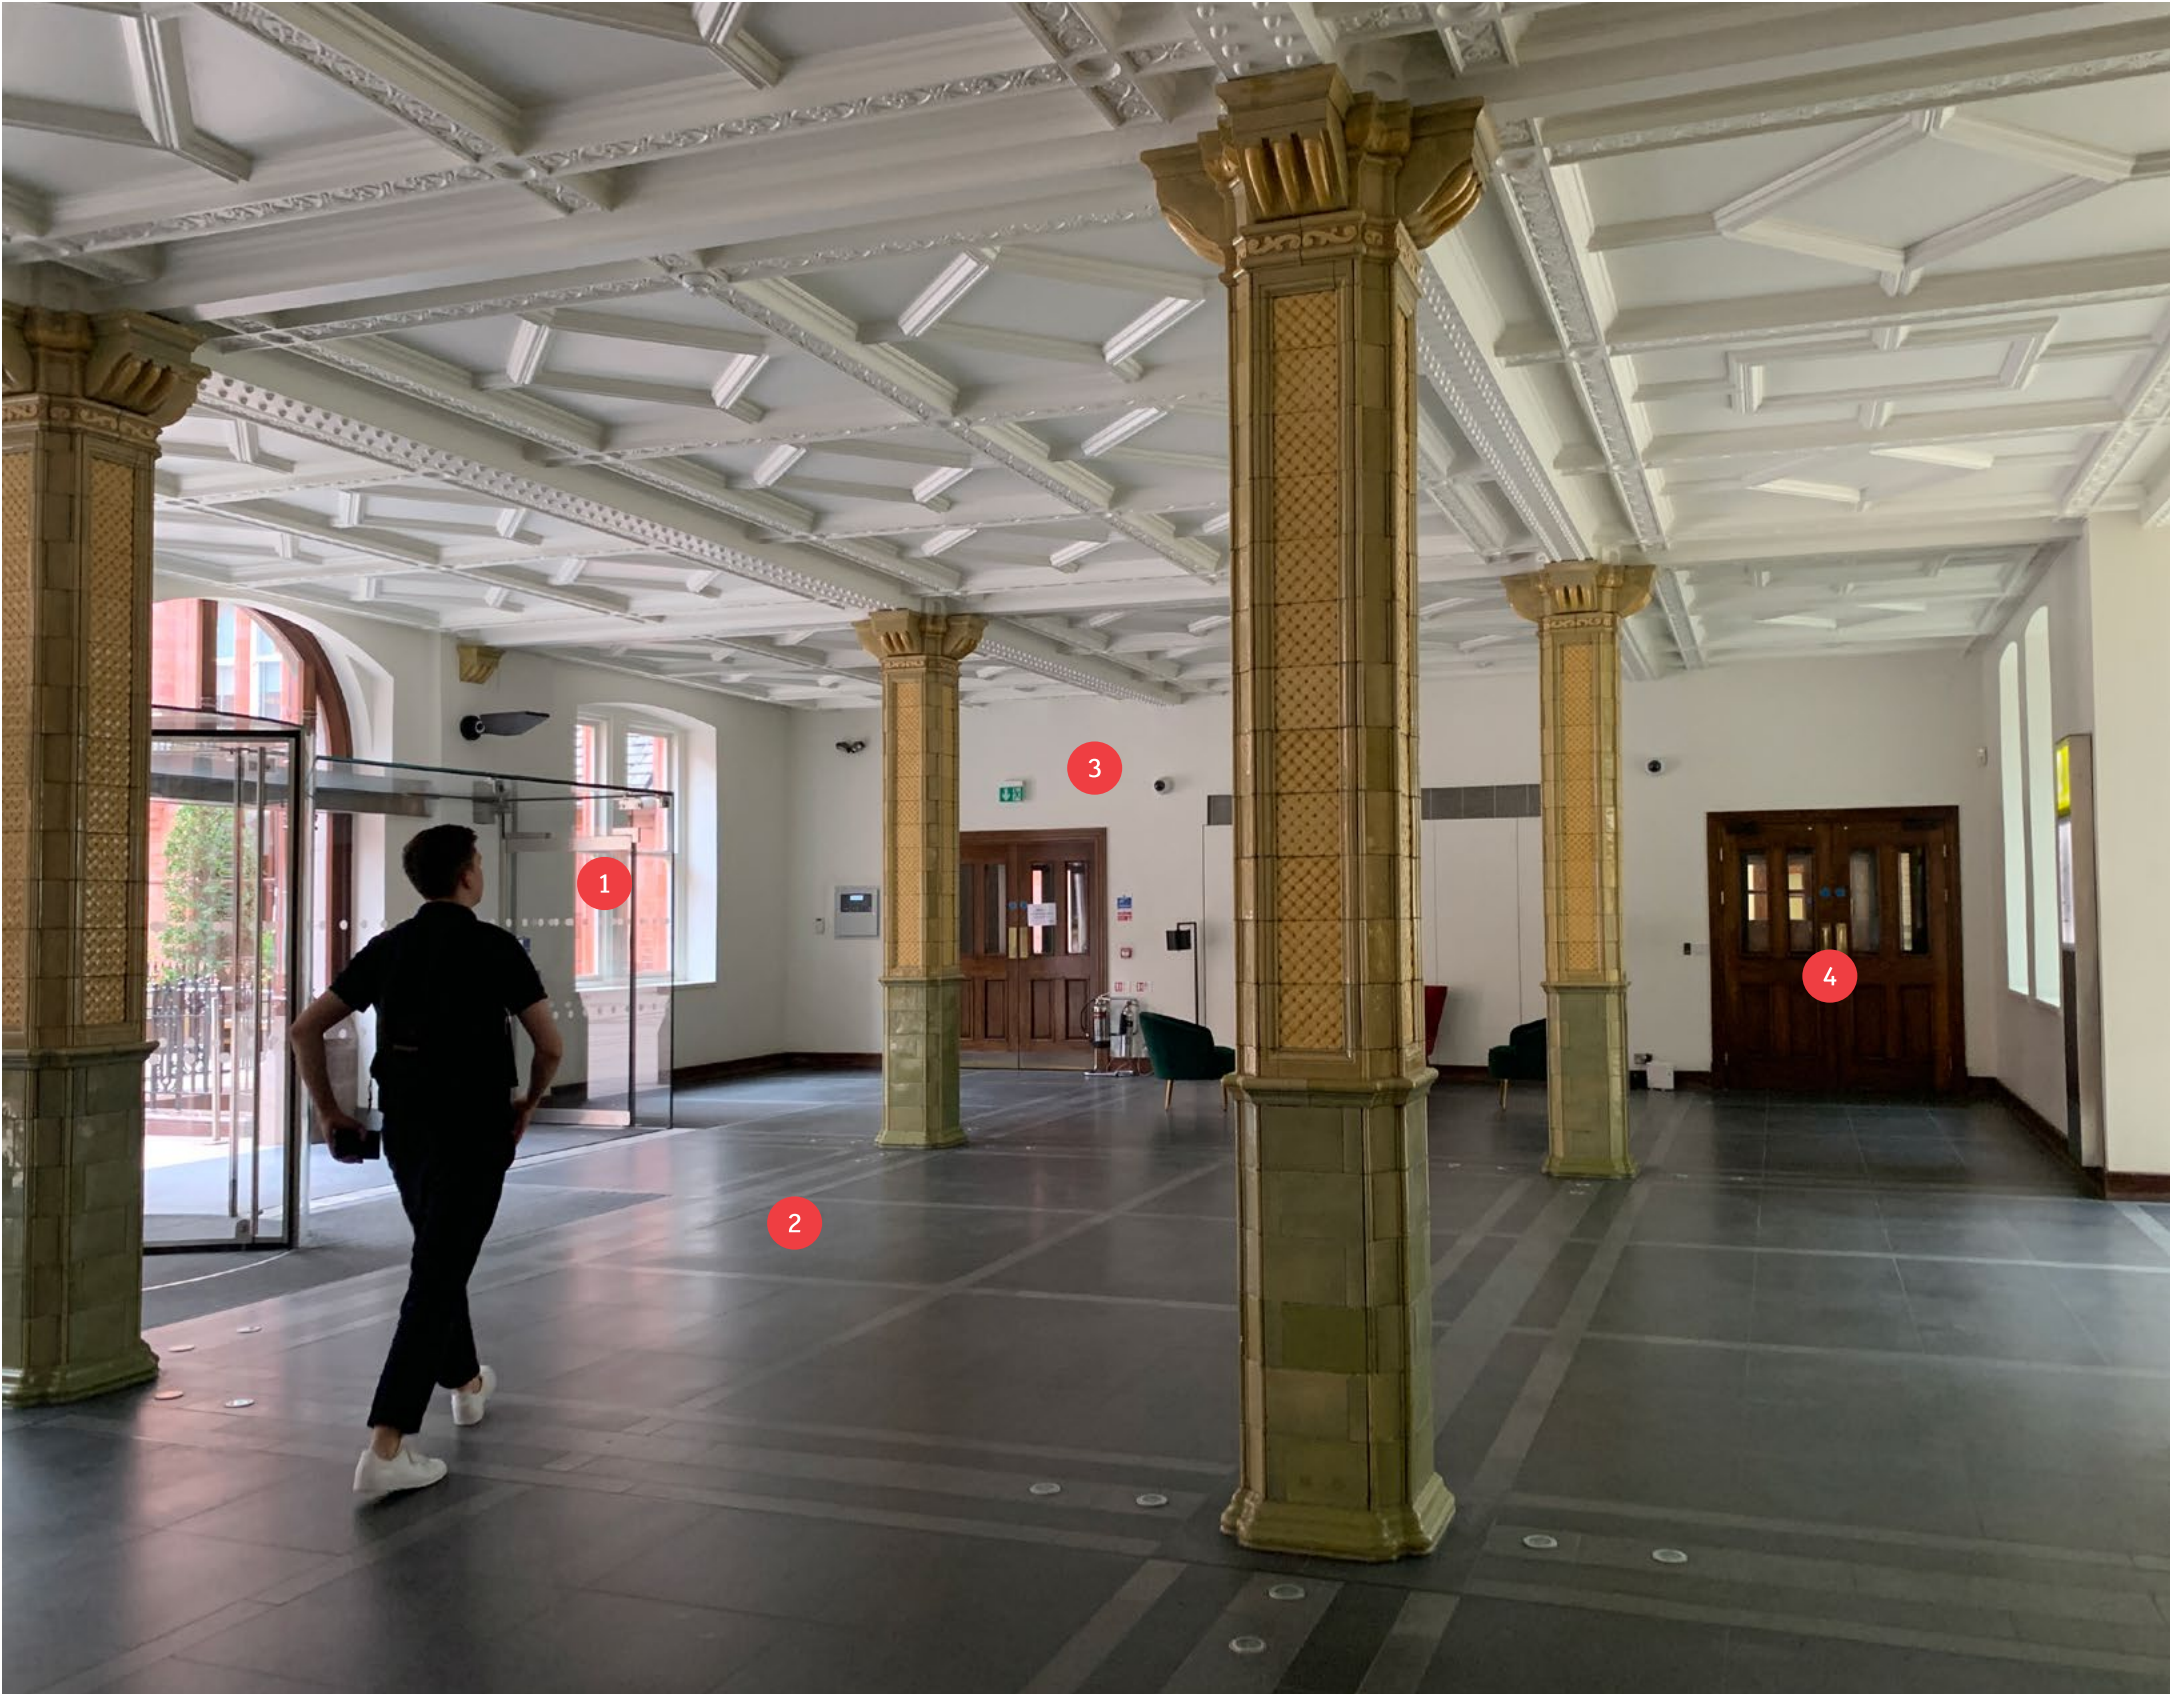
Waterhouse Square - Existing Condition

The existing entrance hall is highly significant, with features of outstanding quality such as the faience columns and the moulded plaster ceiling.

Interventions were made internally as part of the EPR works and these include.

- 1. Inset revolving doors and matwell
- 2. Contemporary stone flooring
- 3. Contemporary partition on non original line
- 4. Heritage style contemporary doors

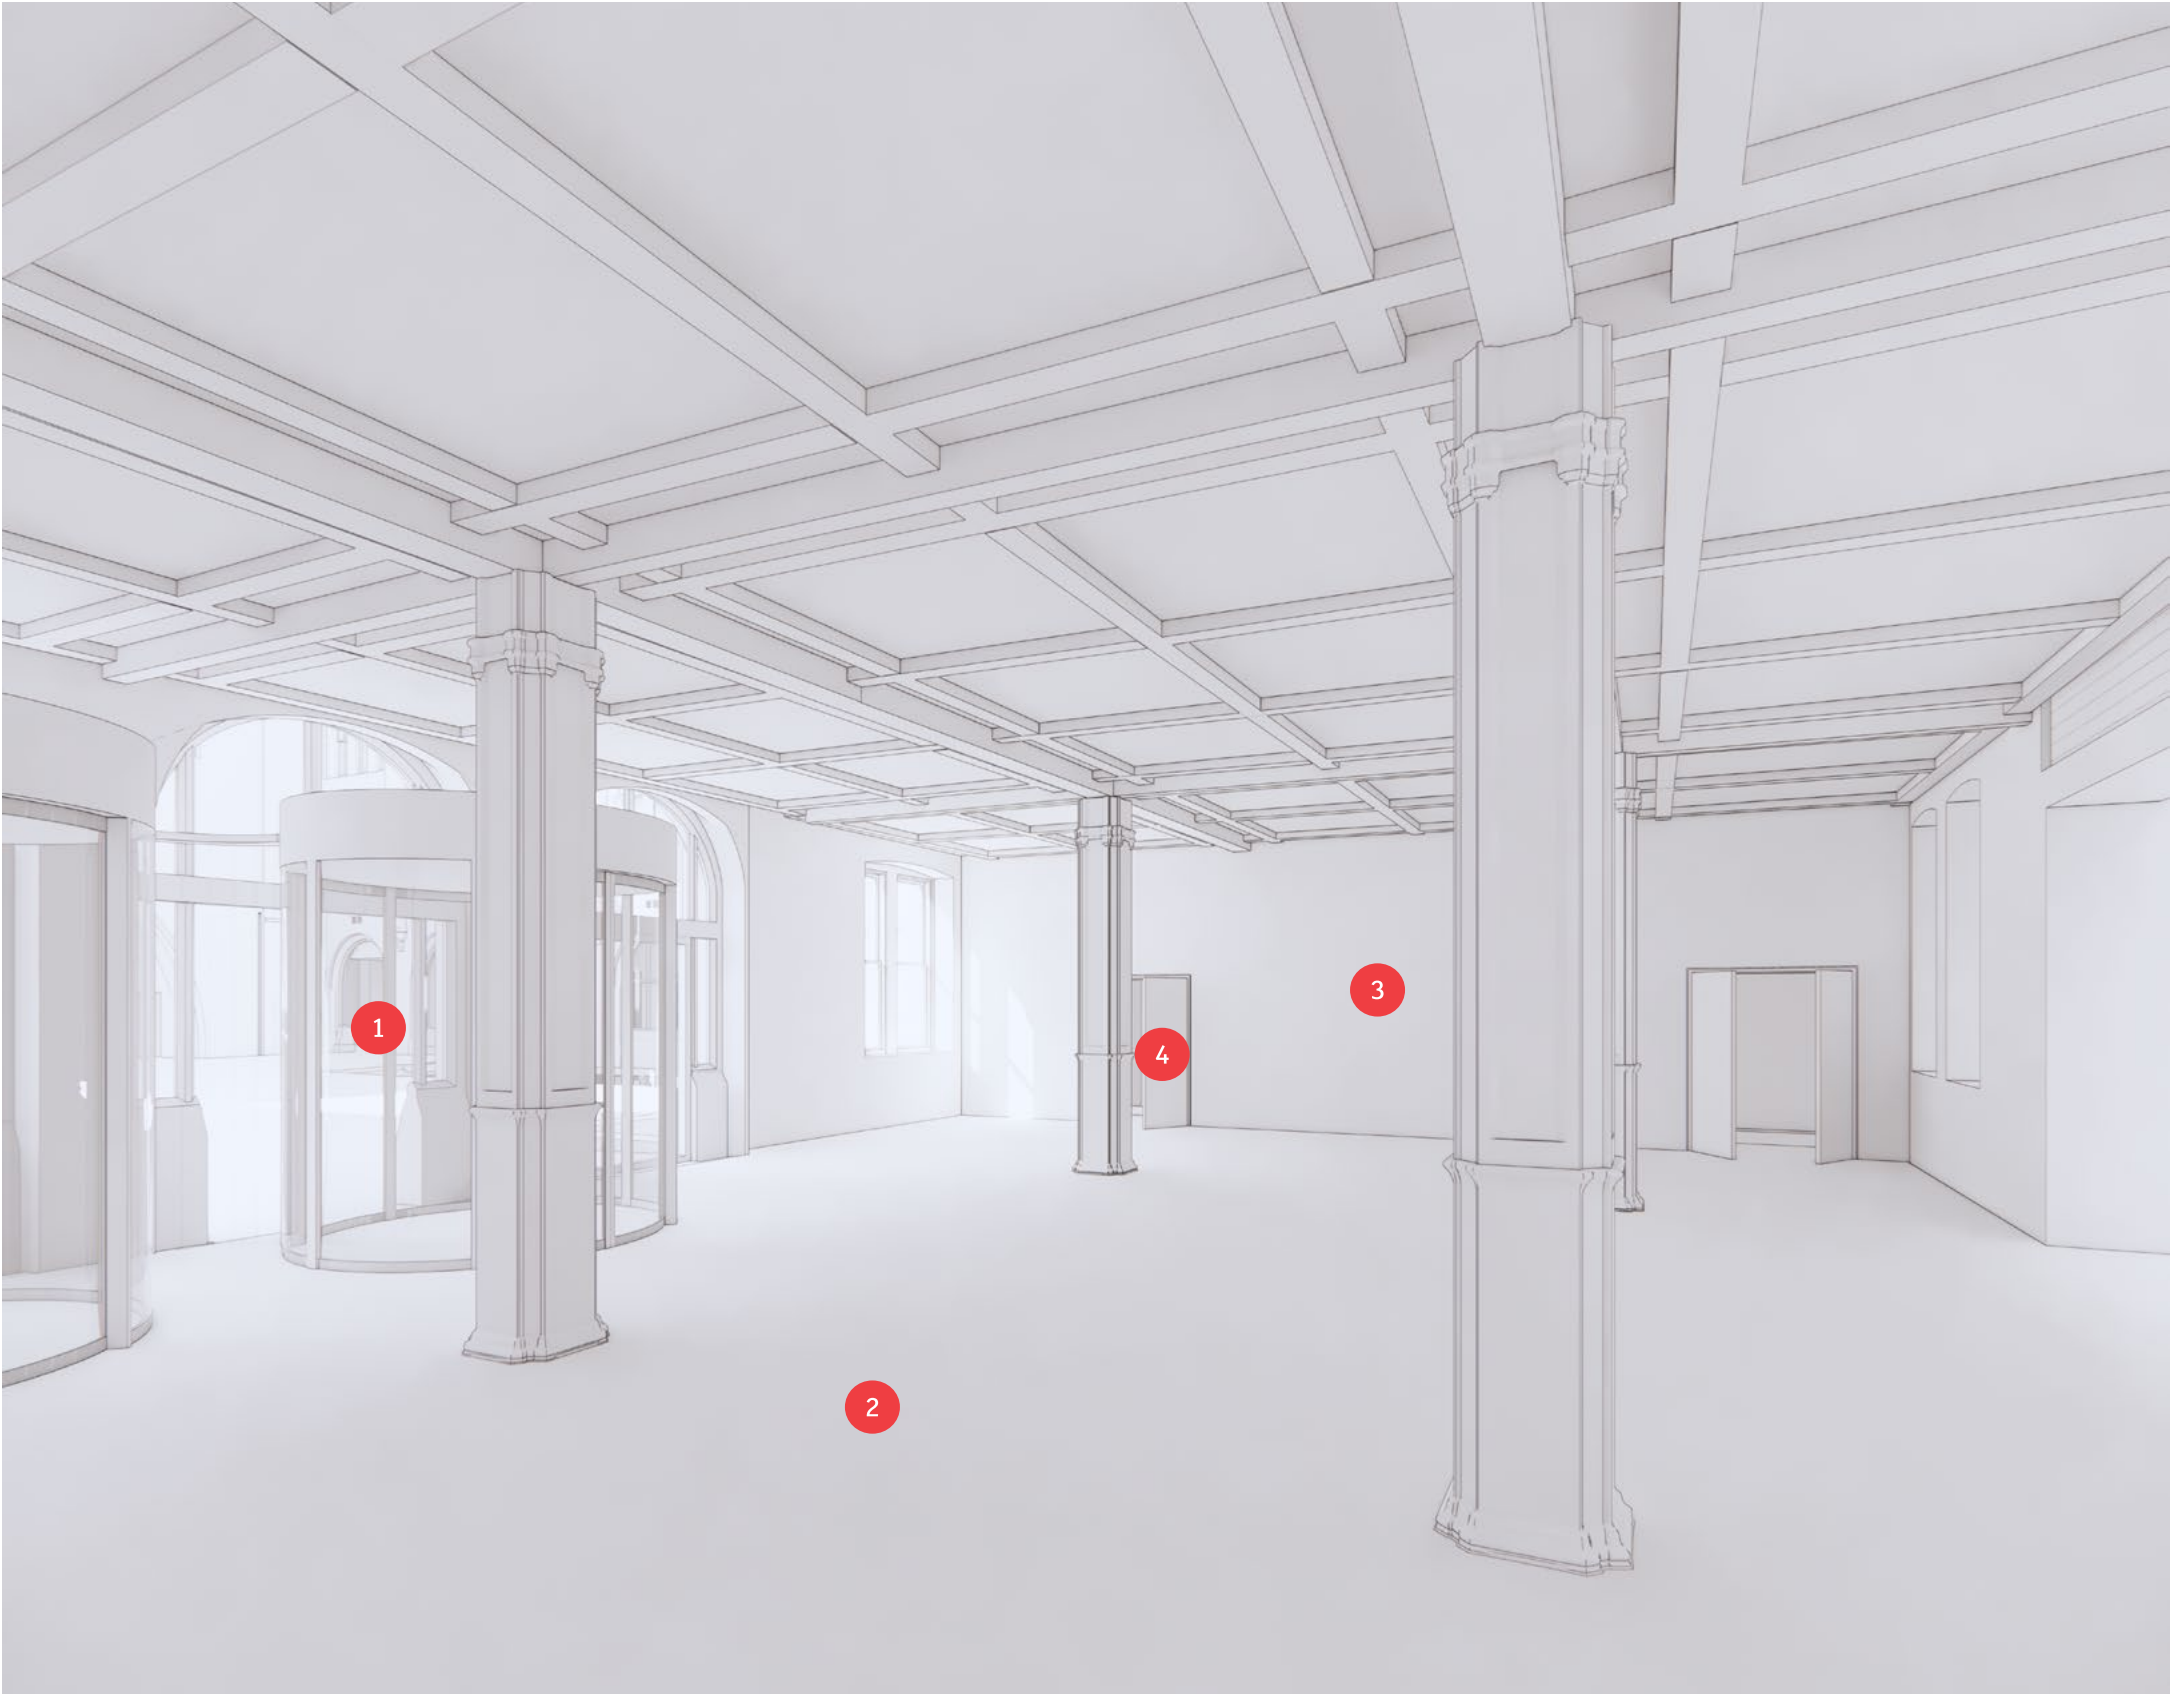
Waterhouse Square - Proposed Condition

The proposal seeks to intervene with the non original features only. The faience columns and the moulded plaster ceiling will be retained and refurbished or repaired as required..

A new partition is provided on the line of a historic partition, which separated the historic entrance and the clerks room. The interface of the partition with the moulded ceiling will be carefully considered. New drum doors are also provided to reduce the intrusive nature of the existing glazed lobby, allowing more space for the expression of the heritage features.

It is also proposed to replace the contemporary heritage style doors and provide a new floor finish to the space.

- 1 New drum doors
- 2 New floor finish
- 3 Partition reinstated on original line
- 4 New heritage style doors
