Basement Impact Assessment

31 Daleham Gardens, London NW3 5BU

Report No: 2023-002-SIM-DAL Rep.003

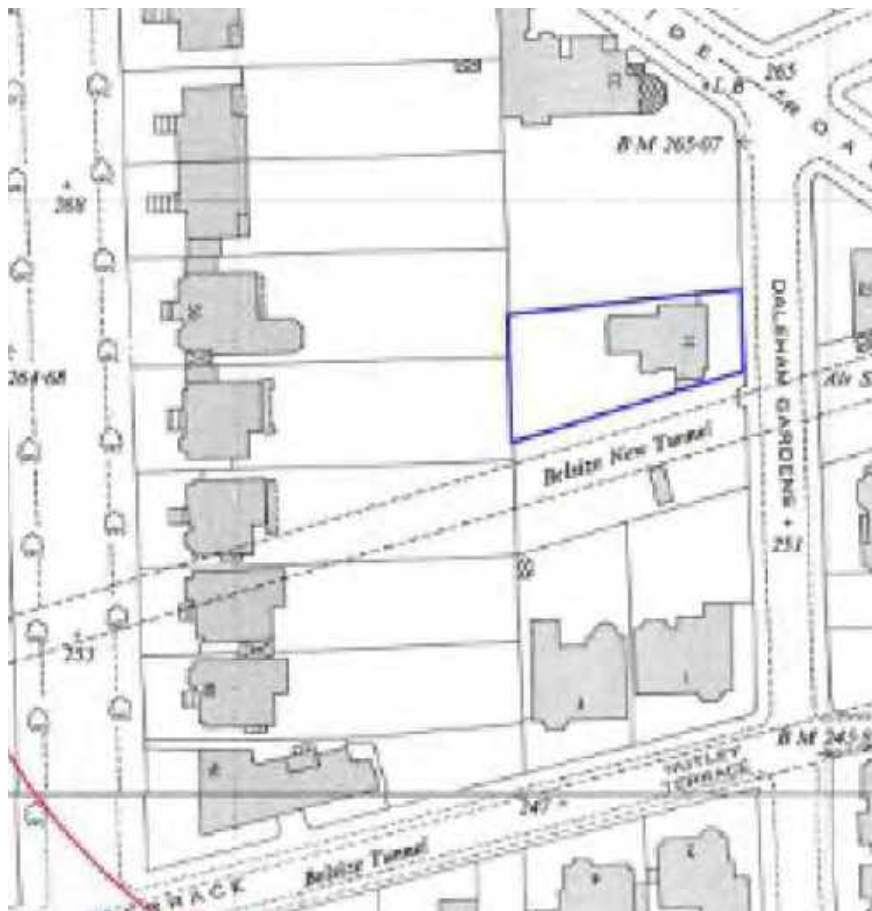
Figure 3: Plan Showing Location of Belsize Tunnel in Relation to Site From 1953 Historical Map

The site is also very close to the alignment of the Belsize Railway Line, which passes under 31a Daleham Gardens according to available information (see Figure 3). The tunnel was built between 1865 and 1867 as part of the Midland Main Line.

14. Is the site over (or within the exclusion zone of) any tunnels, e.g. railway lines?	Yes	See Figure 3. This current information is based on record
