PROJECT
74 Albert Street, NW1 7NR

SHEET TITLE
Proposed front steps renovation

355-DWG-177

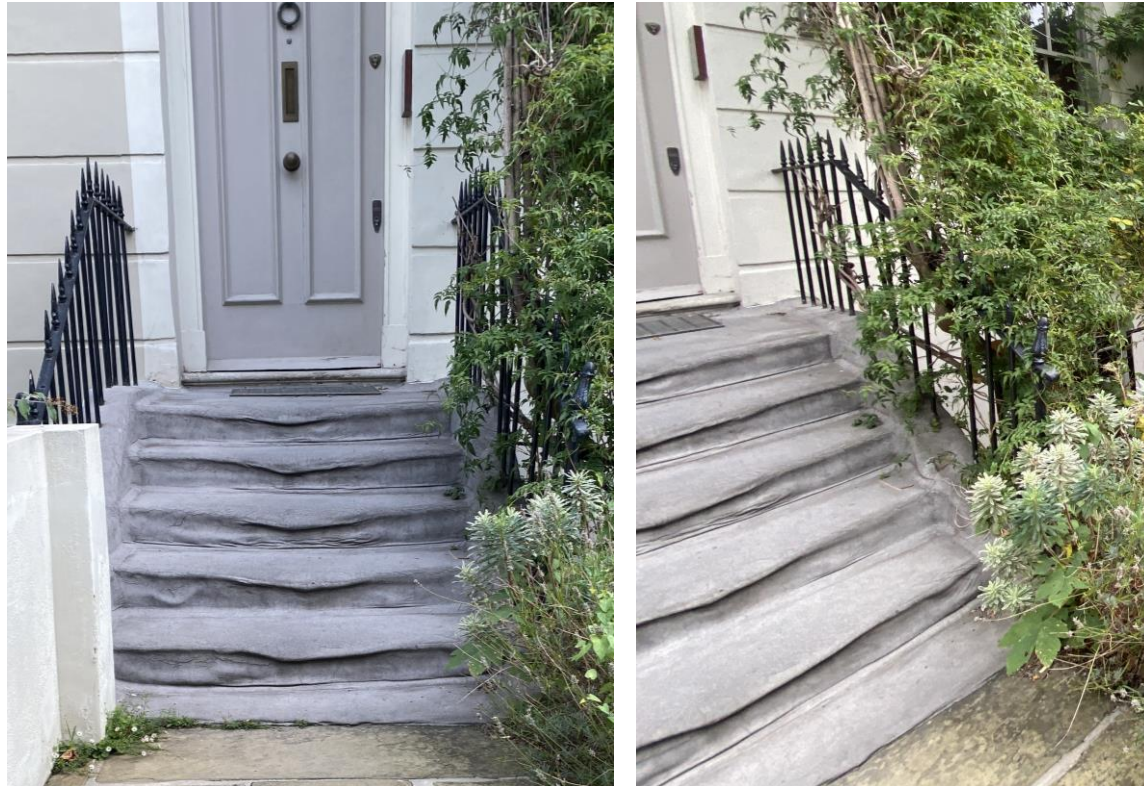
Existing steps covered in asphalt that has been poorly laid and has therefore melted, potentially causing trip hazard

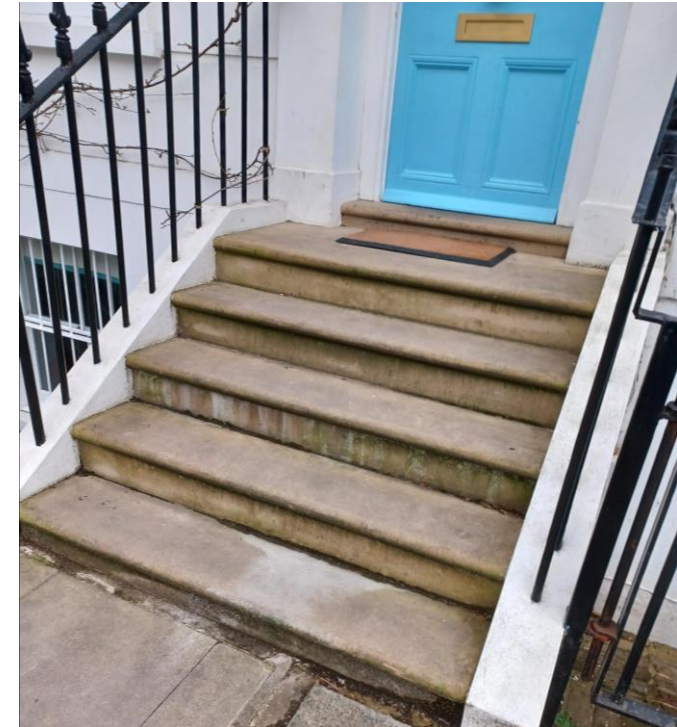
Proposed

Example of York stone steps on Albert Street (no. 113). Also shows concrete sides to frame the new steps.

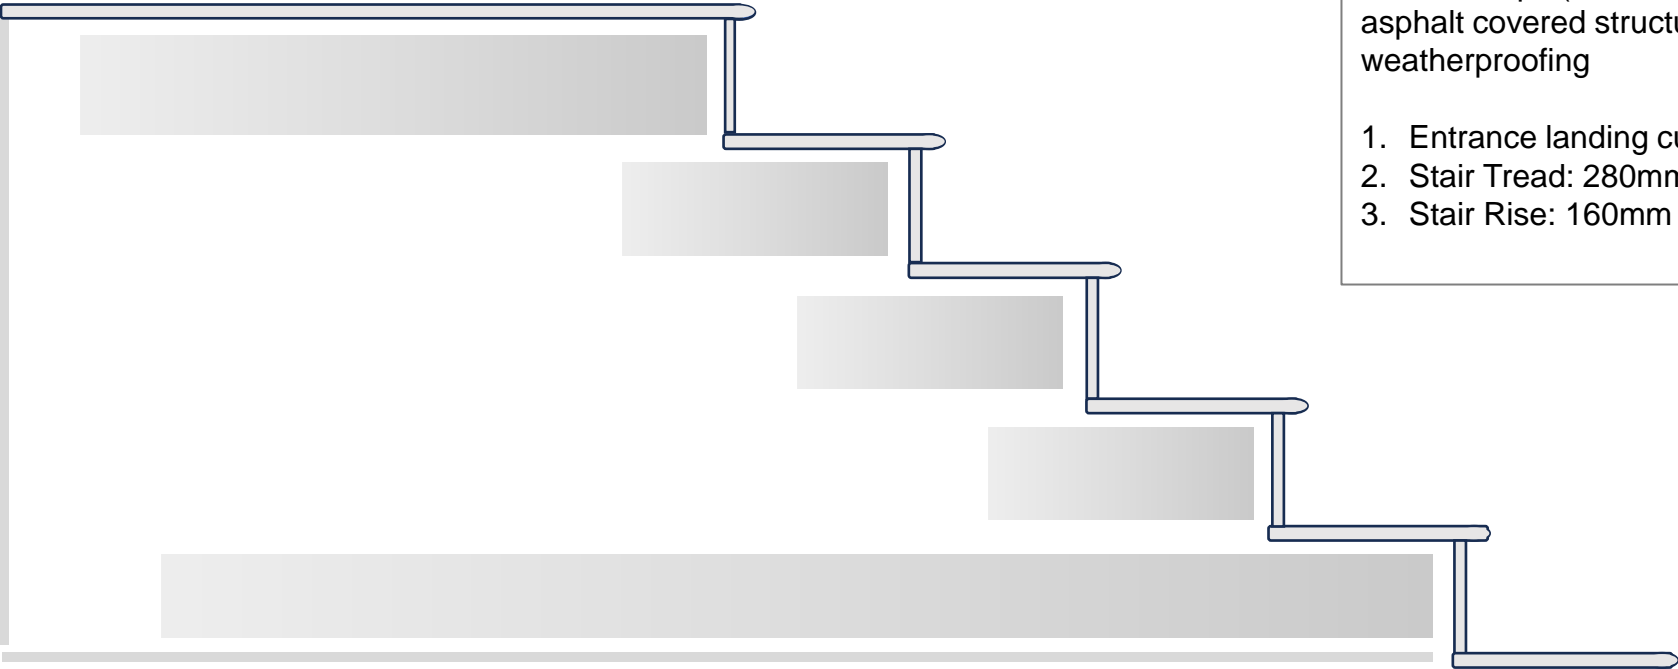
Proposed Design – Side Elevation

York stone used in keeping with heritage advice and other period houses on Albert Street (cf. no. 113)

6 stone steps (shown in light grey) laid on top of existing asphalt covered structure (shown in dark grey), to ensure weatherproofing

- 1. Entrance landing cut from single piece of stone (?)
- 2. Stair Tread: 280mm, bull-nosed
- 3. Stair Rise: 160mm

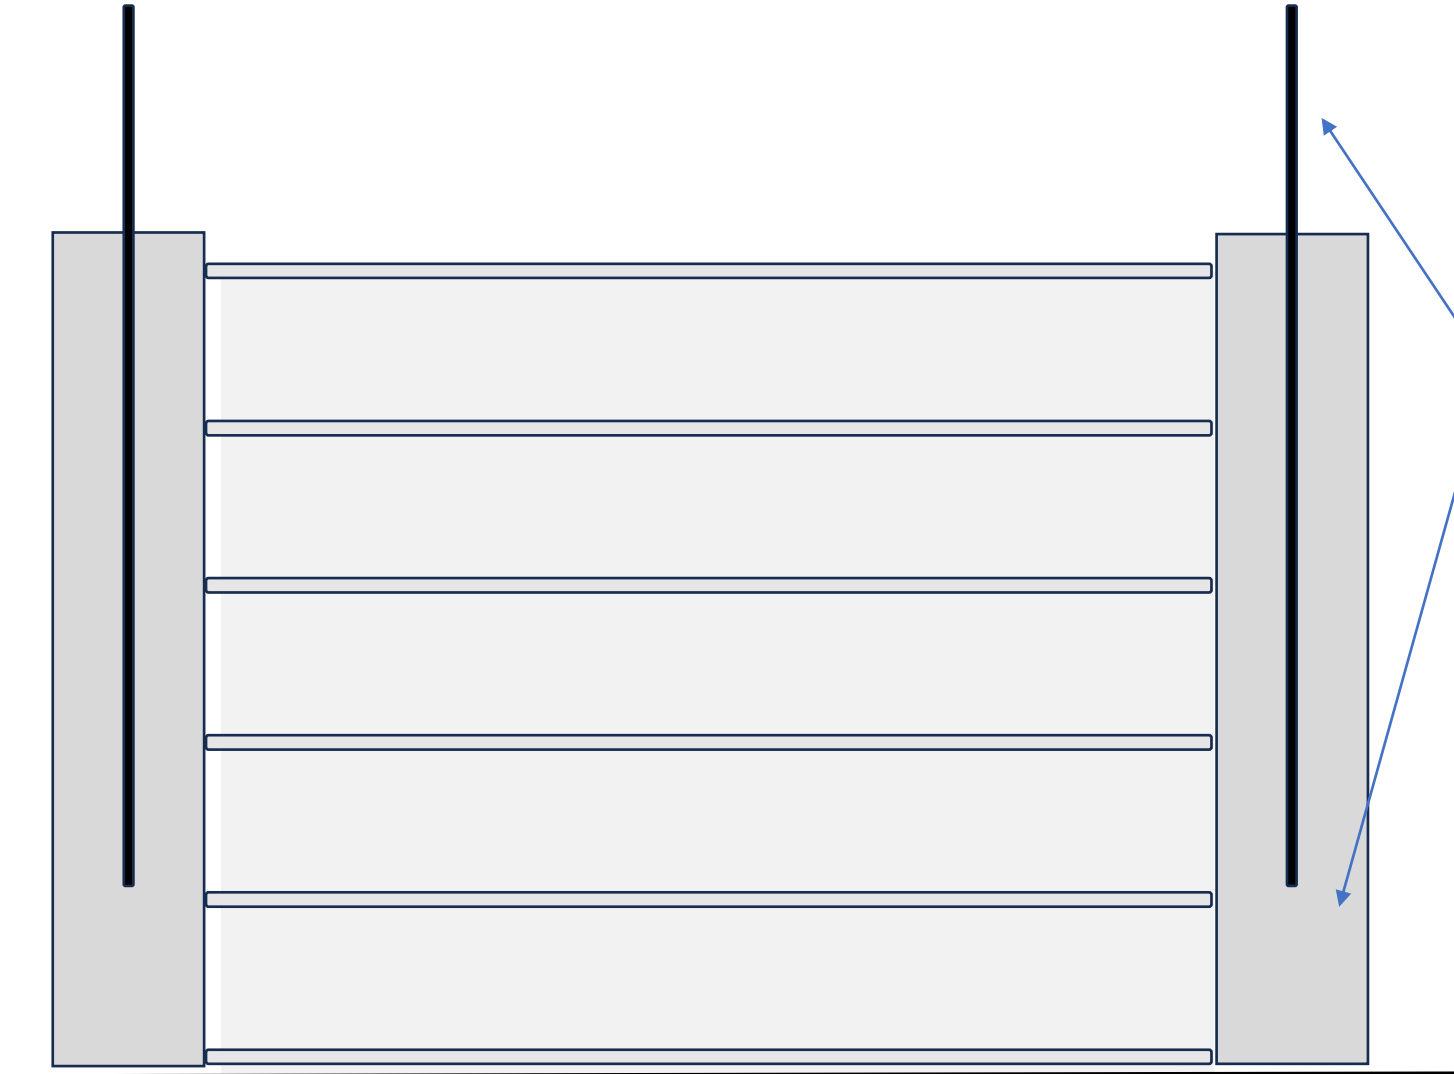
Proposed Design – Front Elevation

Existing cast iron railings retained and repaired where damaged. Stripped and repainted.

Steps to be framed with sloping concrete (set in boxing). Railings currently set directly in asphalt, causing weathering.

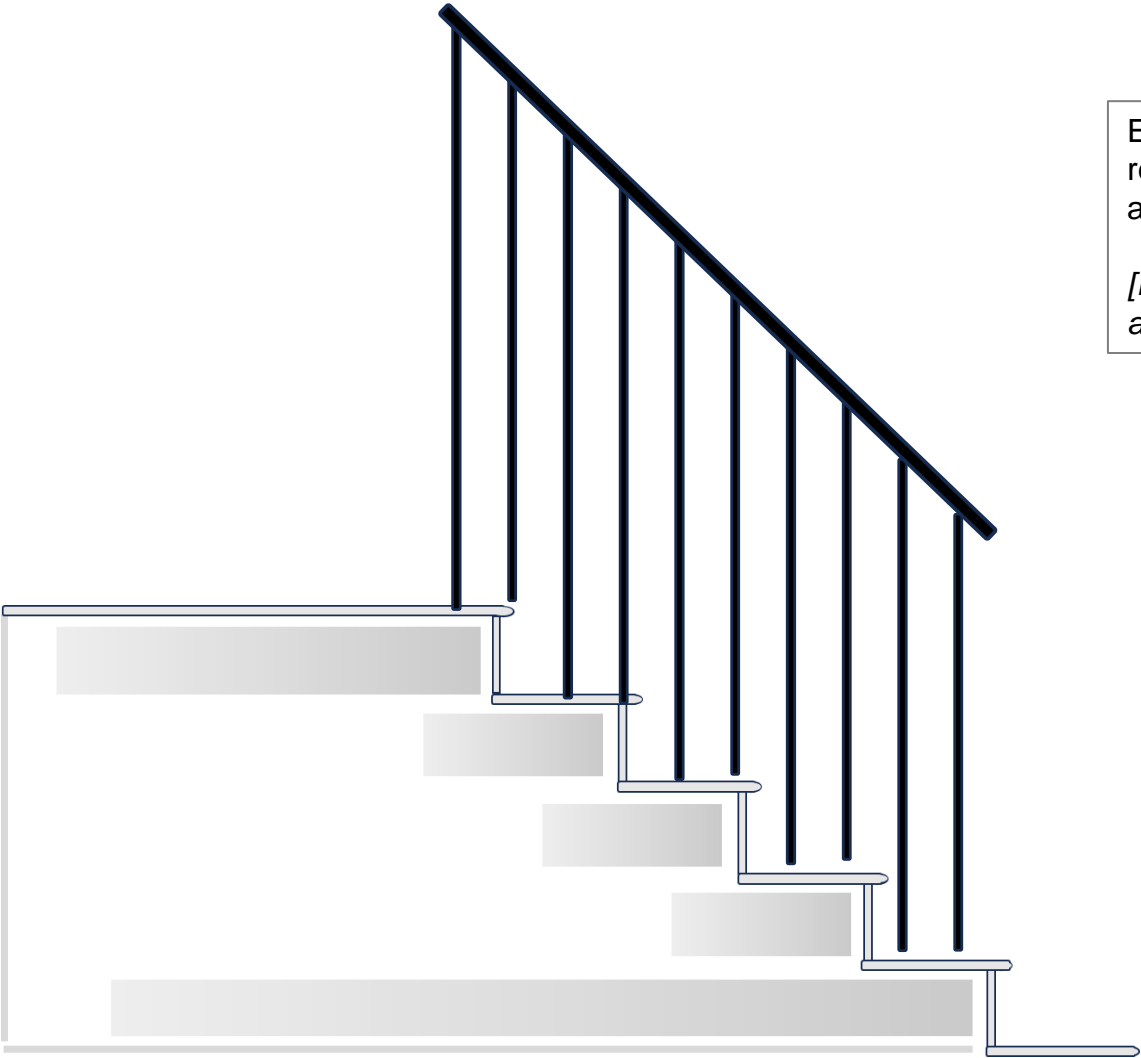
Proposed Design – Railings Illustration

Existing cast iron railings retained and repaired where damaged. Stripped and repainted.

[Railings are for illustration purposes and not shown to scale]
