Proposal No.80 extension flank wall external insulation proposal

Proposals No.80 extension flank wall external insulation details

Proposals Heritage Impact of no.80 extension remodel and external flank insulation

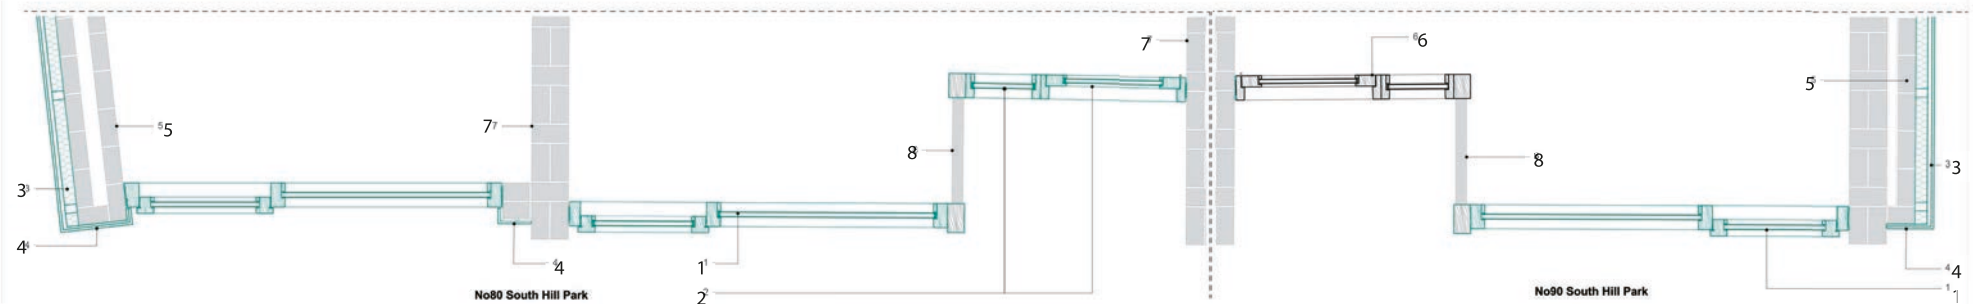
Ground floor plan - insulated gable end details at no.80 & no.90

1. New hardwood timber framed windows to match original design from 1950s, to improve the existing thermal building performances
 2. New hardwood timber framed door and side fixed panel to match original design from 1950s, to improve the existing thermal building performances
 3. Permeable insulation to un-insulated flank wall, with wood-fibre batts fixed to the mortar courses masonry and finished with a permeable lime render, to improve the existing thermal building performances. Permeable render finish to match brick colour of lighter bricks and exposed slabs
- Note:** Thermally, the existing uninsulated flank wall is a significant problem in terms of internal comfort, energy and cost efficiency as well as risk to the existing fabric because of current condensation

4. Permeable pender finish on wood wool panel to brickwork return, reduced thickness to max. 30mm overall. Lime render finish to match brick colour of lighter bricks
5. Existing uninsulated cavity wall
6. Existing brickwall, original end of terrace flank wall
7. Existing party wall
8. Existing solid return to porch entrance (blockwork with tiber goalposts at both ends)
9. Existing hardwood timber framed door and side fixed panel retained as recently renewed and matching the original design already
10. Existing exposed concrete slabs refurbished
11. Permeable render finish to match existing concrete slab behind

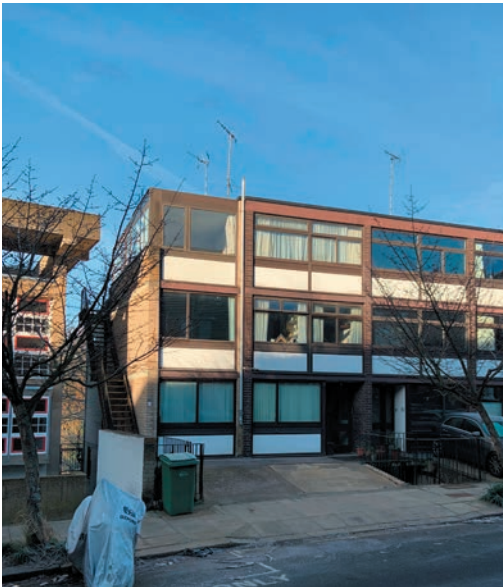
Existing view of no. 80 extension and flank wall

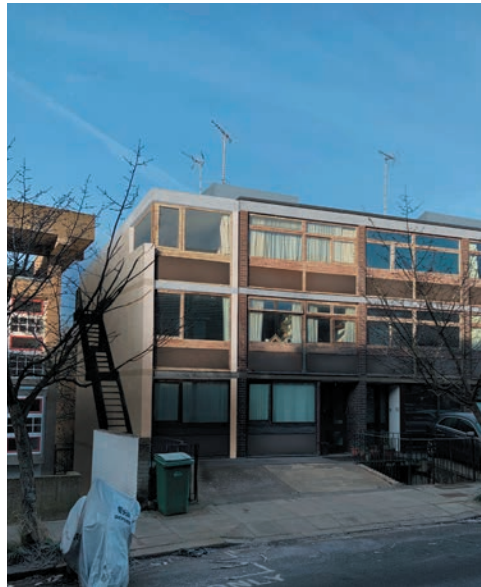
Rendered view of no. 80 extension and externally insulated flank wall

We believe that, providing the render colour matches the lighter brick of the flank walls and the slight setback onto the main frontage is maintained, then the potential harm is mitigated and the overall benefit is significant.

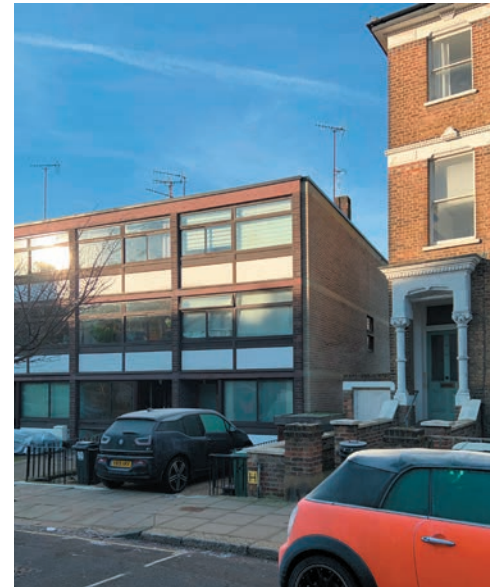
Existing view of flank wall at no90 end of terrace

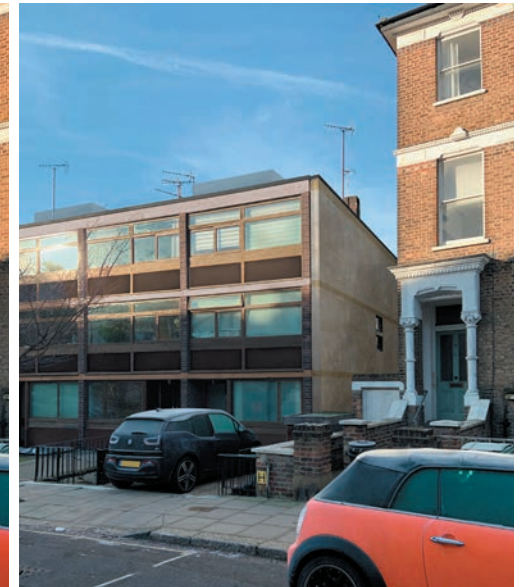
Rendered view of flank wall with external insulation at no90 end of terrace

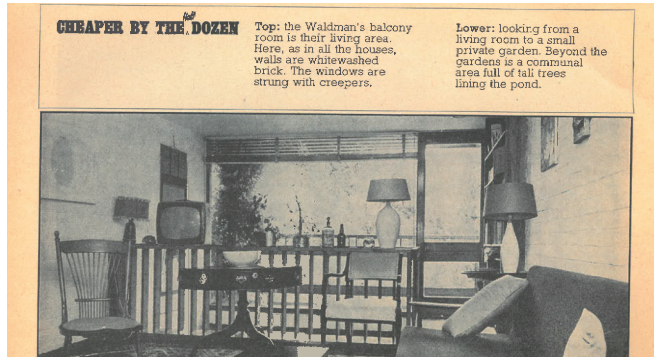
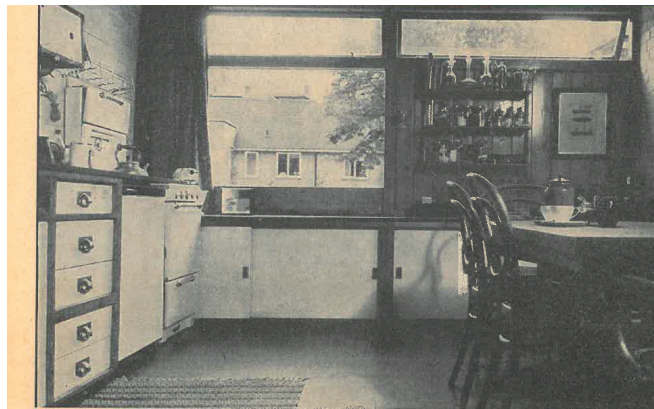
Interior photos of the Waldmans house (no.80)
Top photo shows the original void between ground and lower ground floors which is now filled in.

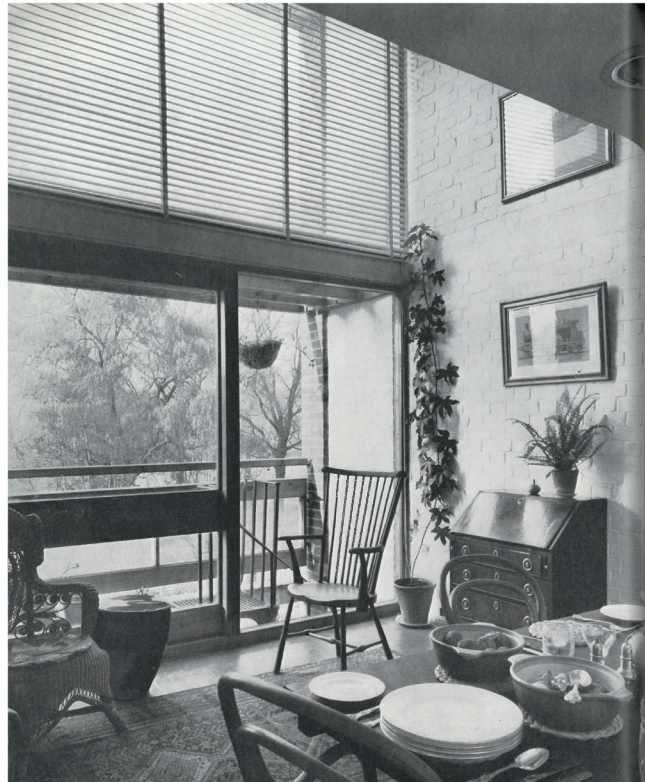
Design intent is to re-open the original double height void to create a space much like the Howells' living room at 82 pictured here
