99 FROGNAL

STRUCTURAL OVERVIEW AND DESIGN CRITERIA

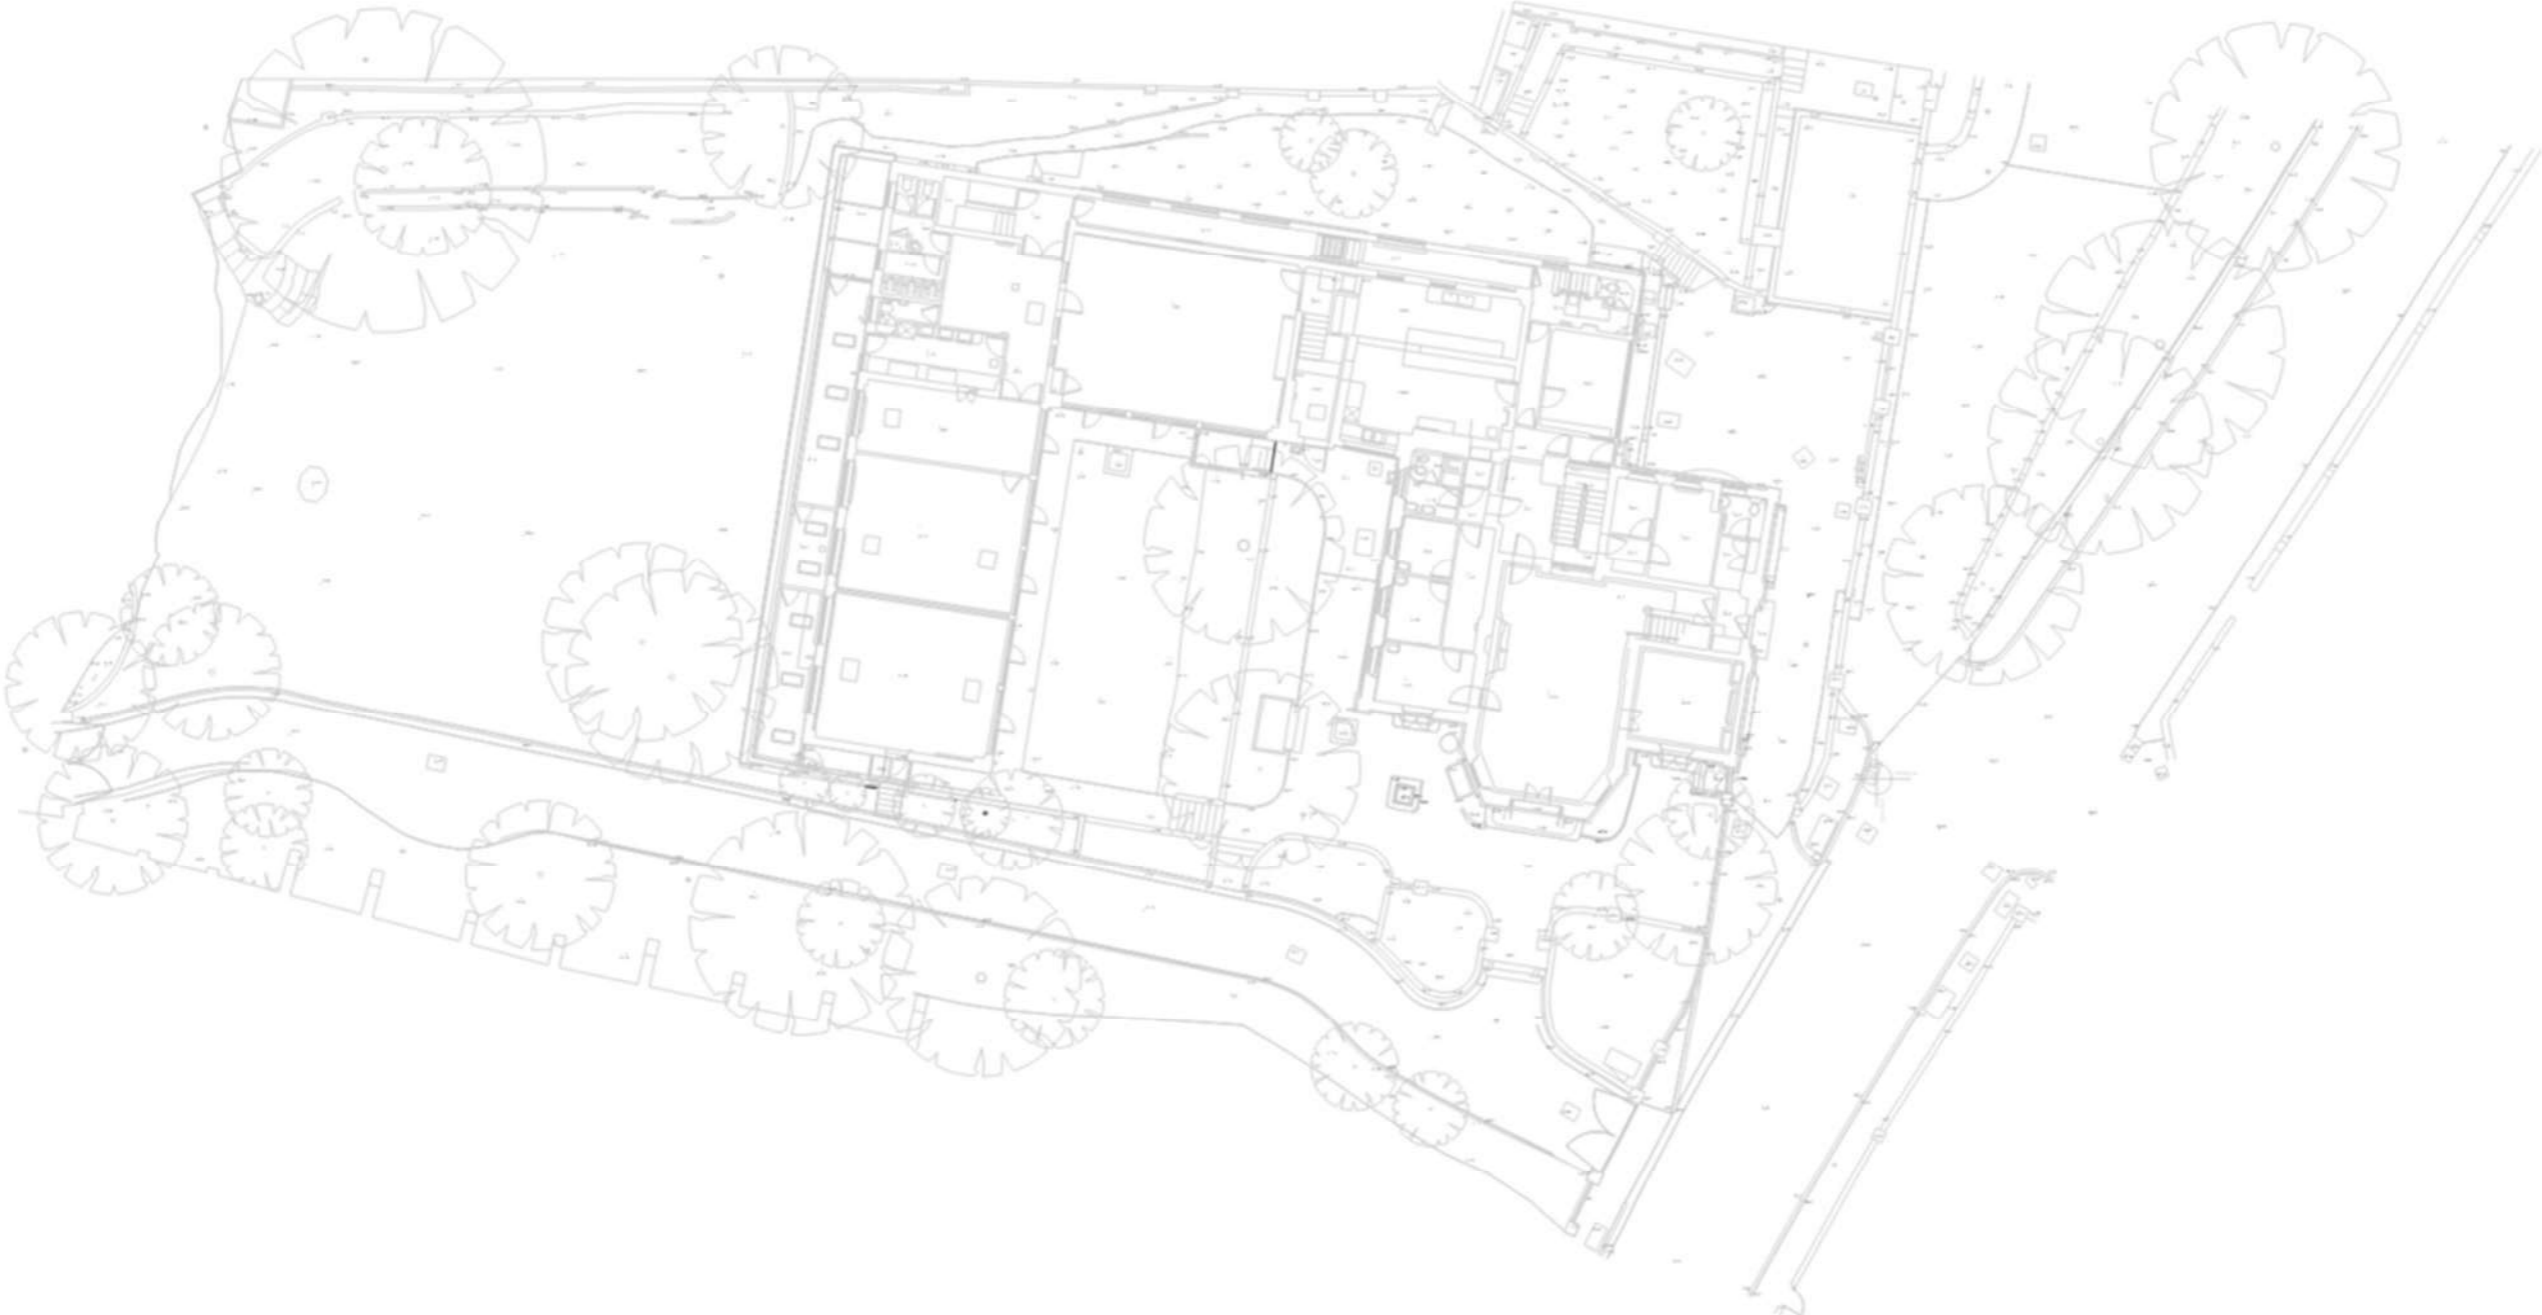
99 FROGNAL TOPO SURVEY MAP

A topographic survey has been undertaken which covers all areas within the property boundary including the adjacent footpath and road. The land is sloping up to the north and west, from a level of 109m AOD at the eastern extent up to 119m AOD at the north-western corner. Behind the northern wall of the extension building the land slopes up from a level of around 112.5m AOD to a level of 114m AOD at the boundary wall.

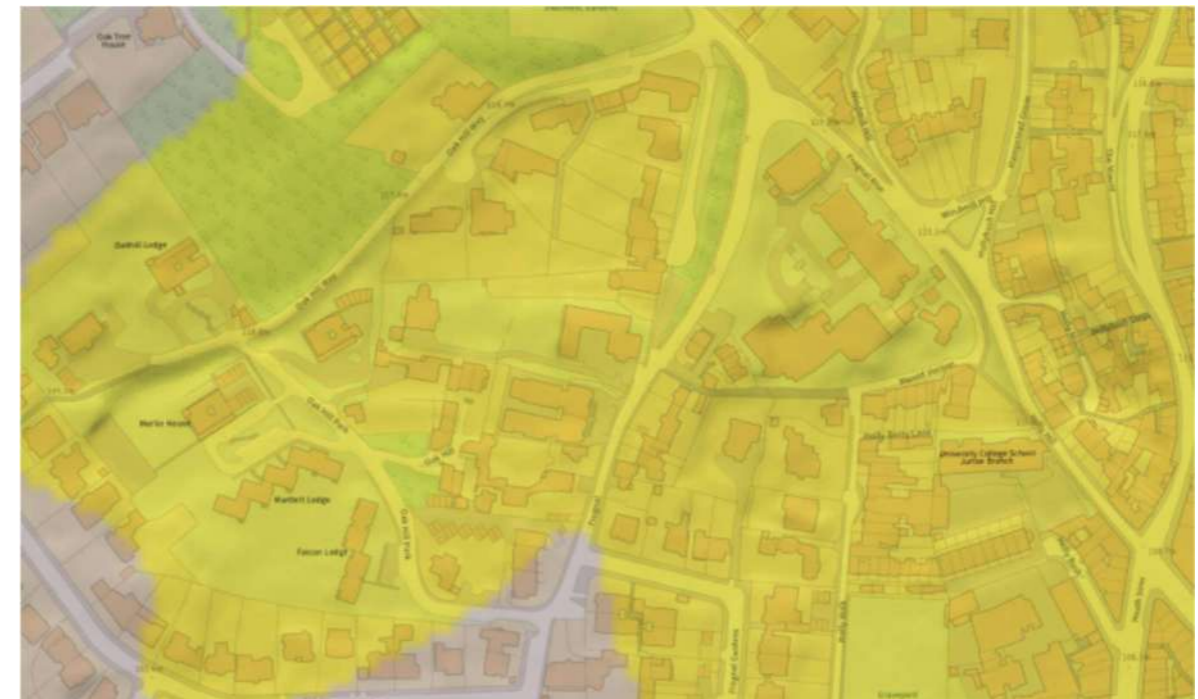
BGS MAPS – BEDROCK GEOLOGY

The British Geological Survey (BGS) mapping shows that site is underlain by Bagshot Formation, with no superficial deposits. The Claygate Member and the London Clay Formation are also shown in close proximity to the site and are thought to underlay the Bagshot Formation.
