7 THE GROVE, HIGHGATE, N6 6JU

Conversion of two dwellings to single family home, and construction of a side extension
along with other external and internal alterations

DESIGN AND ACCESS STATEMENT

Planning Permission and Listed Building Consent Application
21st December 2023

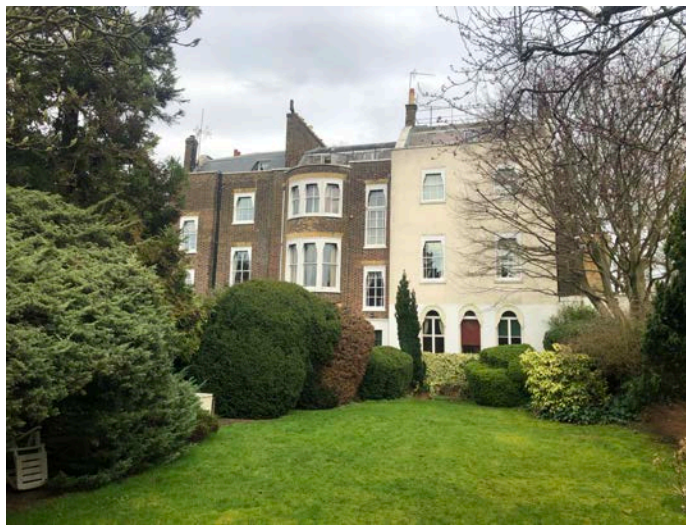
Figure 1: Rear elevation from garden.

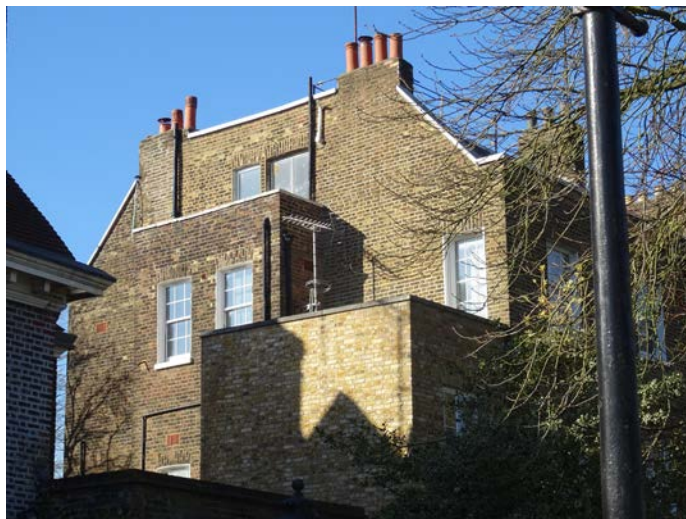
Figure 2: Side elevation.

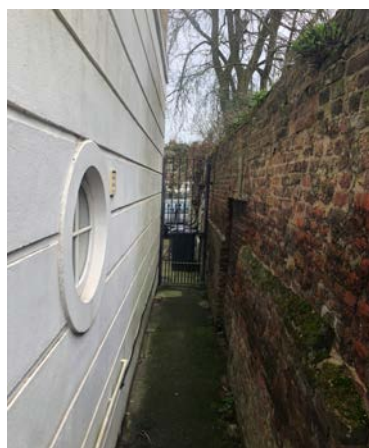
Figure 5: Side Passage and 2011 extension 7A round window.

The side passage is in the sole use of no. 7 and available for the purposes of the maintenance of no. 7A only. Any loss of privacy attributed to the 2011 installation of the round window to the side/south elevation by the owners of no. 7A shall not affect the continued use of the side passage by the occupiers of no. 7.

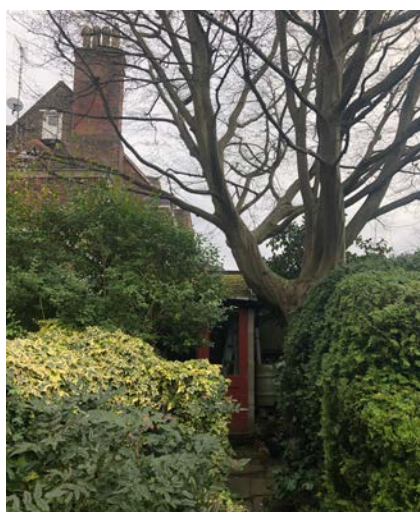
Figure 7: Mature hornbeam adjacent to existing garden shed.

Deep mc foundations are proposed to be minimised to a 600x600 pad at the corner of the extension and a strip adjacent to no. 7A; ground beams bearing off these pads and the flank wall of the existing building support the new walls over whilst allowing for the preservation of roots beneath.

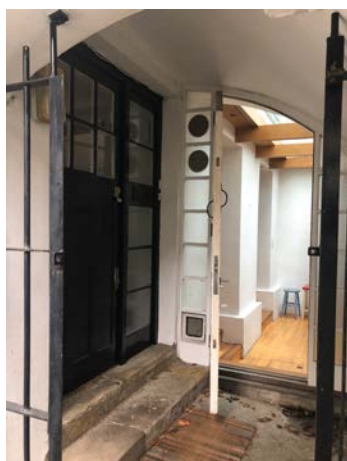
Figure 8: External door in Front Area to existing 7B.

One of the two external doors that currently serve flat 7B will be retained to provide separate access for guests if required; the lowering of the floor level to the Entrance Hall at basement level means that the number of steps at the threshold to this door is reduced from two to one.

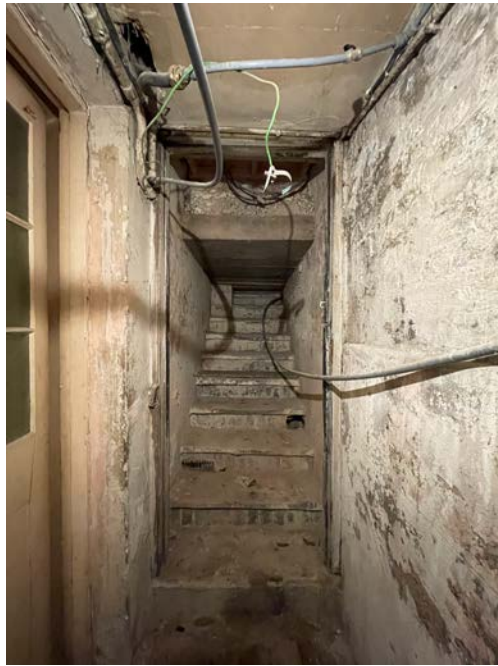
Figure 9: Blocked back stair/ proposed staircase store and area of new ceiling.

New vented panelled door within existing frame to Staircase Store.

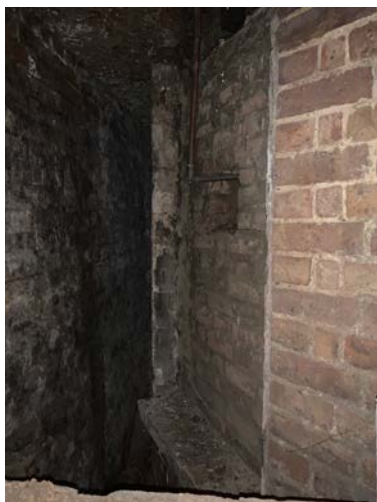
Figure 11: Existing Rear Well with blocked window openings and concrete slab above.

Demolish concrete floor slab over to recover Rear Well; make good retaining wall as required;

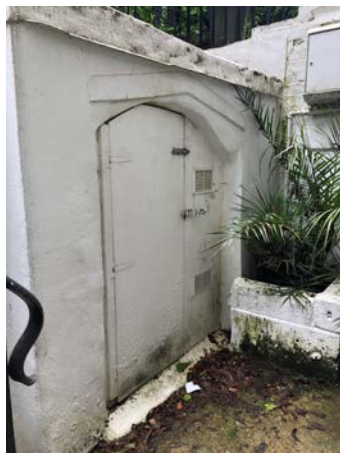
Figure 12: Existing door to South Vault and meters.

Raise cill to door opening to Meter Vault and fit new painted timber boarded door/fixed panel with black iron ironmongery;
New partition with painted boarded linings, and boarded door South Store;
Replace steel stair with new LCC tread stair

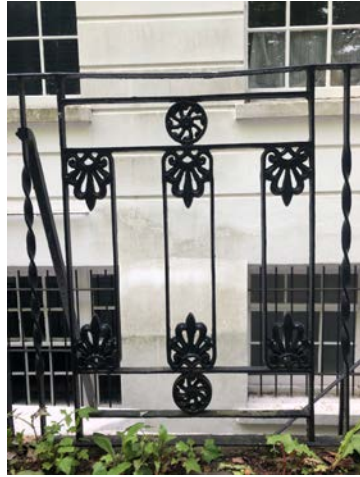
Figure 13: Painted cast iron panels on existing South Front Area, to match.

New balustrade to South Front Area comprising painted cast iron panels to match existing/ original on low wall with gate to access replacement stair.

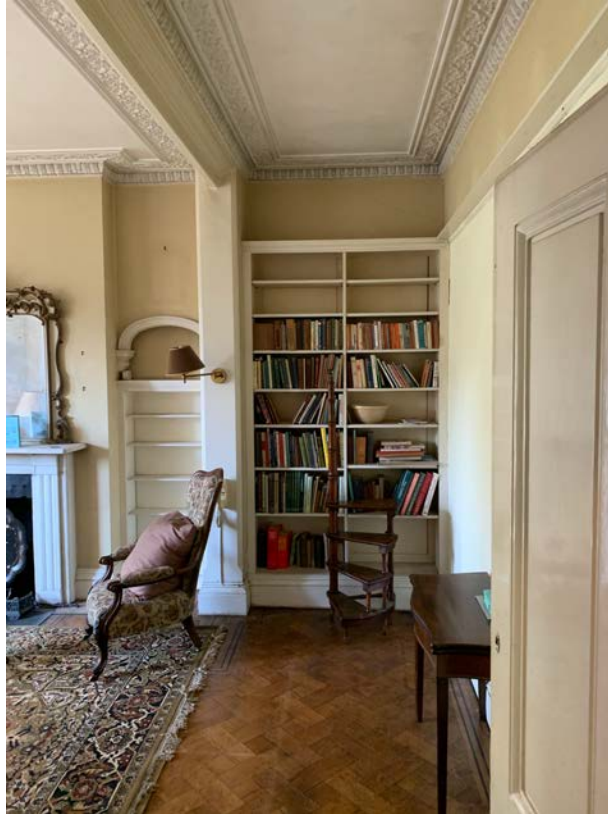
Figure 16: Existing cornices, and bookcases and decorative brackets to rear reception niches.

Line flue to existing fireplace to rear reception; restore marble chimney piece;
install woodburning stove.
Take pressing of later C19 cornice and reproduce to suit new planform;
Make good skirtings, architraves etc. as required;
Ease shutters to front windows; install Storm Glazing slim secondary glazing
to interior of existing windows to front and rear reception rooms;
Retain existing decorative overdoor to front reception.

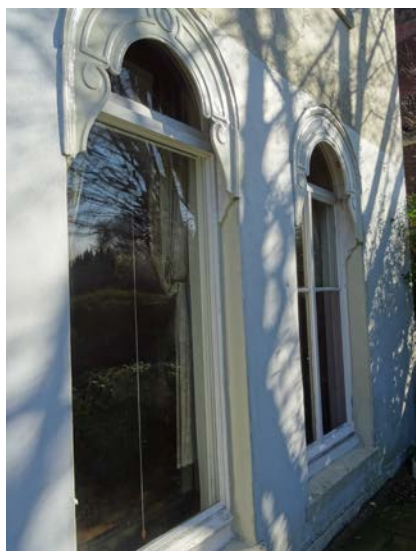
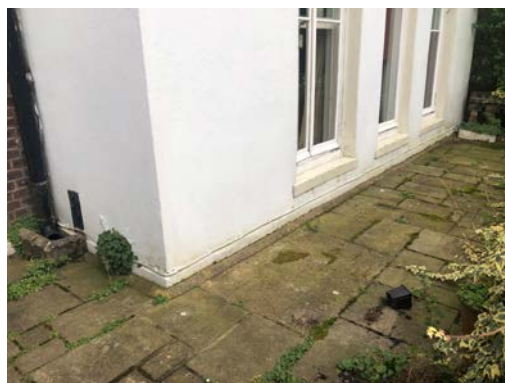
Figure 17: Fixed window to patio and bonnet blinds; Figure 18: Cills and existing York stone paving.

Excavate to accommodate water harvesting tank to specialist detail;
 New cantilever slab on masonry support walls on mc footing outside of site specific RPA; helical piles to support walls to beds;
 Supplement and lay random York stone paving;
 New York stone steps;
 Adapt level of rear yard and form step; relay and supplement existing York stone paving;
 New metal security gate to Side Passage;
 The rear masonry wall to the South Wing has been finished in a cement based render, probably during the 1940s works; the brickwork is found to be saturated both at high and low levels and the render is blow in large areas;
 It is proposed to carefully remove the render and replace in a lime render finish with a render band at first floor level;
 The thinness of the render coat is visible on the south/ side elevation ref GRO7SU102. It is proposed to extend the render to the south/side elevation as shown on drawing GRO7GA102 and to stop the return section at a string course/ band which picks up that on the rear elevation of the extension. By extending this to the rear/ west elevation of the South Wing, the vast expanse of painted render is broken up and so this elevation dominates the overall composition less. We know that an awning was once fixed in this line which would have served a similar purpose.

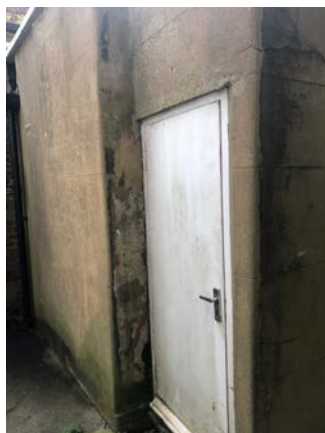
Figure 19: Existing Sauna building.

Demolish existing Sauna and Garden Shed; replace timber side gate with new iron gate; demolish and prop rear wall to WC in closet wing and prop structure over as required;

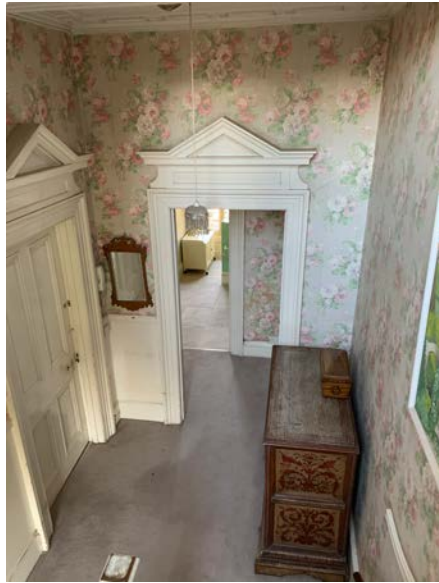
Figure 20: Modern painted timber overdoors on first floor landing

Strip modern painted timber overdoors;
Repairs, reinstatement and alterations to parquet flooring by specialist

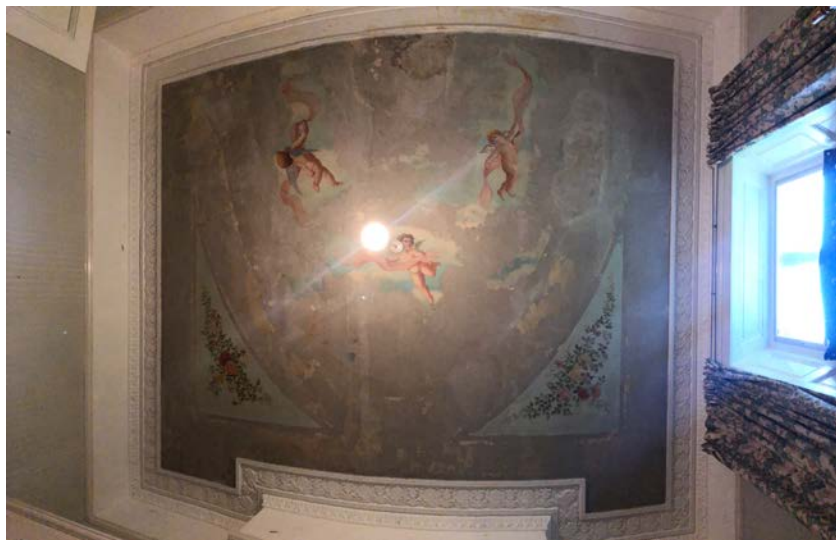
Figure 22: Damaged ceiling painting in existing Bedroom 2/ proposed Dressing Room.

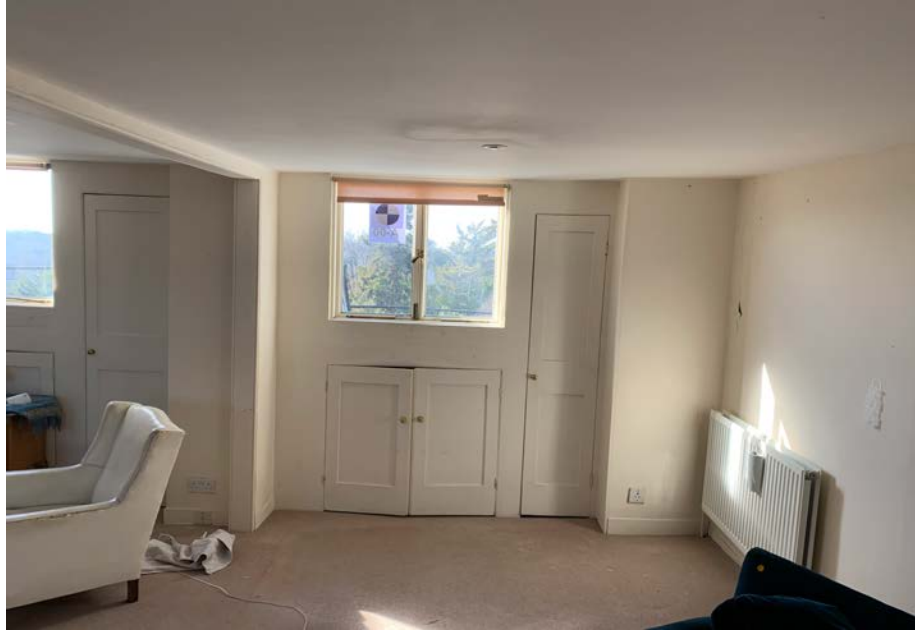
Figure 25: Existing third floor dormer window to rear bay.

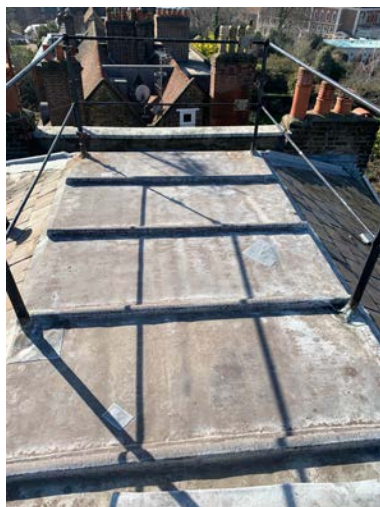
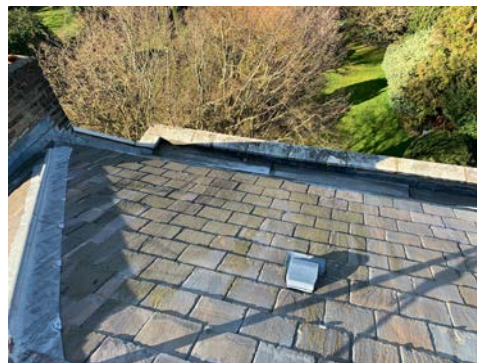
Figure 28: Roof safety handrail; Figure 29: Existing rear slope of south roof, with roof vents.

Reinstate or replace slipped or damaged slates;
 Replace plastic roof vents with custom lead eyelid vents;
 Strip lead sheet flat roof section and replace like for like; replace/ repair formation boards/ substructure as required where rotten; replace access hatch with new low profile glazed rooflight in new location to operate as automatic opening smoke vent;
 Repointing/ repair to chimney stacks where required;
 Replacement of lightning conductor.
 Lead box gutters, flashings etc. to be examined by conservation leadworker; repair/ replace only where essential with minimum disruption to formation boards;
 Inspect outlets and hoppers to box gutters; allow for increasing size of outlets in conjunction with lead work.

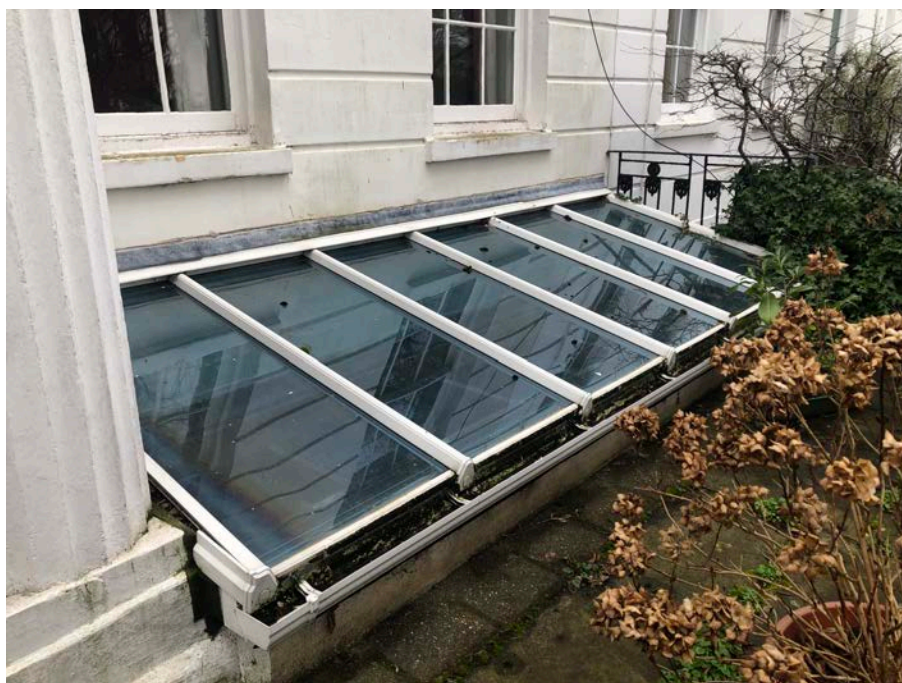
Figure 30: Front Area glazed roof.

The recovery of the north front area through the removal of the glazed roof, the insertion of basement sash windows and timber boarded doors to the storage vaults along with cast iron railings to match the original will have a positive impact. A positive impact will also arise from the replacement of windows to the side of the porch and alterations at porch roof level to enable the restoration of the cast iron balcony at first floor level.

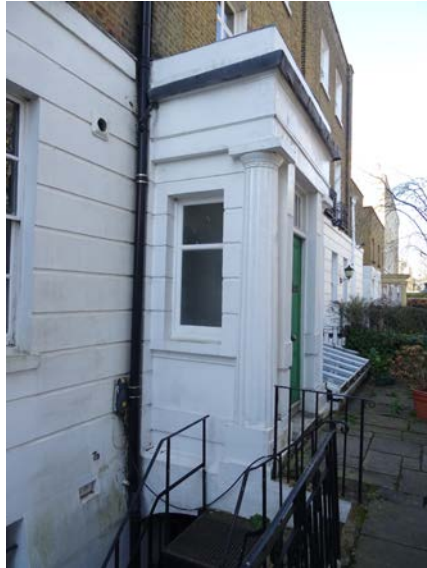
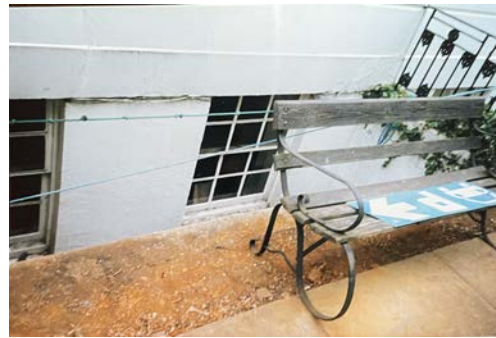
Figure 31: Modern porch windows; Figure 32: Historic photo of 1980s basement works, and lost original sash window.

Removal of UPVC patent glazing to north front area and reinstatement of original sash windows at basement level;
Replacement of Porch fixed casement windows with modern cast glass with traditional sash windows with clear glass;

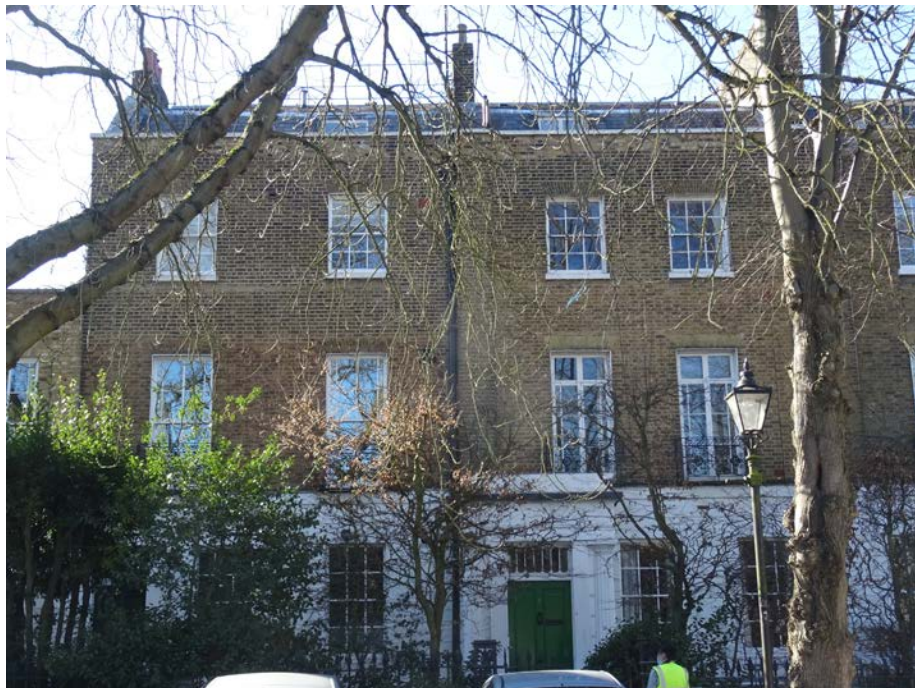
Figure 33: Front elevation casement windows to third floor, and roof safety handrail visible from street.

The replacement of modern casement windows with sashes modelled on those visible in a historic photograph will have a positive impact.

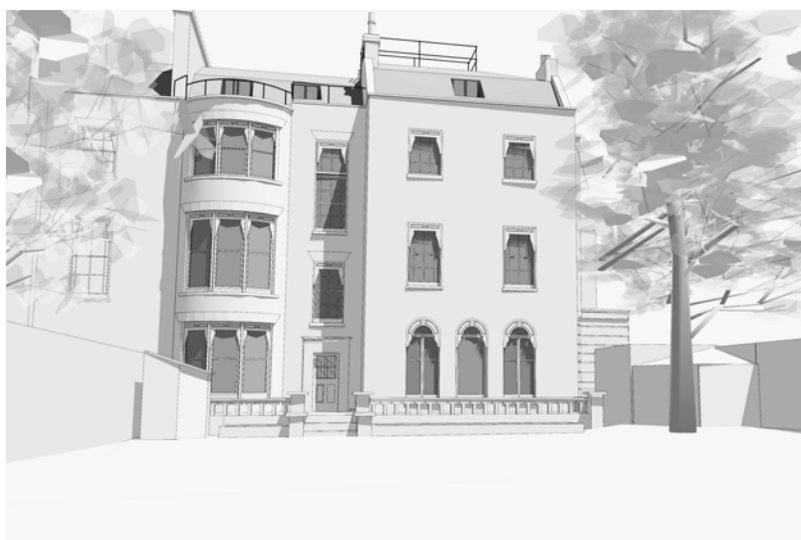
Figure 34: Visualisation of existing rear elevations.

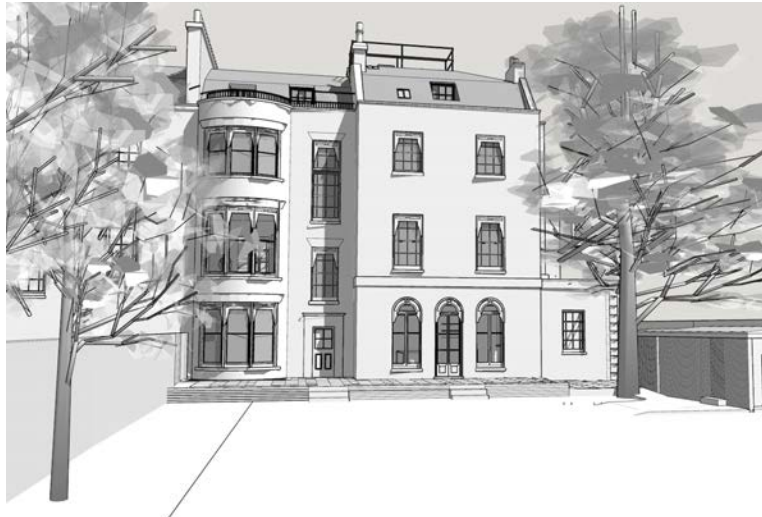
Figure 35: Visualisation of proposed rear elevation

At roof level, the modern casement windows are replaced with sashes modelled on those visible in the historic photograph below, and will have a positive impact; the insertion of flush conservation rooflights to the rear roof slopes will have a neutral impact as result of their size and detail. The removal of the clumsy safety handrail to the non-original bow bay, along with the removal of its insitu concrete coping, will have a positive impact that will mitigate any harm that arising from the alterations required to enable the use of the bow bay as a balcony.

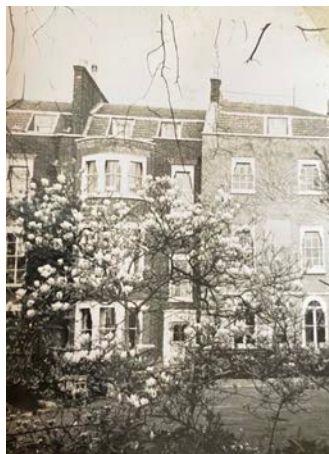
Figure 36: Historic photo of rear elevation, circa 1950s, showing original sash windows to third floor dormers.

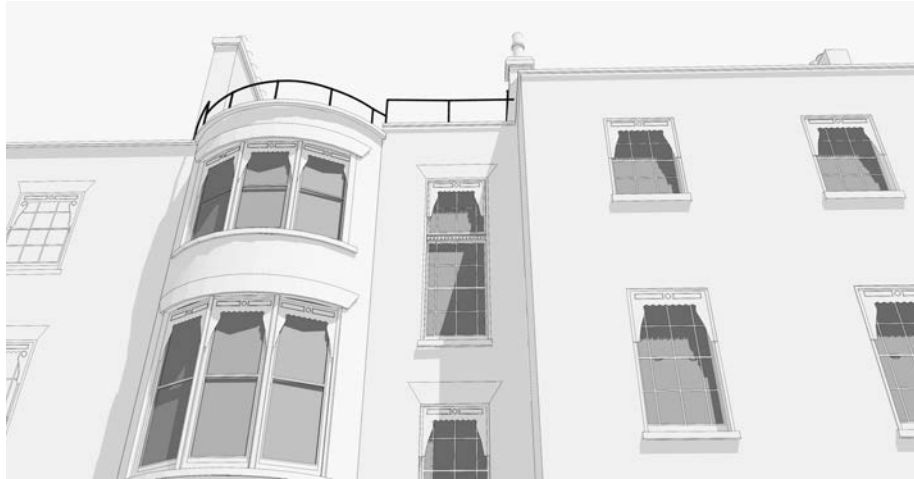
Figure 37: Visualisation of existing bay and safety handrail

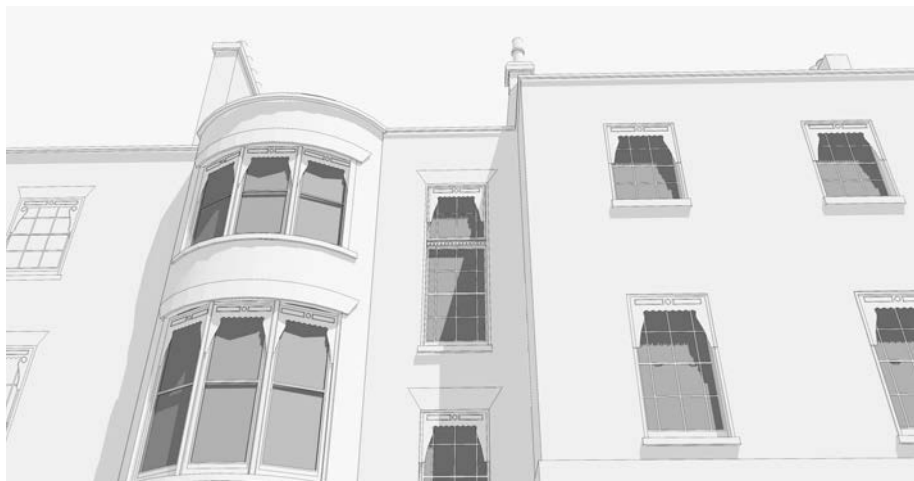
Figure 38: Visualisation of proposed raised bay parapet

The raised parapet wall to the bow bay, which will be capped with natural stone copings in place of the existing concrete coping, means that the steel railing, set fully to the inside of the parapet, is barely visible from the ground. On balance the addition of this handrail, and the removal of the safety handrail atop the coping will have a positive impact. Furthermore, the replacement of the inverted dormer casement window with half glazed doors to provide access

to the terrace is also barely visible due to its location behind the projecting bay. The loss of historic roof fabric to achieve this arrangement does have a negative impact on the heritage significance of the original house, but the measures taken in the design of the doors, parapet and railing minimise the extent.

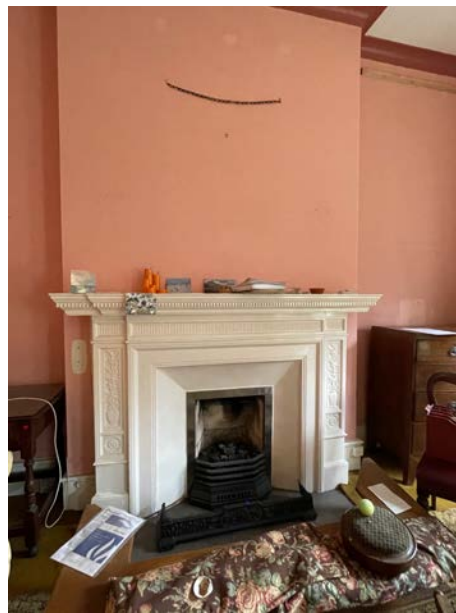
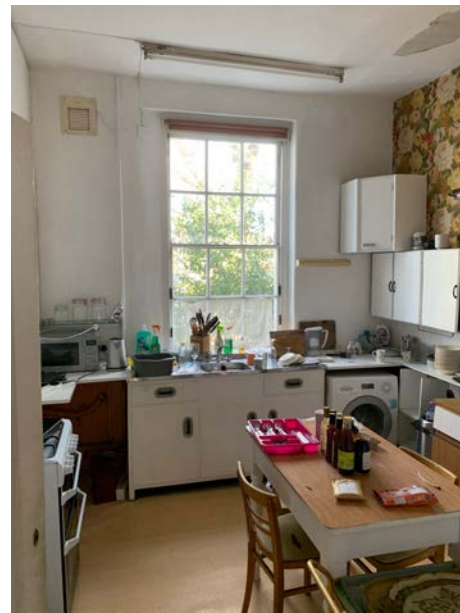
Figure 40: C20 painted timber chimney piece; Figure 41: Existing Kitchen.

The subdivision of the existing front room within the South Wing is of neutral impact, since the existing kitchen is already created out of the subdivision of a much larger room: furthermore the reintroduction of shutters to the original front window will have a positive impact and new mouldings to match existing (all of which are lost here) will create a charming study and playroom.
