refurbishment feasibility report
gl hearn

Refurbishment Feasibility Study

100 & 100a Chalk Farm Road
London
NW1 8EH

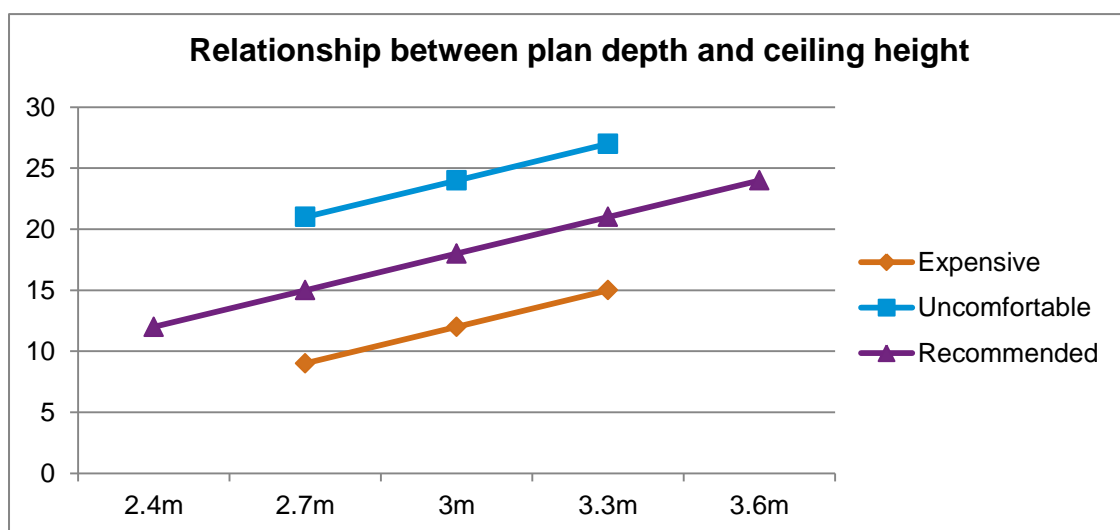
- 8.1.1 Window to window or atrium 13.5m – 21m
- 8.1.2 Finished floor to underside of ceiling 2.6m – 3.3m
- 8.1.3 The relationship between plan depth and ceiling height is critical. Natural light and ventilation is available to occupiers of perimeter space in a zone approximately 5m to 7.5m wide or 2 to 2.5 times the floor to ceiling height of the room. Comfort conditions that are not within this zone have to be maintained using artificial light and ventilation with resulting effects on energy consumption.

8.1.4 The subject office buildings do not perform well in this regard, low floor to ceiling heights are below good design practice levels and obviate adequate plan depth. The low ceiling height would not allow the inclusion of industry standard raised deck floors to any refurbishment, which would serve to reduce the floor to ceiling height further, resulting in space that feels cramped and claustrophobic.
