# 100 Chalk Farm Road

## Basement Impact Assessment

Prepared by

Pell Frischmann

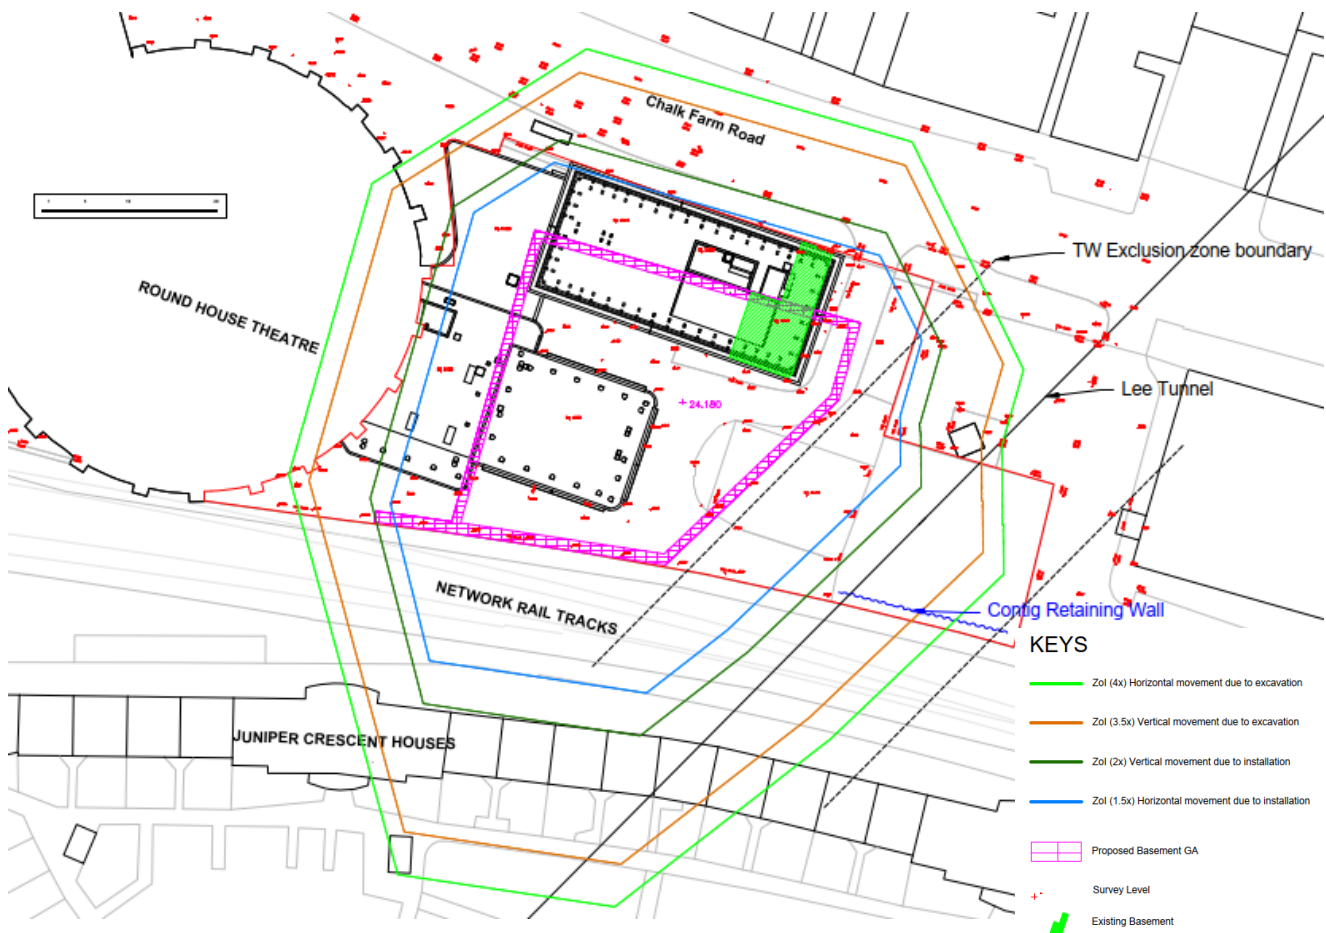
Figure 6 Structures within Zone of Influence

The zone of influence (Zol) is based on the depth of basement or excavation and is defined as per CIRIA C760. See Figure 6 and Table 7 to see the structures within the different Zol. See Appendix C for full sketch.

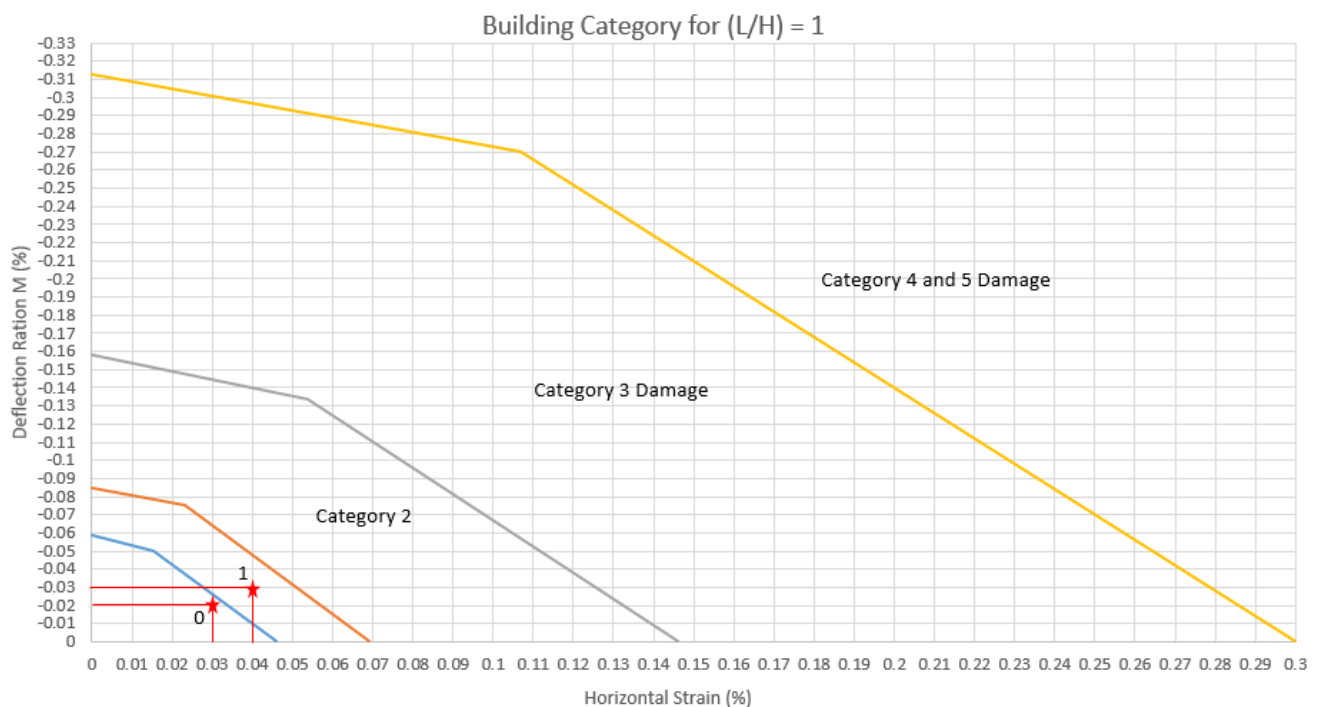
**Figure 7 Building damage category for L/H ratio of 1.**

Structure #	L (m)	H (m)	Maximum Deformations (mm)		Minimum Deformations		$\Delta v$	$\Delta h$	$\Delta v/L$ (%)	$\varepsilon h(\%)$	Burland Category
			Horizotal	Vertical	Horizotal	Vertical					
Roundhouse Theatre (West)	14	13.1	3.82	2.22	0.00	0.00	2.22	3.82	0.02	0.03	0
Juniper Crescent houses (South)	7.1	8.1	7.72	4.48	5.06	2.45	2.03	2.66	0.03	0.04	1

A summary of the damage category assessment for building structures affected by the sub-structure works is summarised in Table 1. Camden's Policy A5 for Basements permits a Burland Damage Category of no greater Category 1. It is noted that this Category is not exceeded for the adjacent buildings within the zone of influence of the basement excavation.
