### STATEMENT OF HISTORICAL SIGNIFICANCE

### 88 ALBERT STREET CAMDEN LONDON NW1 7NR

Prepared By:	Philip Sciberras BSc (Hon) MRICS
Date:	6th March 2024
Doc Ref:	240131 HH

#### Superstructure repairs and associated work @ 88 Albert Street Camden London NW1 7NR

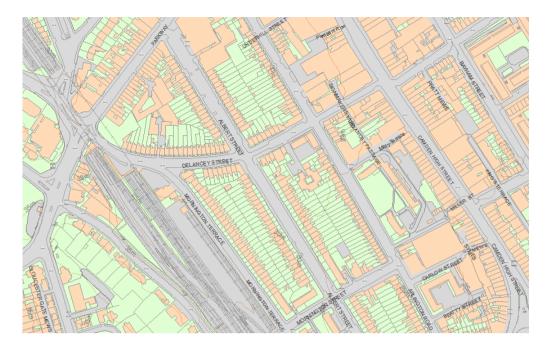
The property stands on a site that is generally level. The property has a small front garden cast-iron railings and brick boundary with steps leading to the entrance.
