Appendix 2 Demolition drawings

No80 to 90 SHP - Demolition Front Terrace Elevation in Context

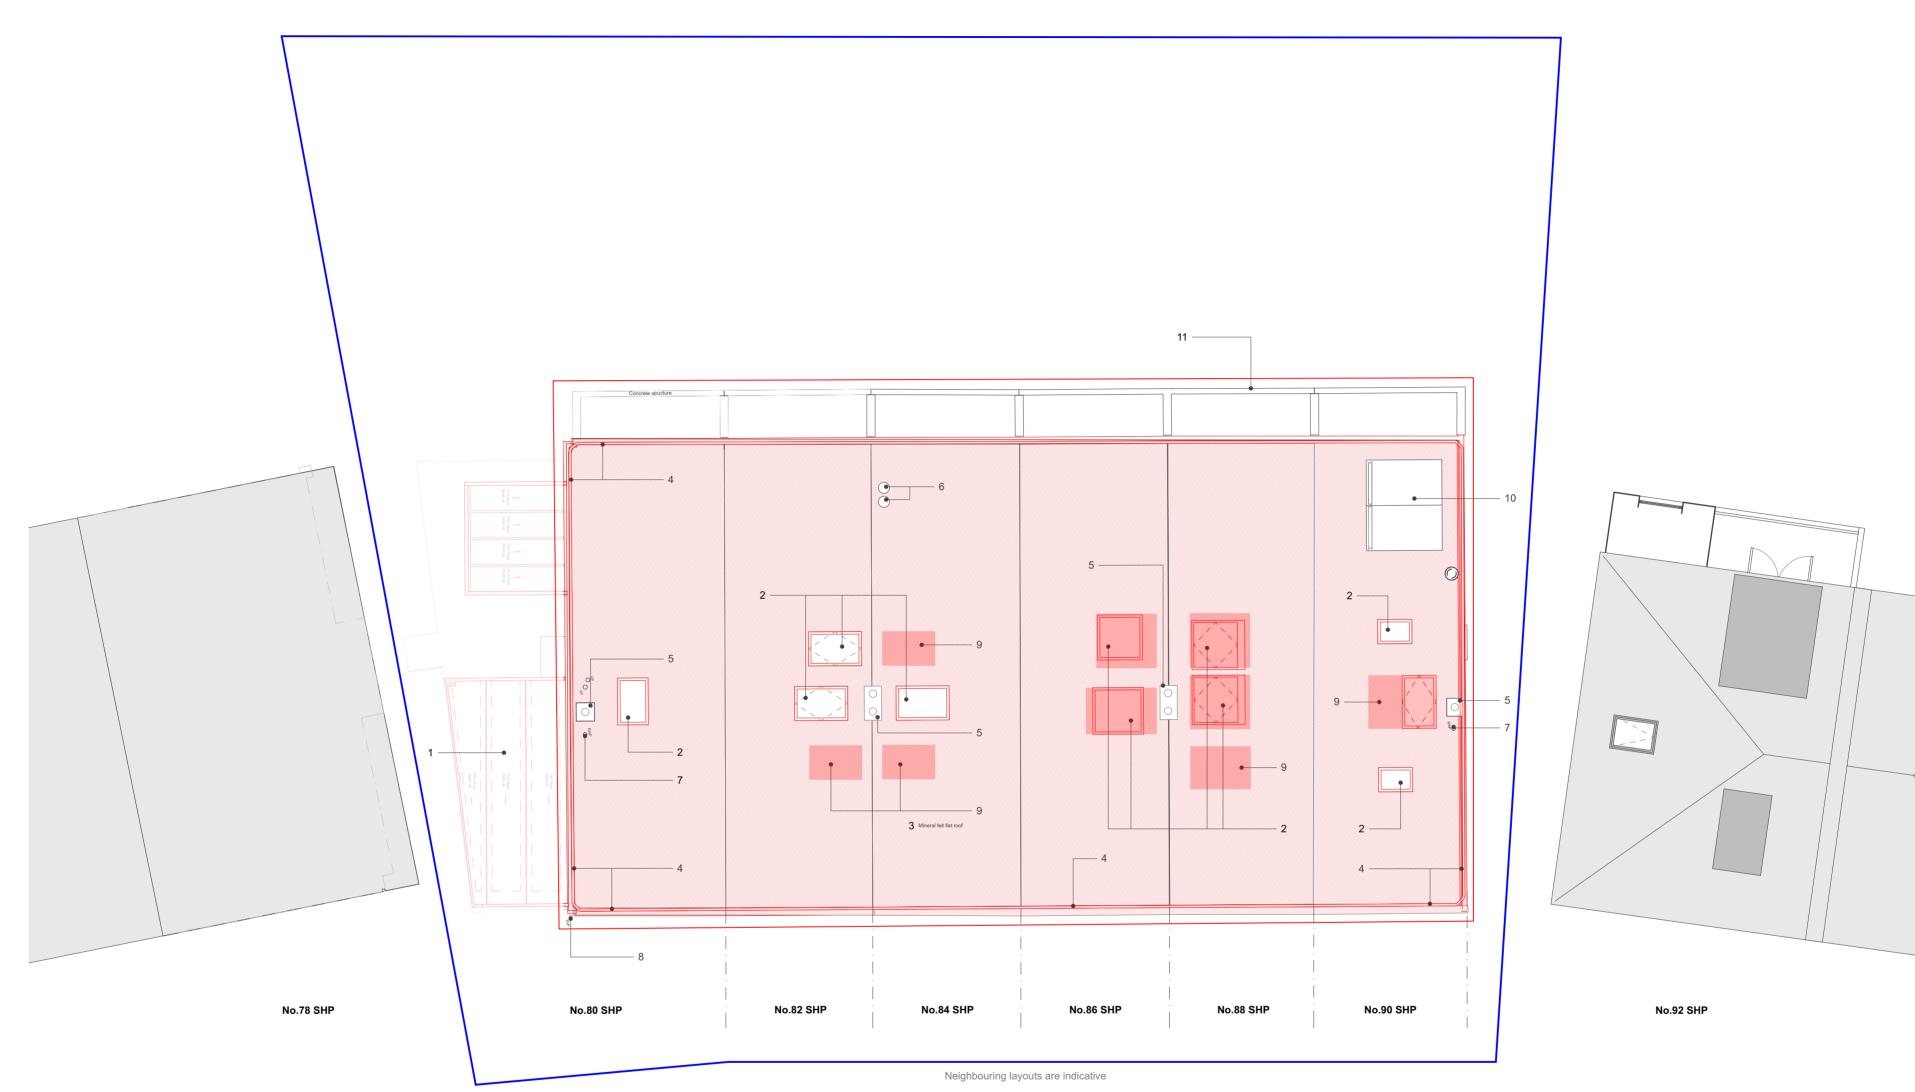
Кеу	 Existing roof extension at no80 SHP - refer to no80 SHP application ref. 2024/0639/P & 2024/0912/L
Existing	2. Existing rooflight replaced or refitted within new roof construction
Existing to be demolished/ removed	 Flat roof, felt finish replaced Roof perimeter upstand and UPVC flashing replaced with new detail Existing flue stack repointed
No80 to 90 South Hill Park, NW3 2SN Development proposal boundary	 Existing stainless steel flues retained (unaffected) Existing RWP retained Incongruous SVP removed New opening in roof created or existing opening enlarged to accept new
 No80 to 90 South Hill Park, NW3 2SN Site boundary 	rooflight 10. Existing solar panels retained at no90 SHP 11. Existing exposed concrete rear beams

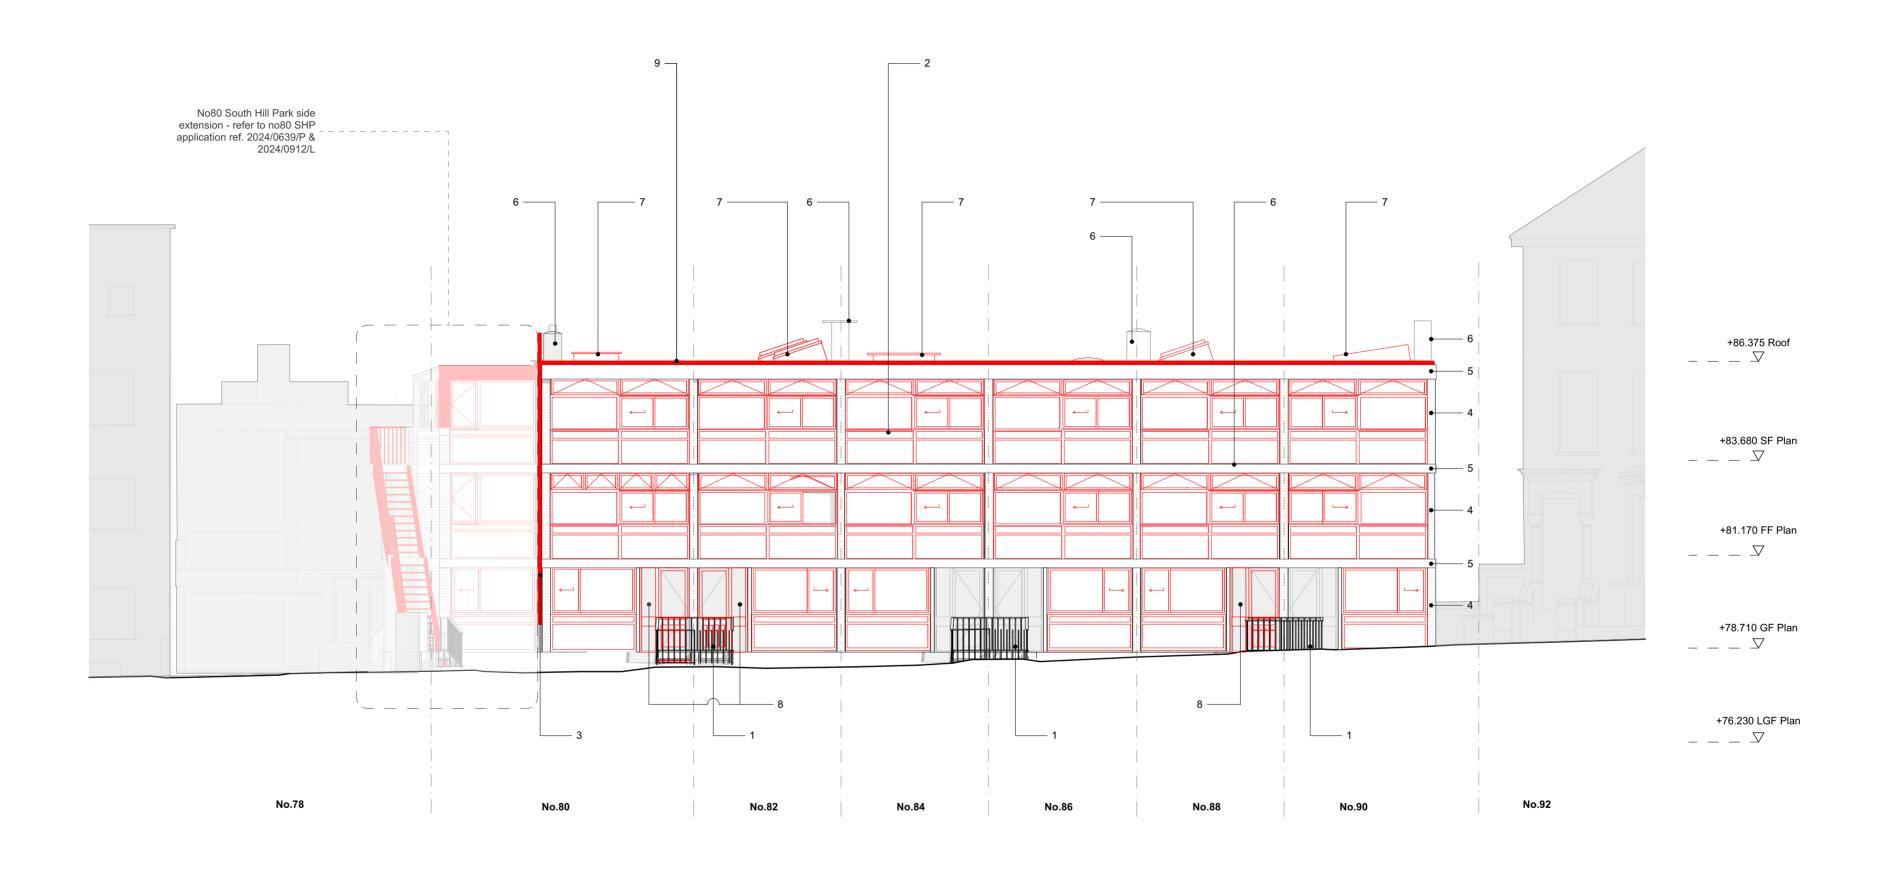
Note: No works proposed to greyed out areas other than masonry / concrete repairs. Refer to Design and Access Statement for more information. For more information regarding works to no80 SHP refer to specific application ref. 2024/0639/P & 2024/0912/L

Metal railing retained and refurbished
 Existing front aluminium windows replaced with new double glazed hardwood timber framed windows to match original design from 1950s
 Incongruous SVP removed and brickwork repaired with matching brickwork
 Existing brickworks repaired/ repointed with matching bricks and mortar
 Exposed concrete slabs/ beams repaired as required

6. Existing flue stacks repaired/ repointed

Consider the stacks repaired reported
 Copening in roof created or existing opening enlarged to accept new rooflight
 Existing porch entrance single glazed soft timber windows/ doors replaced with new double glazed hardwood timber framed windows to match original design from 1950s

9.Existing flat roof insulation and bitumen waterproofing finish replaced with new insulation and waterproofing to comply with current Building Regulations Existing perimeter upstand and UPVC flashing replaced Existing timber joists and soffit underneath retained where possible

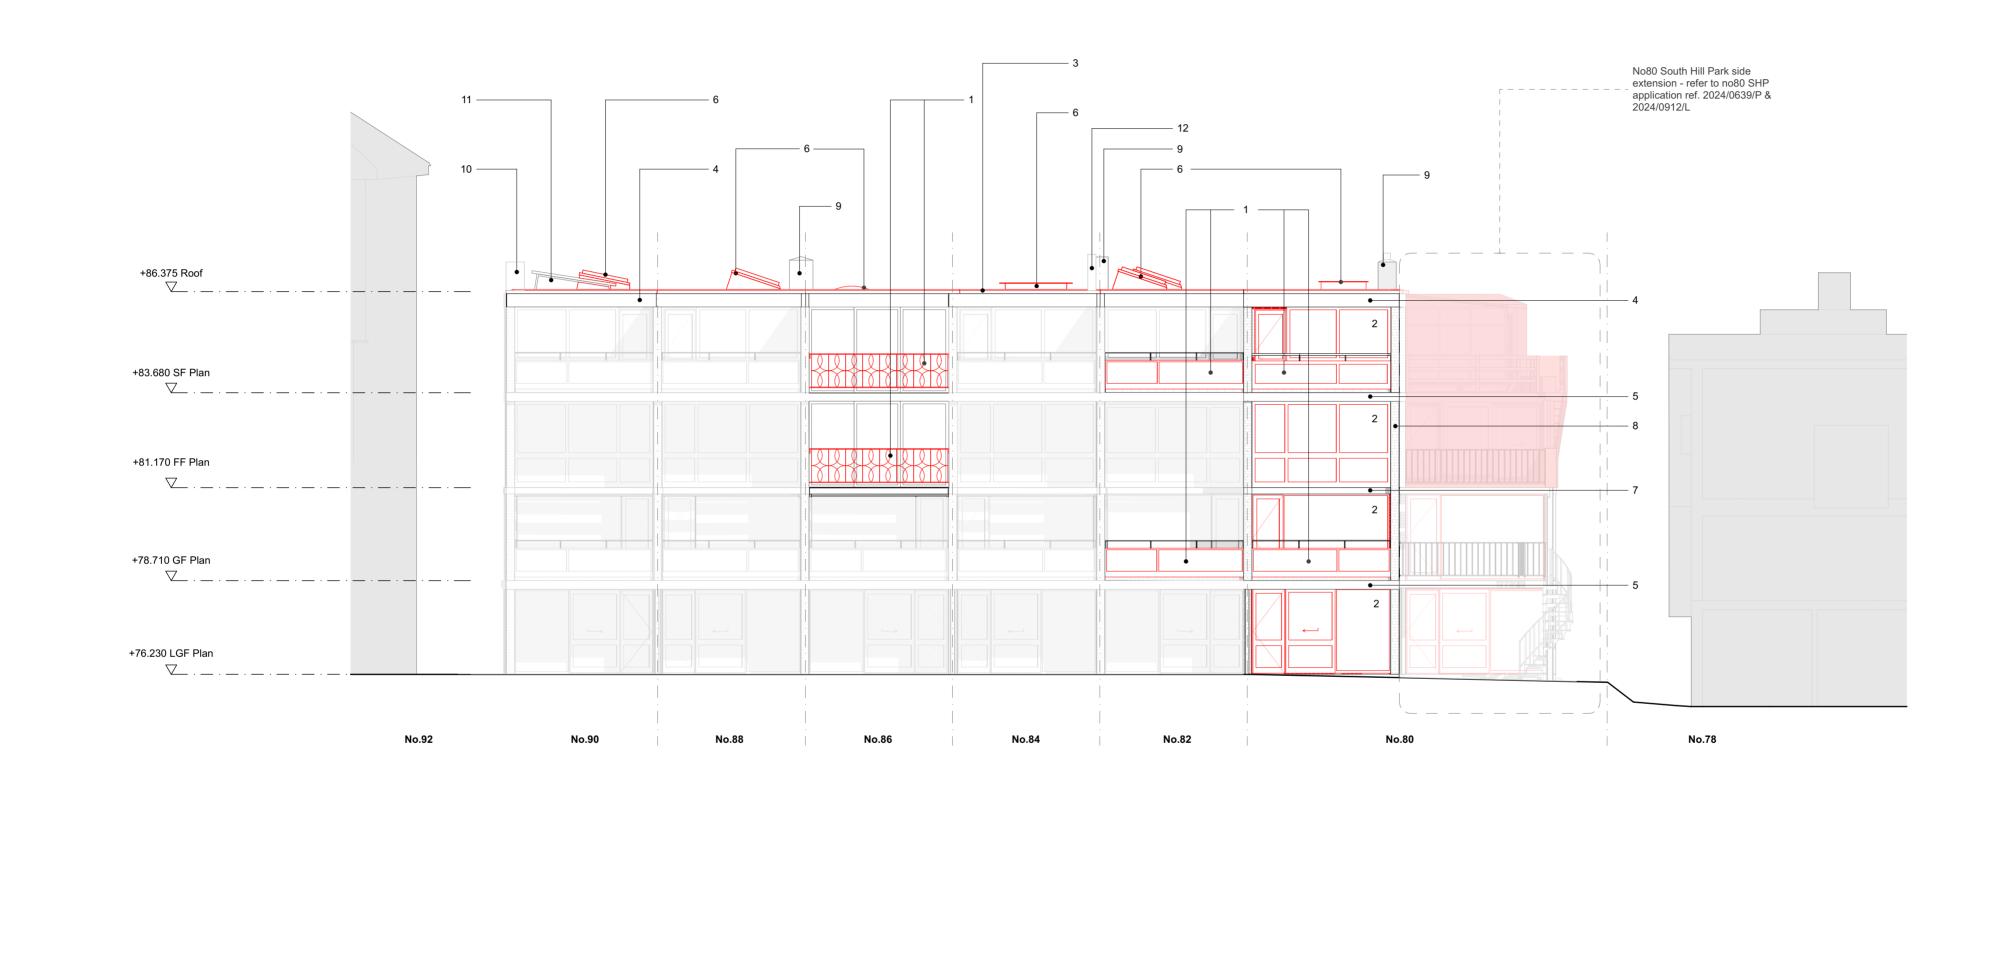
No80 to 90 SHP - Demolition Front Terrace Elevation in Context

Note: No works proposed to greyed out areas other than masonry / concrete repairs. Refer to Design and Access Statement for more information. For more information regarding works to no80 SHP refer to specific application **ref. 2024/0639/P & 2024/0912/L**

1. Existing balustrade replaced where dilapidated or incongruous modern addition with new balustrade to match original design from 1950s 2. Existing single glazed soft timber windows/ doors replaced with new double glazed hardwood timber framed windows to match original design from 1950s, to

glazed hardwood timber framed windows to match original design from 1950s, to rear of no. 80SHP only 3.Existing flat roof insulation and bitumen waterproofing finish replaced with new insulation and waterproofing to comply with current Building Regulations. Existing perimeter upstand and UPVC flashing replaced Existing timber joists and soffit underneath retained where possible 4. Existing concrete ring beam repaired as required

5. Existing concrete slab repaired as required

- 6. Opening in roof created or existing opening enlarged to accept new
- rooflight
- 7. Dilapidated timber brise soleil replaced to match existing
- 8. Existing brickwork repaired/ repointed as required with matching brickwork/
- mortar 10. Existing flue stack retained and repaired
 11. Existing solar panels at no90 SHP retained
 12. Existing stainless steel flues retained

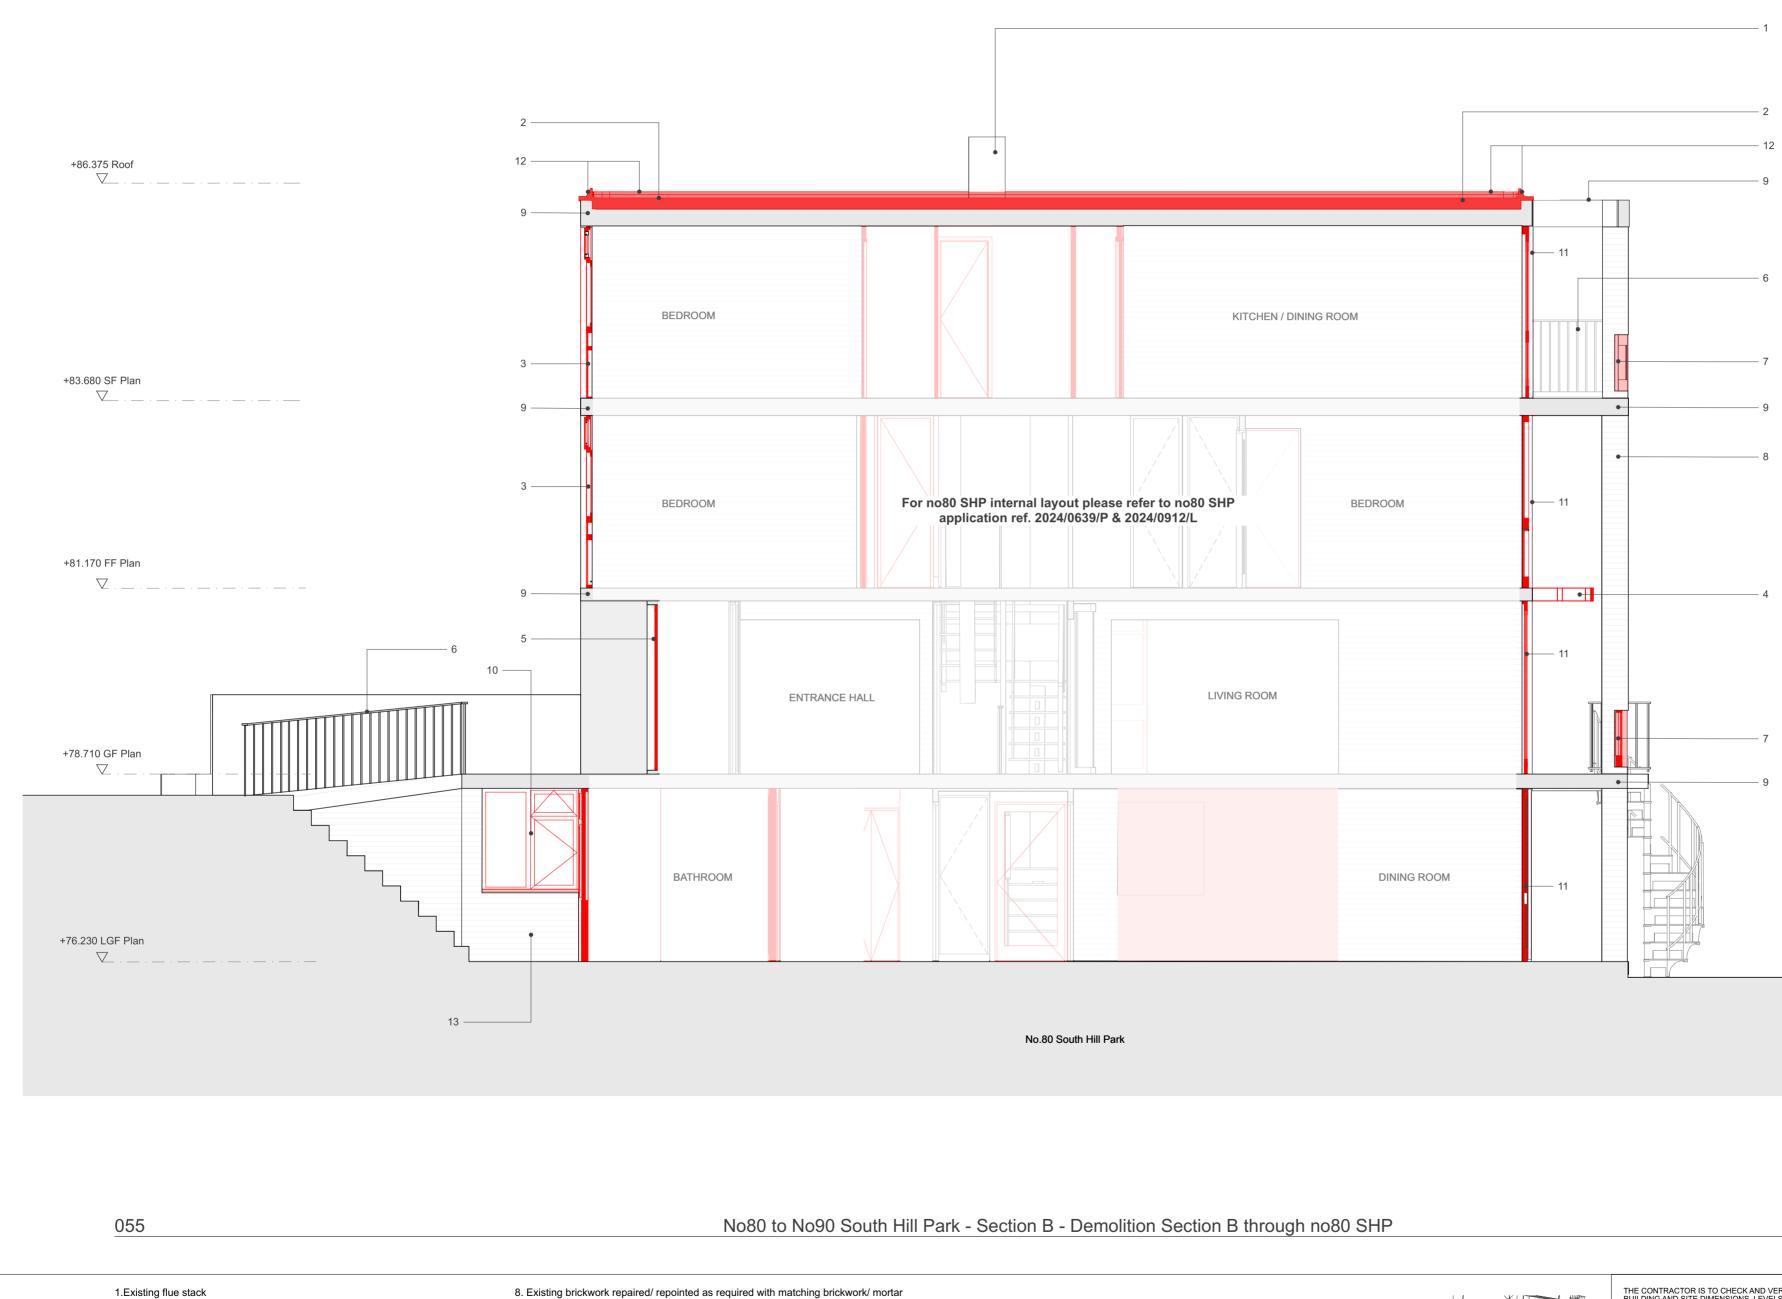
1.Existing flue stack 2.Existing flat roof insulation and bitumen waterproofing finish replaced with new insulation and waterproofing to comply with current Building Regulations insulation and waterproofing to comply with current Building Regulations
Existing timber joists and soffit underneath retained where possible
3. Existing front aluminium windows replaced with new double glazed hardwood
timber framed windows to match original design from 1950s
4. Dilapidated timber brise soleil to be replaced to match existing
5. Existing single glazed soft timber windows/ doors replaced with new double
glazed hardwood timber framed windows to match original design from 1950s
6. Metal railing retained and refurbished
7. Existing glazed timber balustrade replaced where dilapidated or incongruous
modern addition with new balustrade to match original design from 1950s.

9. Exposed concrete slabs/ beams repaired as required 10. Existing UPVC window replaced with new double glazed hardwood timber framed

windows to match original design from 1950s 11. Existing single glazed soft timber windows/ doors replaced with new double glazed

hardwood timber framed windows to match original design from 1950s, to rear of

no80SHP only

12. Existing perimeter upstand and UPVC flashing replaced 13. External front access to Lower Ground Floor

Note: the LGF access layout differs along the terrace units i.e. currently used as external

bin store with no access to the LGF at no80 SHP For the internal layout of no80 SHP, refer to no80 application ref. 2024/0639/P &
