# Existing Terrace roof

## Terrace roof plan key proposals :

# Proposals Existing and proposed roof build-up details

# Proposals Proposed safe roof access

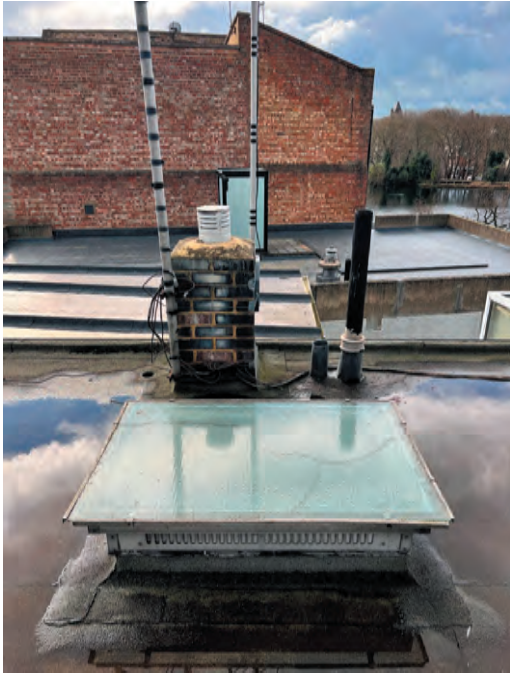
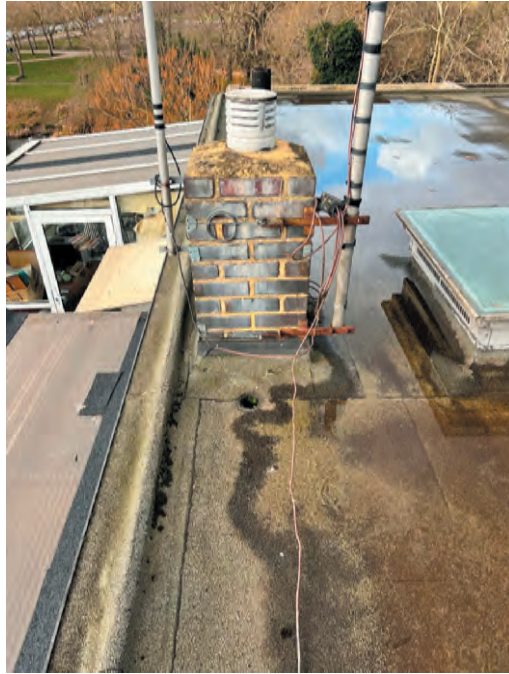
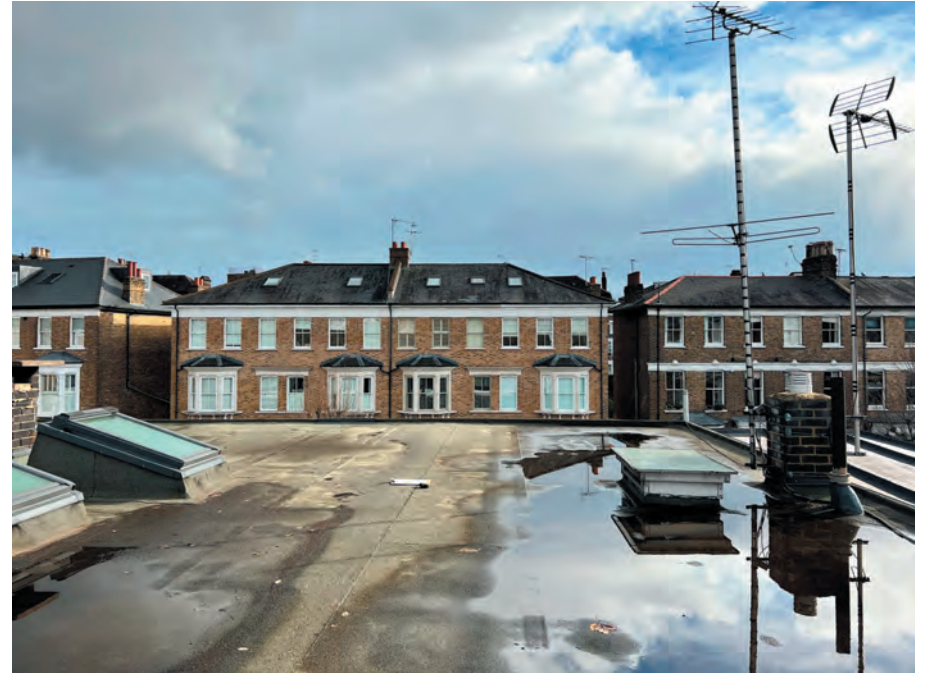
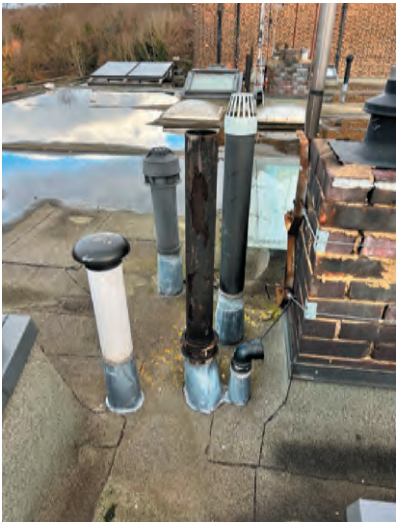
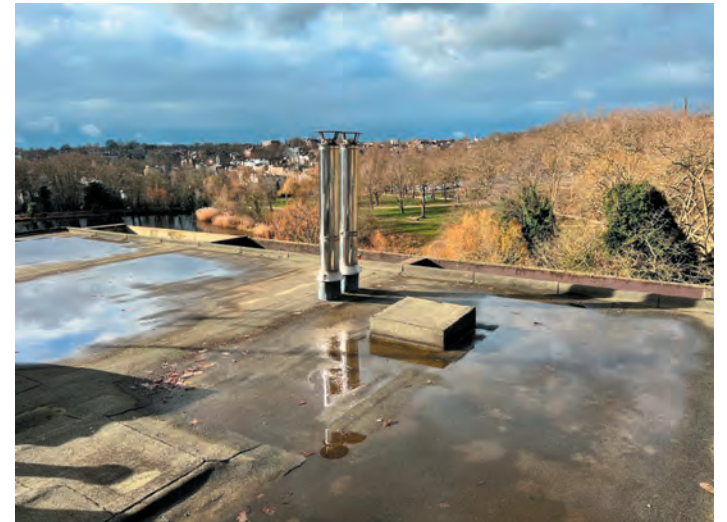
Existing Terrace roof plan: photographic survey

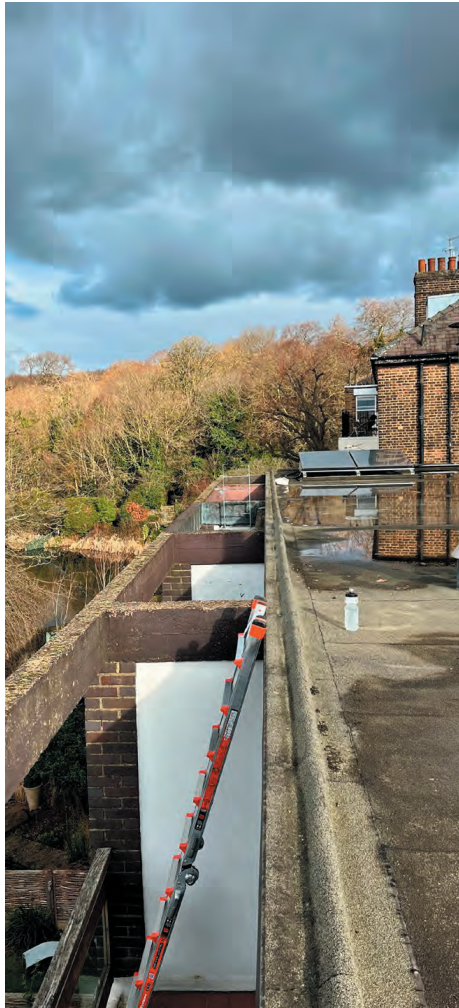
Existing unsafe roof access

There is currently no means of safe access to the terrace roof. It is proposed to install safety hooking points for movable ladders to the rear terraces' concrete beams. A mansafe system installed as part of the terrace roof improvements will also allow for safe roof access for maintenance

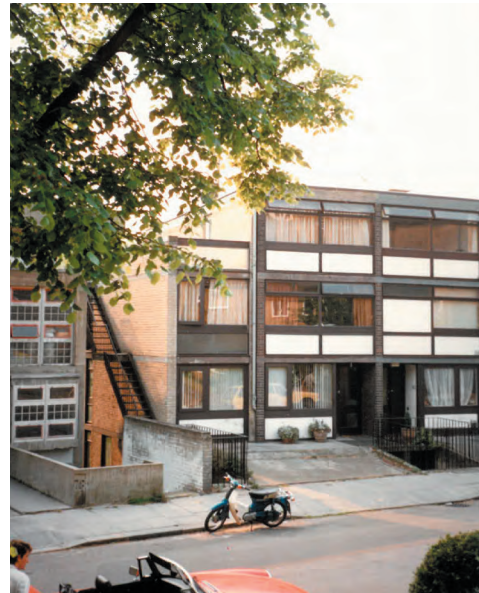
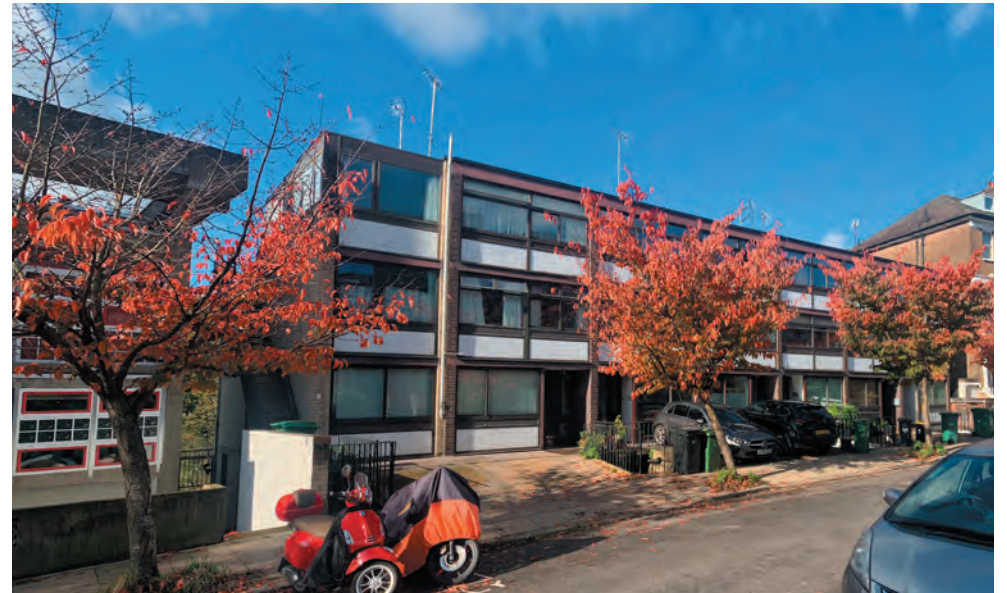
View of the terrace at present showing now dark, aluminium framed windows and the concrete ring beams painted to a darker colour than the previous iterations. Additions to the no.80 extension were made on the second floor with a lean-to bedroom and greenhouse added, compromising the overall design consistency.

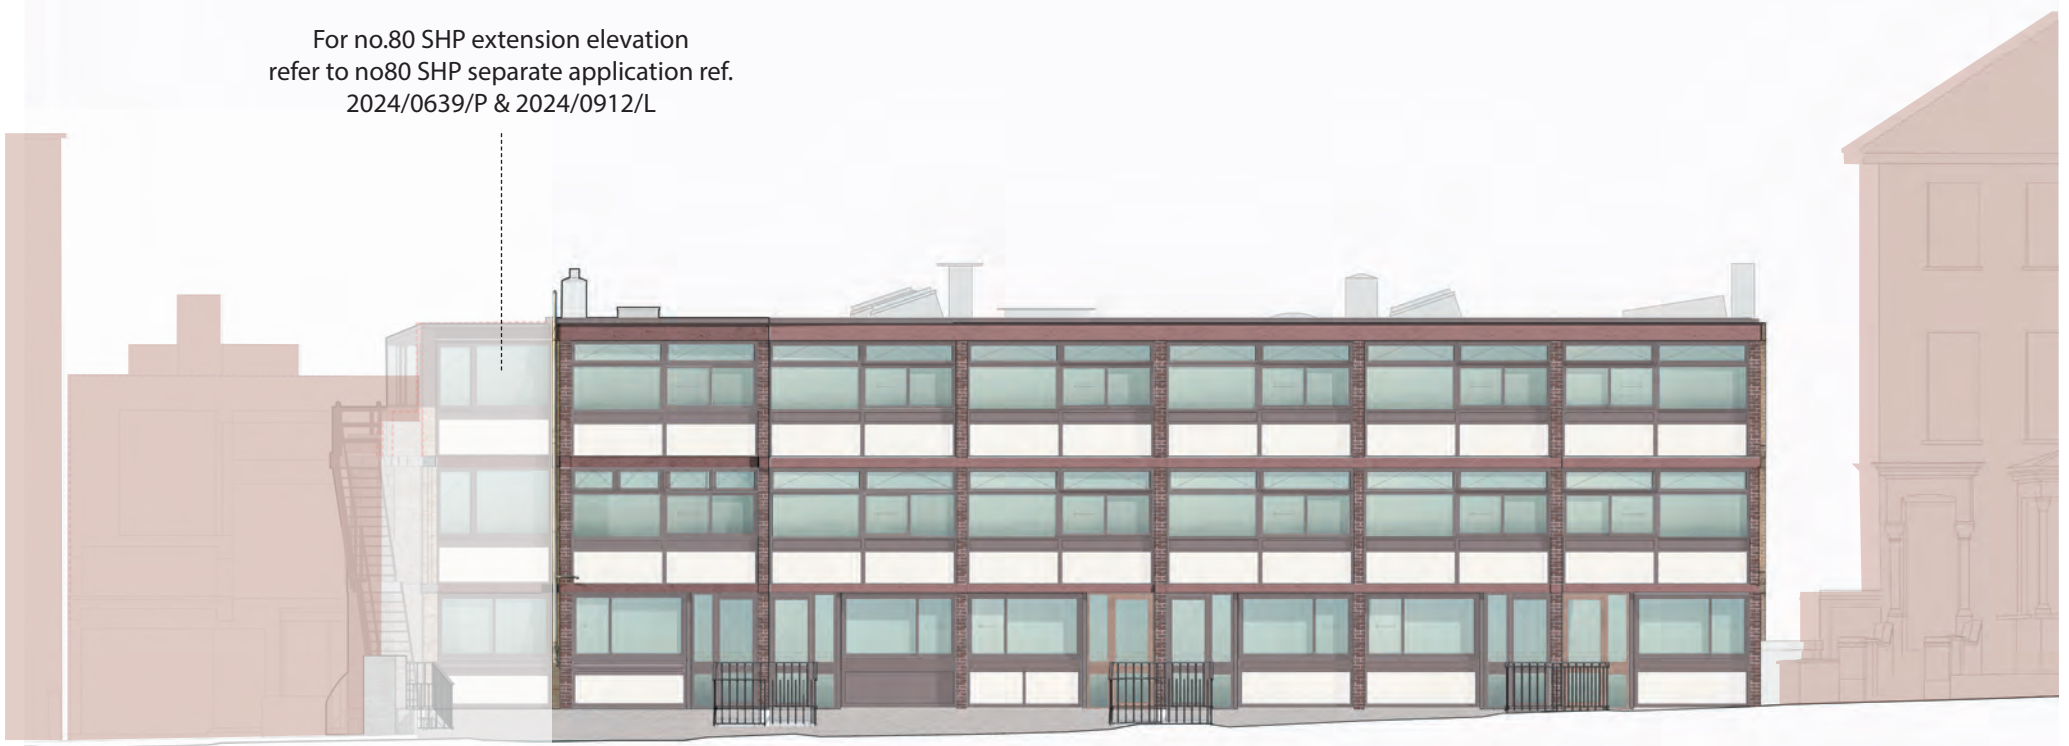
## Existing facade

Note painted concrete ring beams

White solid lower spandrel panels to glazing

Aluminium framed windows

Flimsy 2nd floor extension to no.80 - refer to no80 SHP separate application

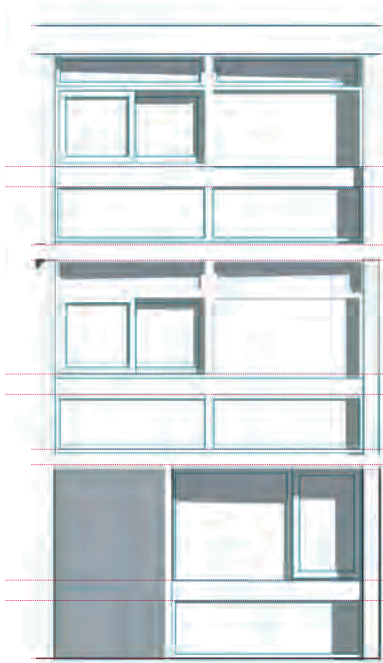
**Front** Elevation, typical proposed window bay

Using 'Modulor'/Golden Mean proportions, the glazing has been set out meticulously and one of the key drivers of the project is to reinstate this principle in timber joinery as per the original, bringing back a warmth and clear hierarchy to the composition. At present, the concrete ring beams are painted to match the aluminium glazing, which in turn is a similar shade to the vertical brick piers. The overall effect being to muddy the clarity of the original design.

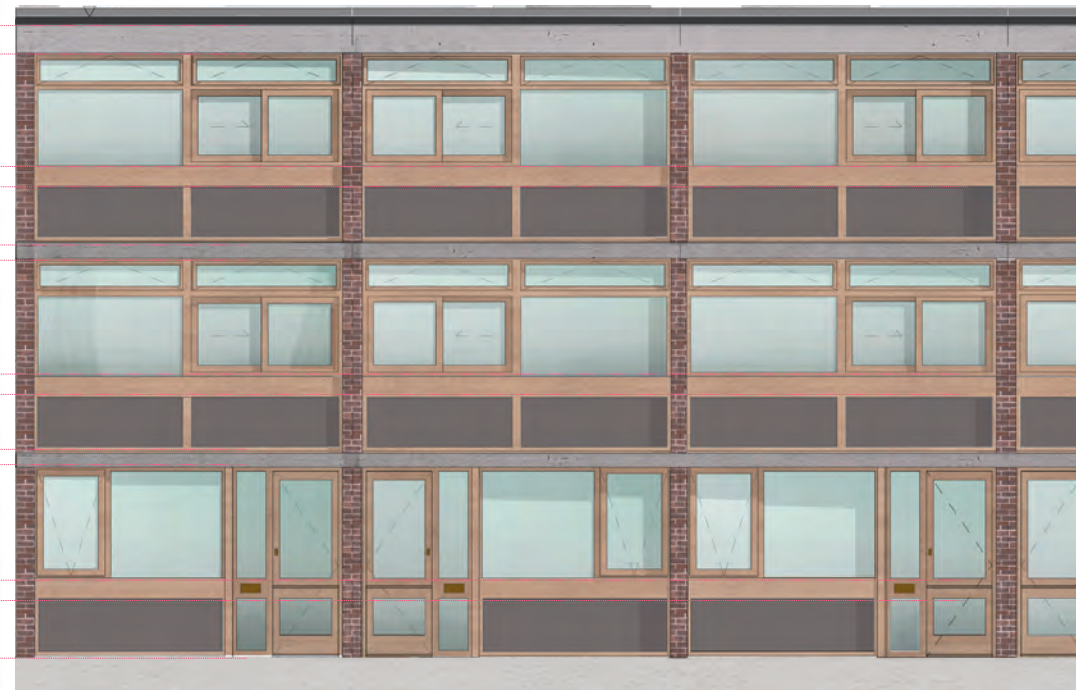
Proposed front rendered elevation

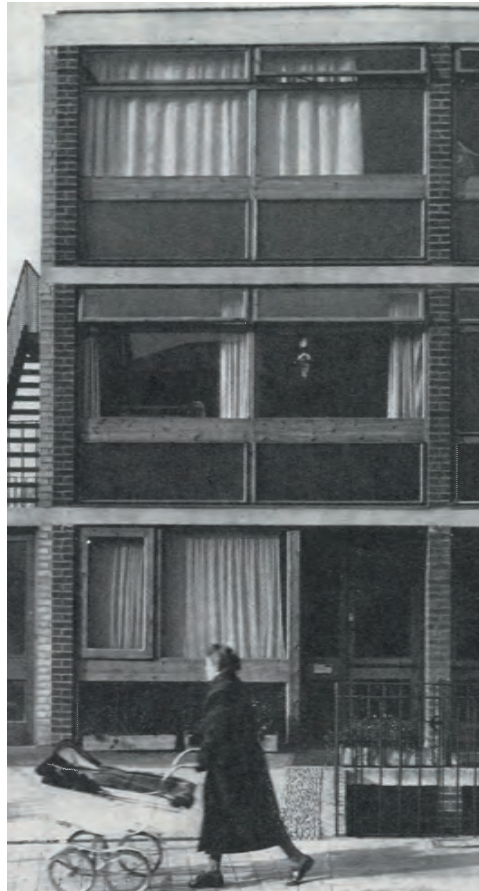
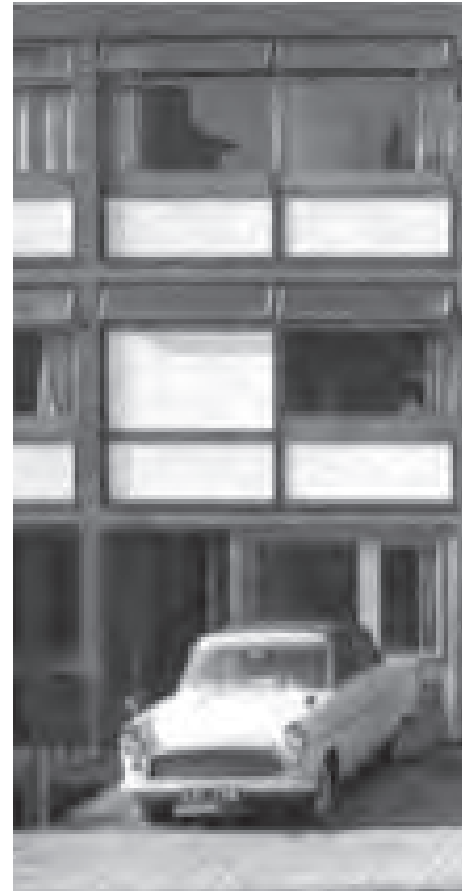
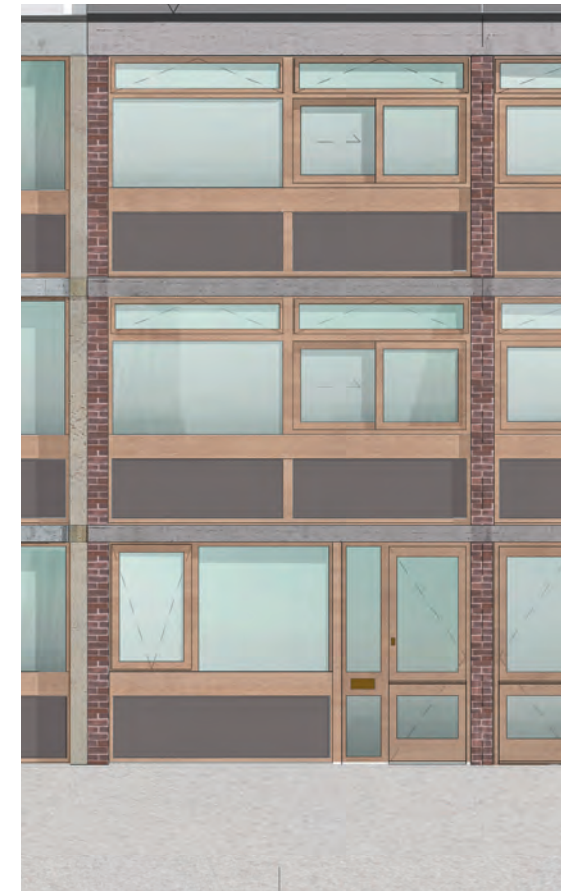
Examining the Howells' original drawings and specification, it is clear that the lower opaque panels were in fact back painted Georgian wired glass. This was replaced with solid white spandrel panels in the 60s which arguably compromised the aesthetic balance of the facade composition, with these bright white visually jarring elements. This change also included changing some of the fenestration and fixed panels arrangements. Our proposals seek to revert to the original specification, with lower span-

drel panels made with back painted Georgian wired glass, but with insulated solid panels to the interior face. Externally this would therefore appear as per the original design, but would offer a more practical and energy efficient internal wall lining.

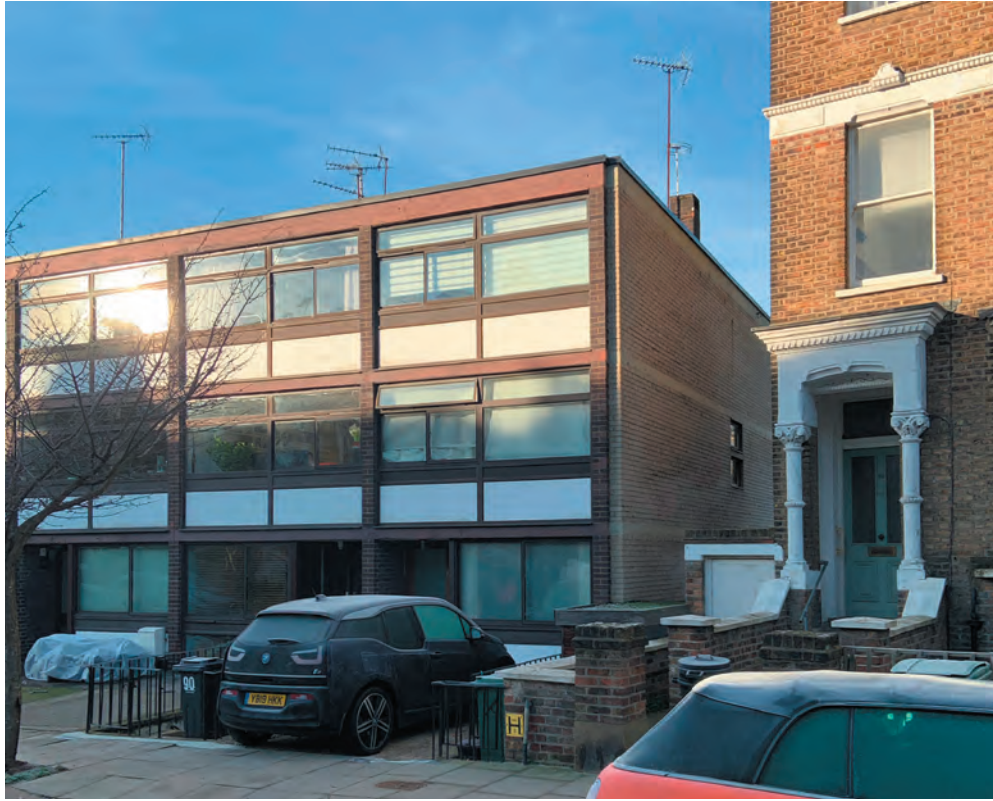
Existing photo of the end flank wall of no.90 SHP

Works to the front facade will present a significant improvement to the Grade II Listed terrace in a number of ways:  
Reinstating original materials, fenestration layout and proportions  
Designing and carrying out the works in a unified way across the terrace in the spirit of the original Howell Killick Partridge Amis design ethos.  
Repairing the concrete ring beams so as to reinstate the visual rhythm of lateral exposed concrete beams punctuated by vertical brick party walls.  
Since the concrete has been painted dark, the horizontal concrete is perceived as part of the current dark framing of the windows, which compromises the original design.

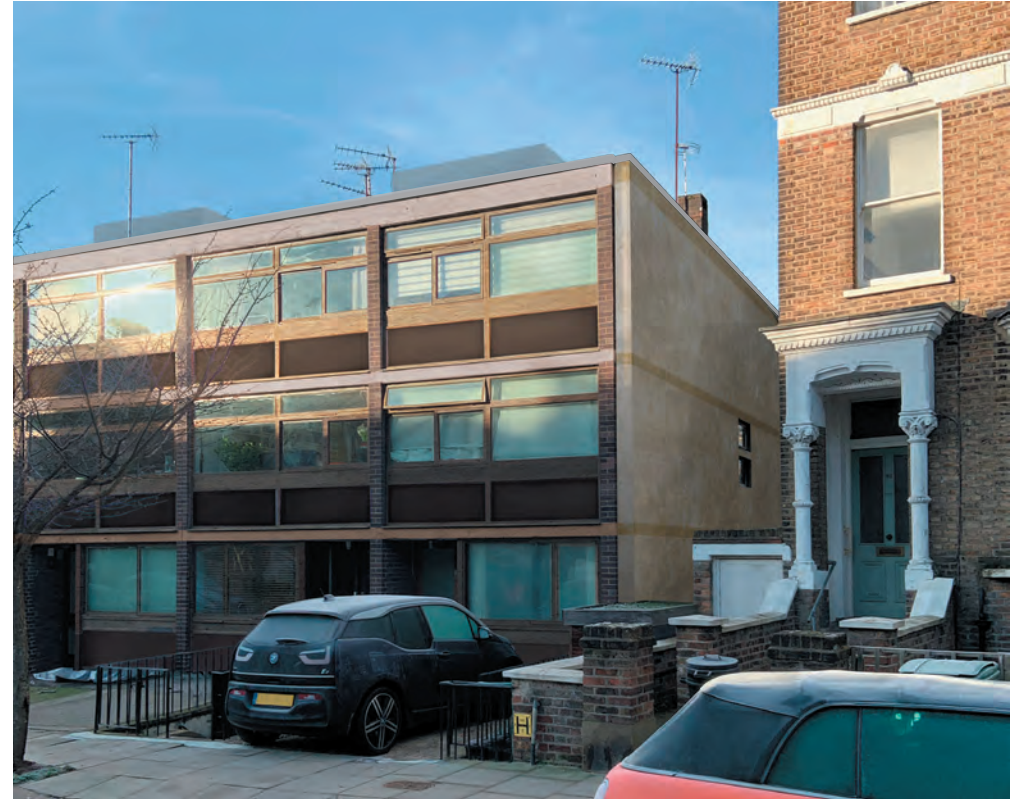
Proposed view of the end flank wall of no.90 SHP

The proposed external insulation to the terrace flank walls also returns to the front of the extension, reinforcing the perception that it complements the terrace but is a clear addition as per Gill Howell's original intent.

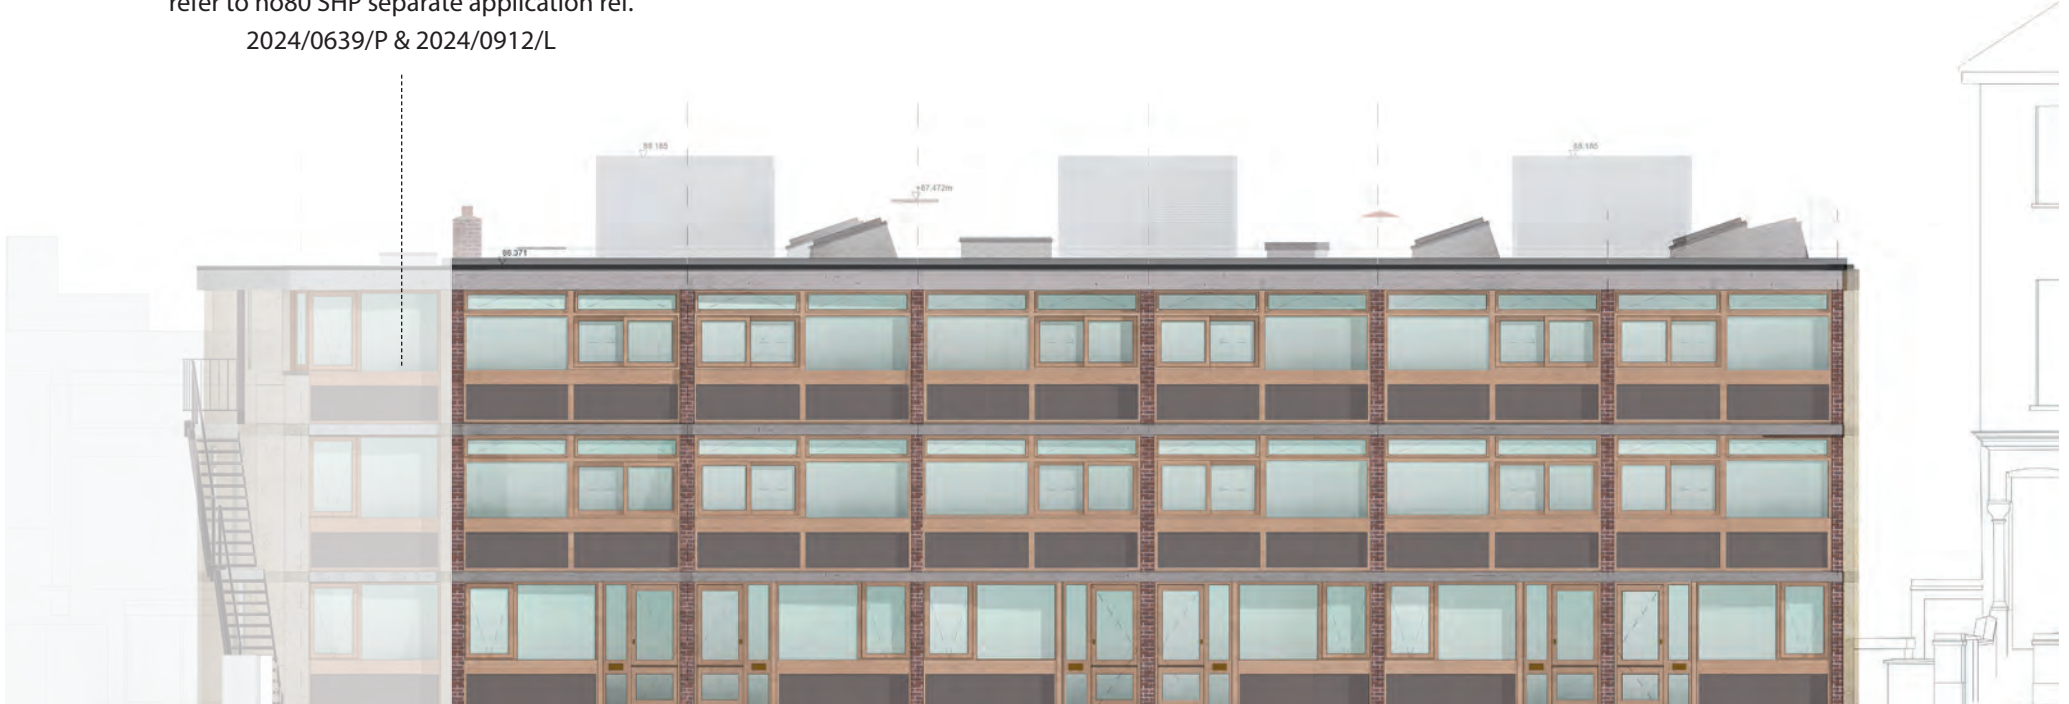
Rendered view of the terrace showing the new ASHP louvred acoustic enclosures

The proposed installation comprises one ASHP per dwelling for no. 82, 84, 88 and 90 South Hill Park and two for no.80 and 86 which are divided in two separate residential units. The units are currently proposed to be located adjacent to the party walls in two clusters of two units and one cluster of three units. The positioning of the units near to the centre of the roof avoids a line of sight from the windows of the nearest neighbouring building (92 South Hill Park) which will reduce the level of ASHP noise received. Each group of ASHPs will be enclosed by acoustic louvre screens which will help contain the emitted noise and reduce the levels reaching the neighbouring buildings and the rooflights of No.80 to 90.

A new low-lying horizontal steel frame is to be formed above the existing roof level on which the ASHPs will be mounted. This structure will be supported on anti-vibration pads on the top of the masonry separating walls to avoid the transmission of any vibration from the ASHPs to the light-weight roof or building structure.

The ASHP predicted noise levels meets the Camden Council noise criteria of 10dB below night-time background noise.

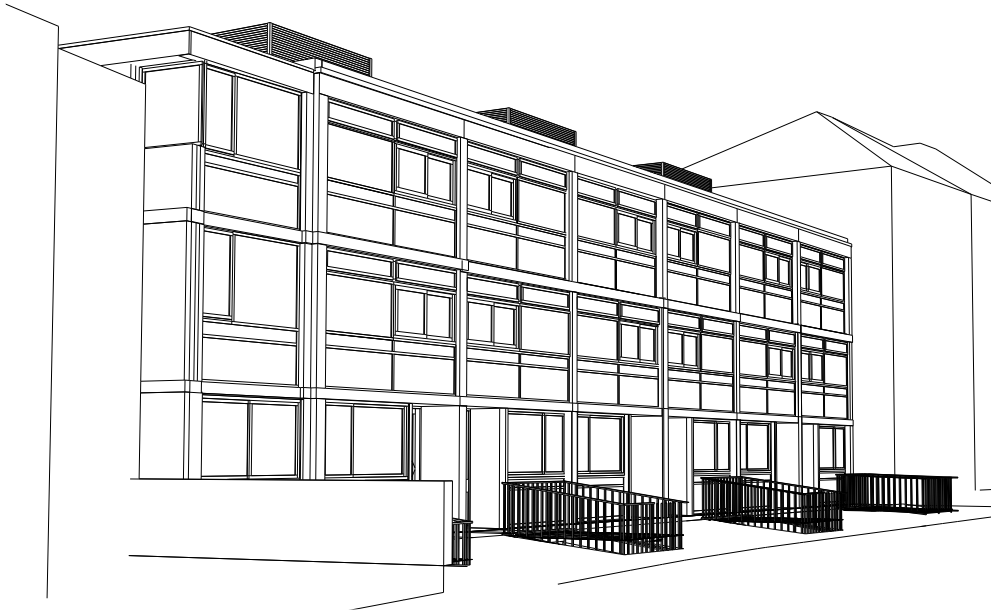
Wireframe south view of no. 80 to no.90 South Hill Park proposal

Our assessment is that the air source heat pump enclosures are marginally visible from the street and that in fact, some articulation of the flat roof, adding in some intermittent, but regularly spaced higher elements positively contributes to stitching the terrace into the height of the adjacent Victorian buildings more effectively.

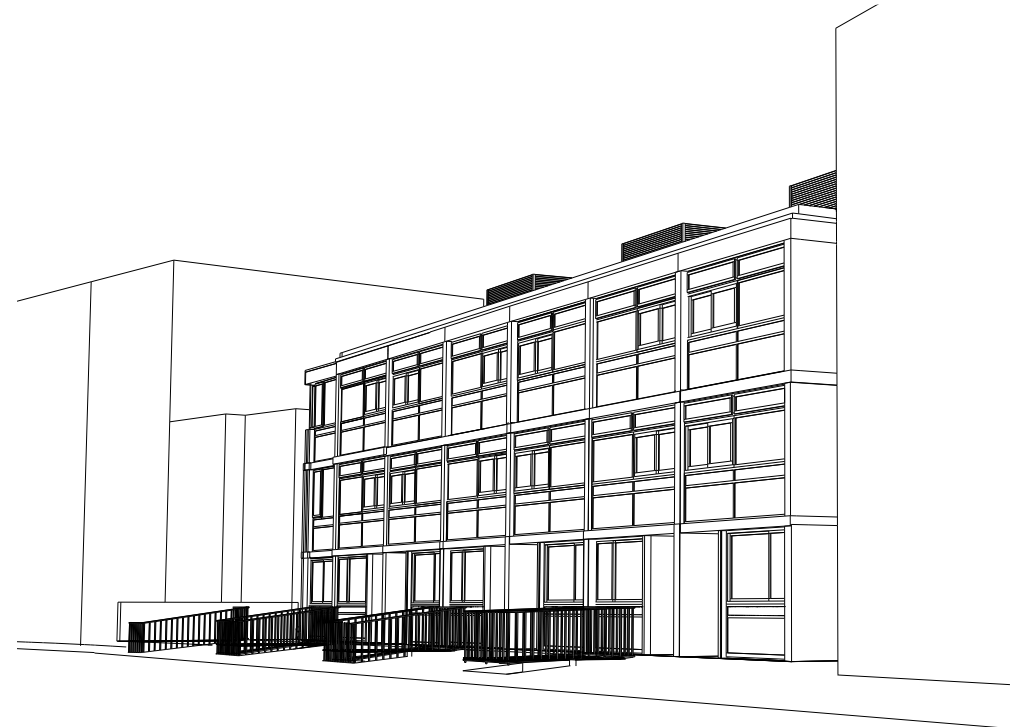
Wireframe north view of no. 80 to no.90 South Hill Park proposal

The air source heat pumps would only be visible from the upper floors of the houses adjacent and within the long view from the Heath - see section on rear facade. The air source heat pumps have been located as far as possible from the perimeter of the terrace roof and mirror the symmetry of the porch

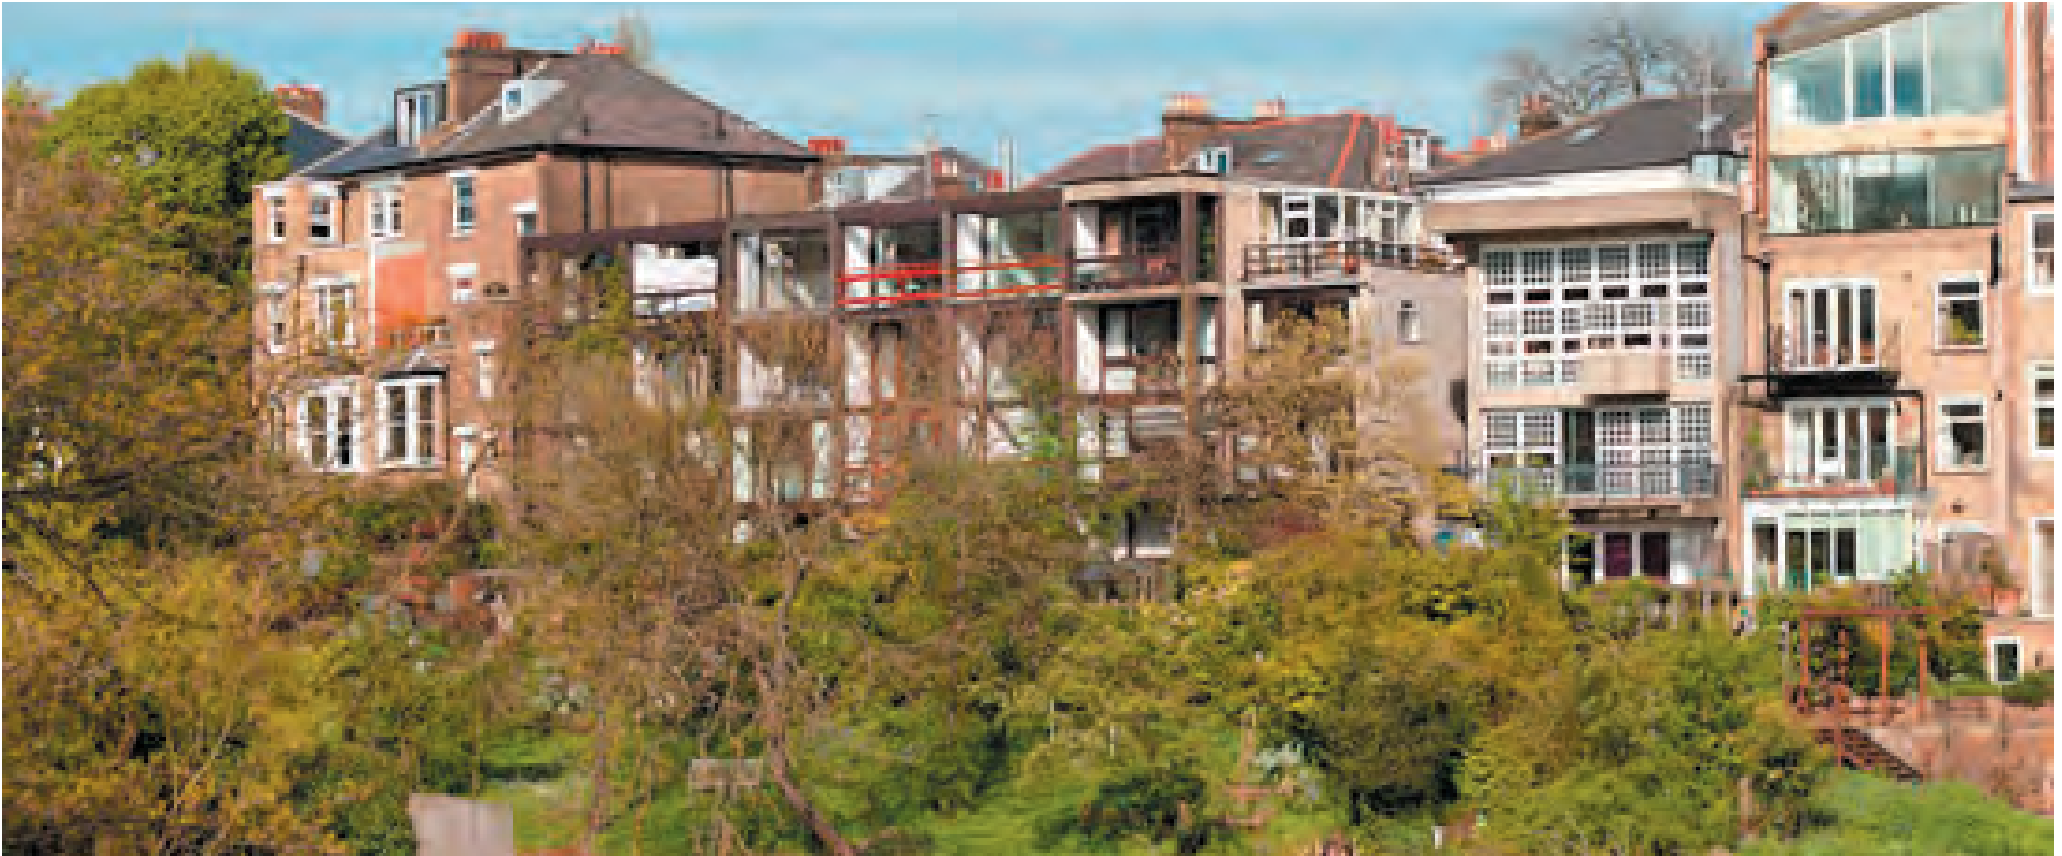
South Hill Park existing elevation

In this long view, there are a variety of adhoc additions to the roof eg TV aerials, rooflights, solar panels at no.90, a rooftop greenhouse at no. 80. Our proposals seek to rationalise and upgrade the rooftop. Please also refer to separate application ref. 2024/0639/P & 20240912/L in relation to the no.80 extension.

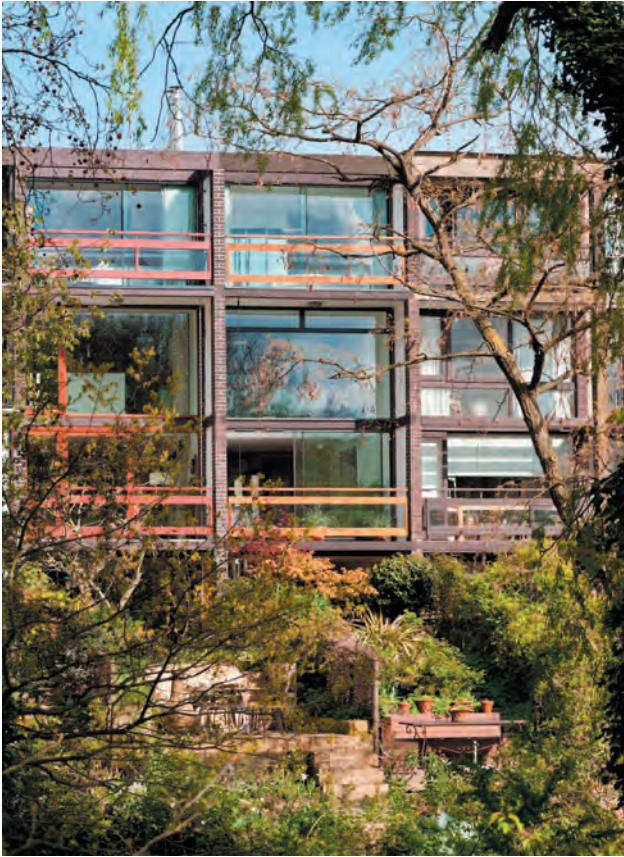
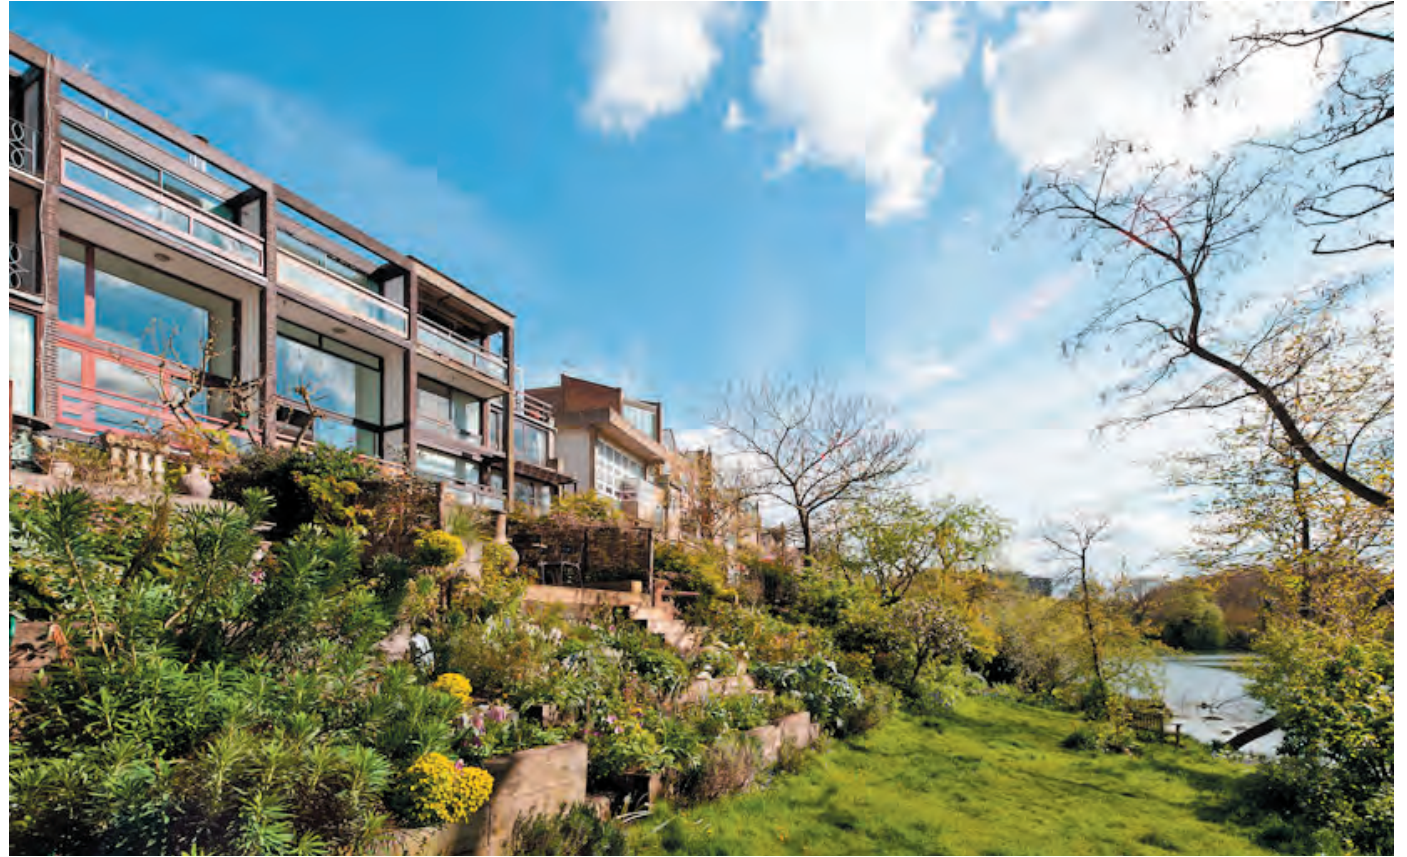
South Hill Park existing rear elevation

The existing rear elevation does not require significant remodelling (except for the top floor of the no.80 extension).

Over the years, balustrades and other details have been replaced in unsympathetic materials/colours whilst the timber framing and brise soleils has rotted in several places.

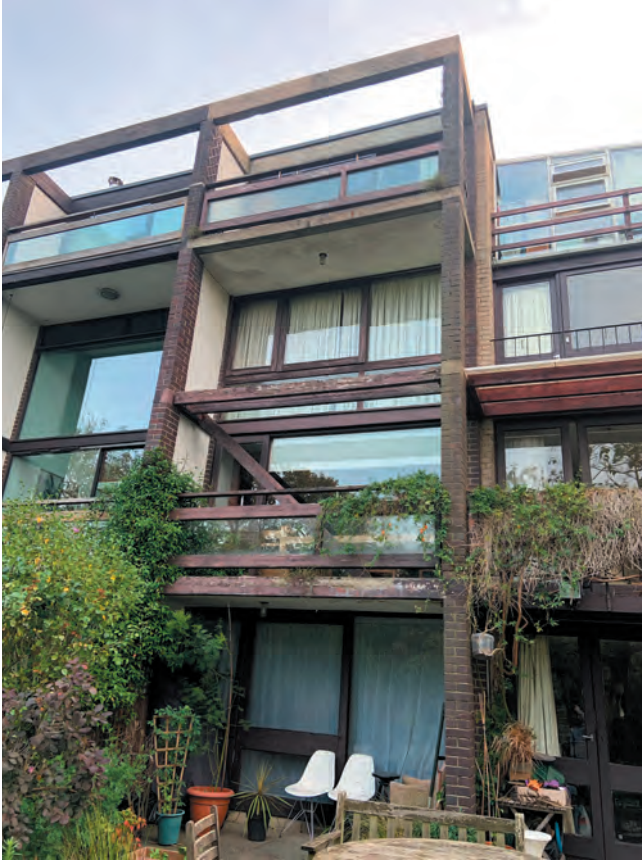
Existing rear view photos of South Hill Park

Photos show the current condition of timber, masonry and concrete requiring significant repair as well as an accretion of unsympathetic additions of balustrades, greenhouses and glazing details that are not in keeping with the original design intent of the Grade II Listed Building.

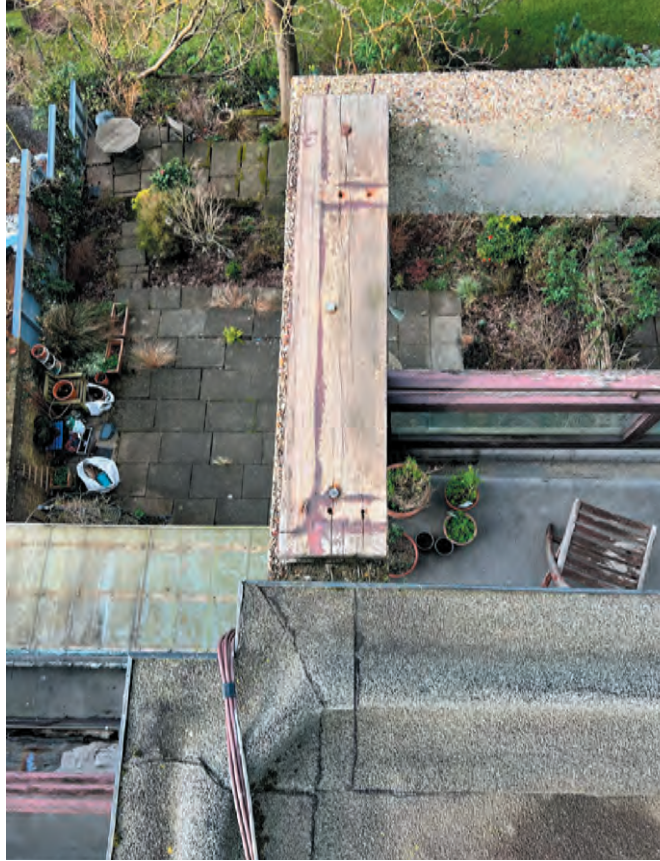
Existing rear view photos of South Hill Park showing rotten timber capping plates over the rear concrete terrace frames

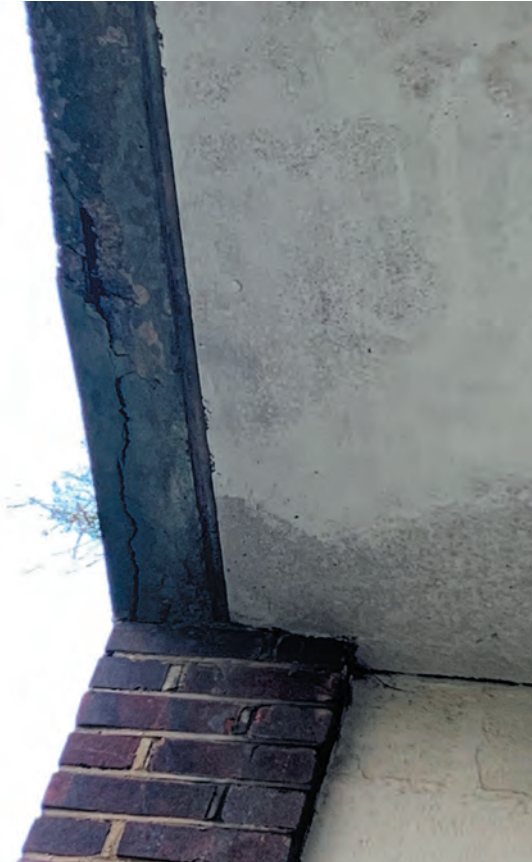
Existing rear view photos of South Hill Park showing concrete spalling and steel corrosion

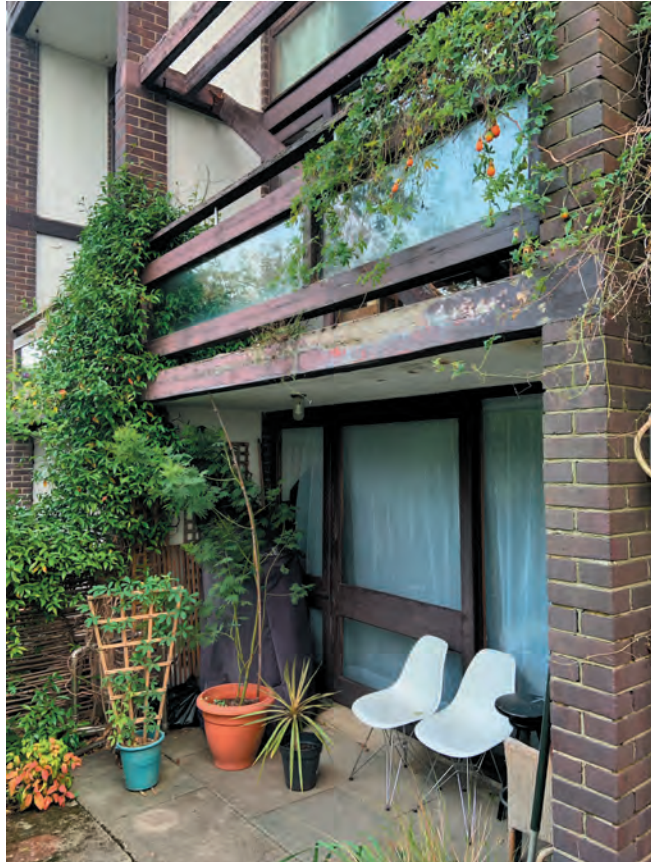
Existing rear view photos of South Hill Park showing dilapidated timber brise soleils

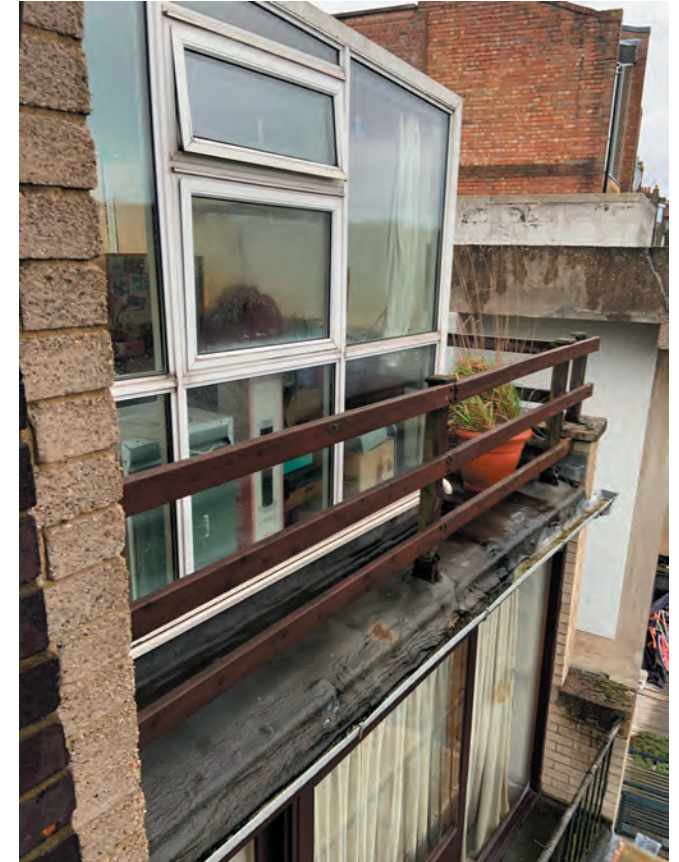
Existing rear view photos of South Hill Park unsympathetic additions of balustrades, greenhouse and glazing details

The priority is repair, sensitive conservation and overdue maintenance as well as the removal of unsympathetic details such as modern balustrades that detract from the whole and replacing this with the original timber and glazed balustrade arrangement.

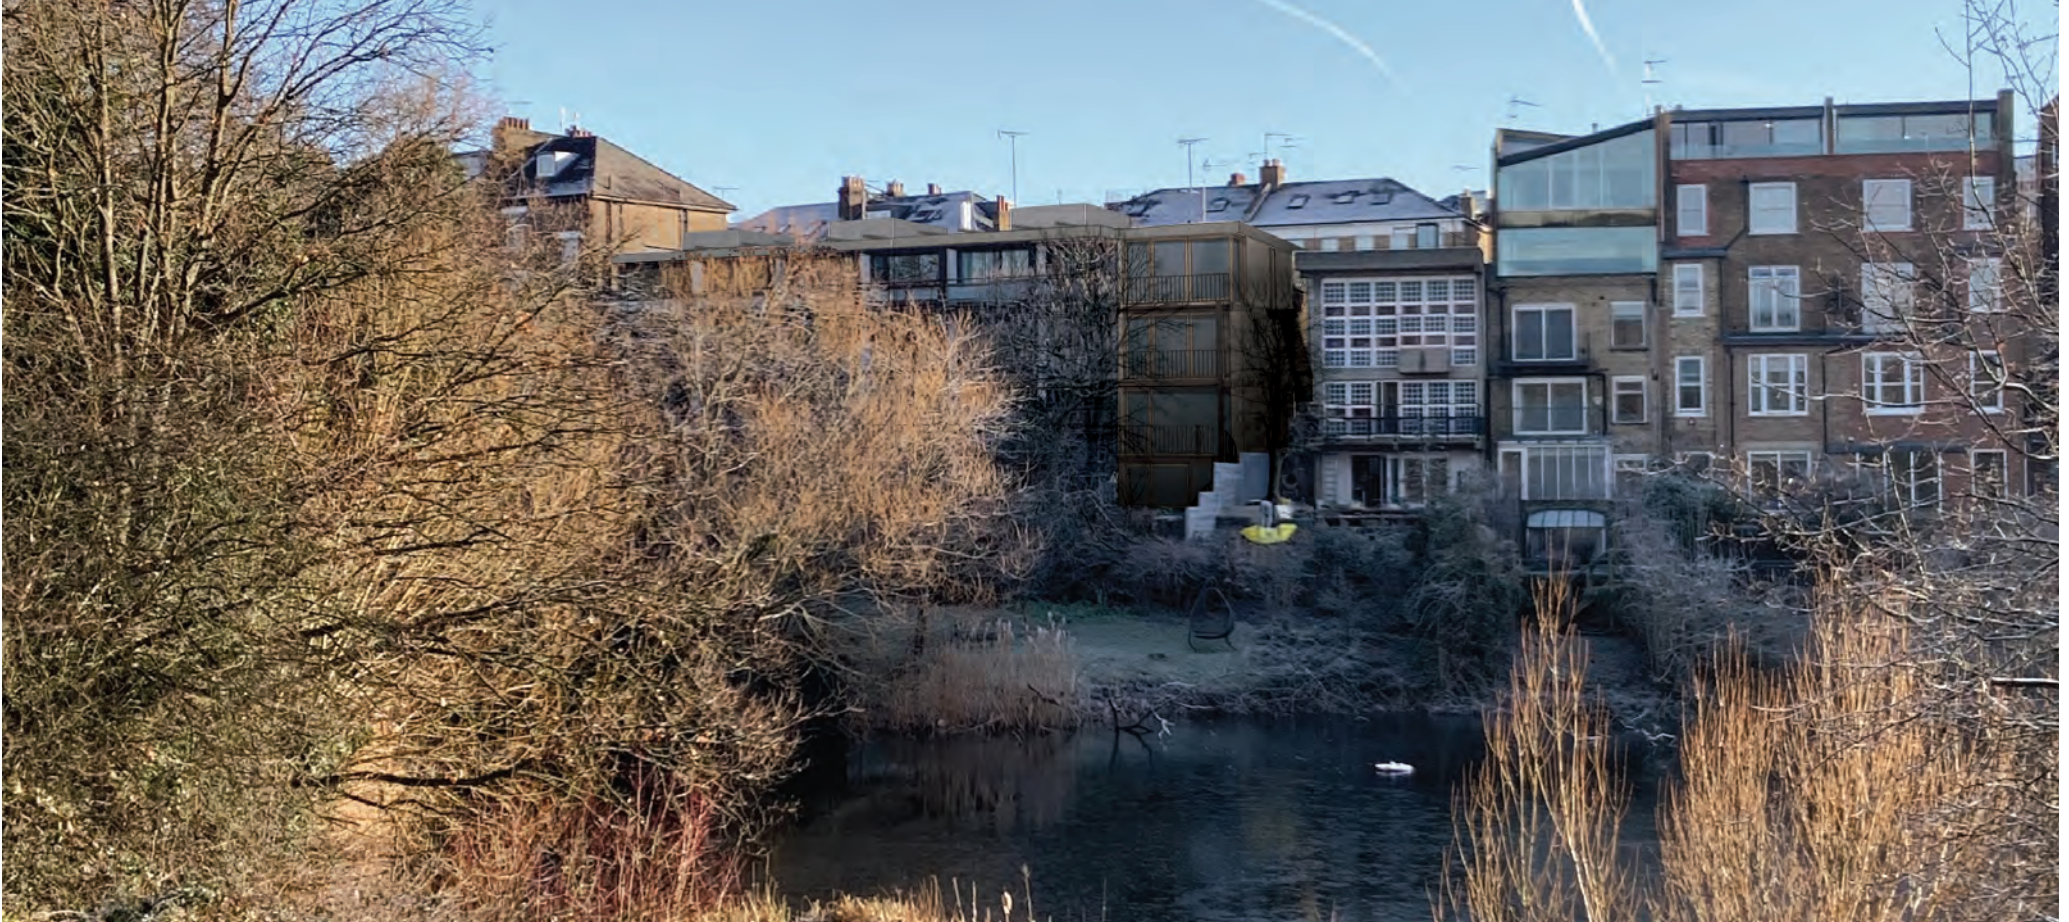
Rendered view from Hampstead Heath

The air source heat pumps are shown here and are visible from the long view which could be characterised as harm, however we believe that they are largely lost within the view and blend with the roofscapes beyond, whilst the sustainability benefits are clear.

Being broken down into three distinct enclosures (PPC to RAL colour no. 7044), these follow the paired symmetry across the terrace and reduces their visual impact by allowing glimpses through and around them.

Photo-voltaic panels are also proposed across the rear of the terrace roof. These will be installed almost flat at 10 degrees, only marginally impacting on the terrace roof parapet line when seen from far opposite the Heath. The existing solar panels at no. 90 SHP are proposed to be retained. A consistent approach to the terrace fabric repairs and reinstatement of original balustrade and brise-soleil details will be an overwhelmingly positive impact.

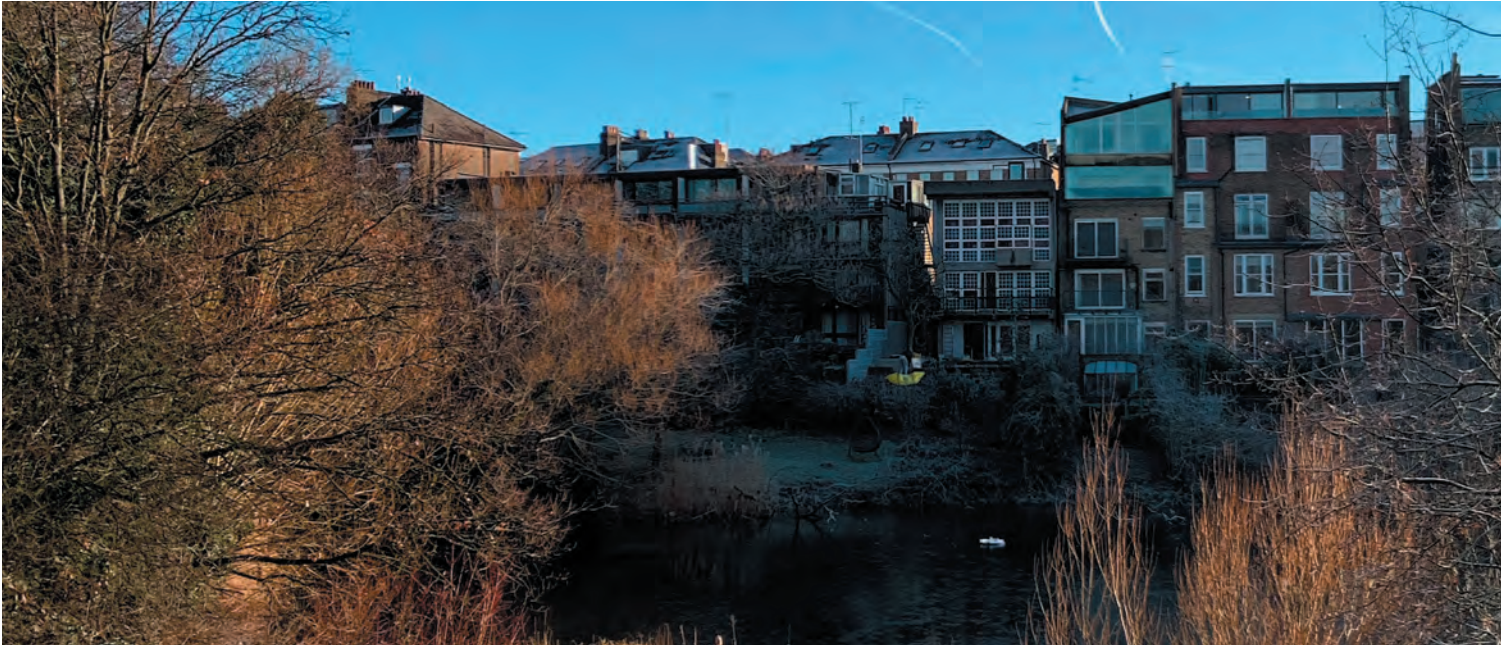
Existing view of the terrace from Hampstead Heath
