# Existing Terrace roof

## Terrace roof plan key proposals :

# Proposals Existing and proposed roof build-up details

# Proposals Proposed safe roof access

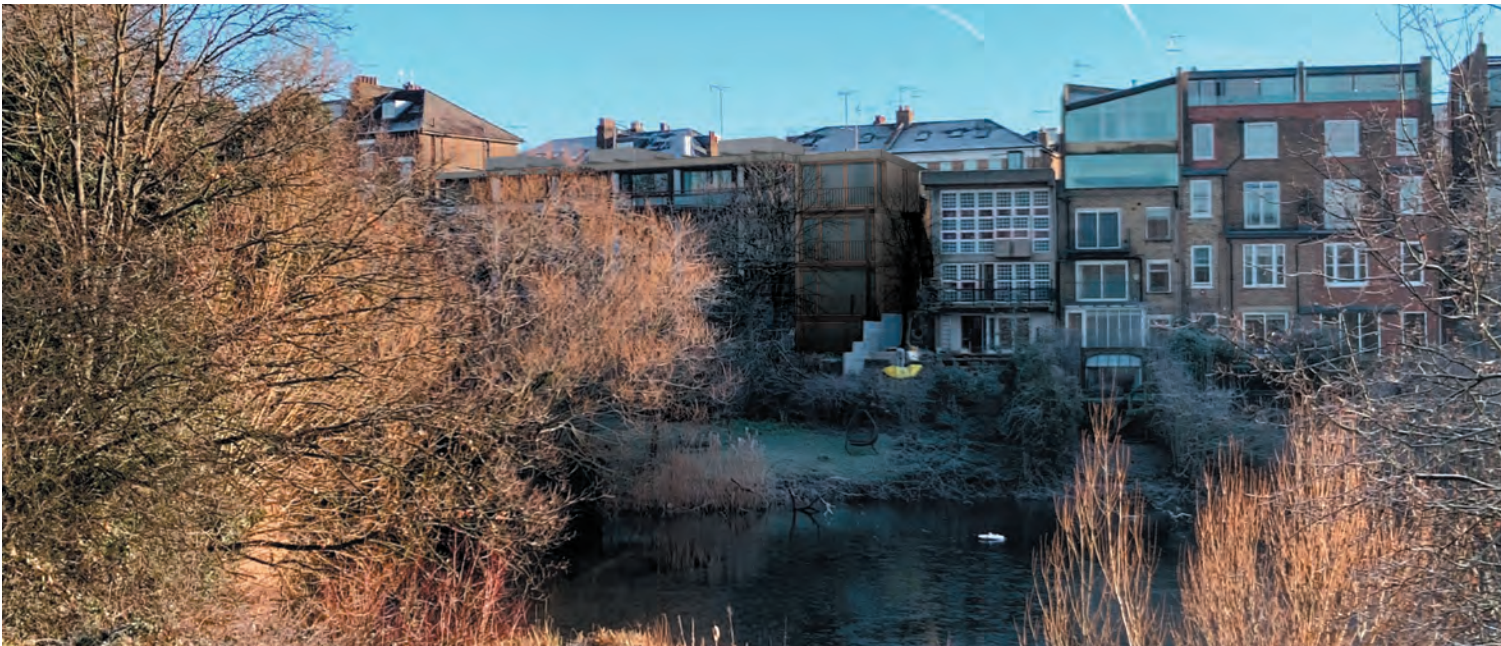
Proposed view of the terrace from Hampstead Heath

Photo-voltaic panels are also proposed across the rear of the terrace roof. These will be installed almost flat at 10 degrees, only marginally impacting on the terrace roof parapet line when seen from far opposite the Heath. The existing solar panels at no. 90 SHP are proposed to be retained. A consistent approach to the terrace fabric repairs and reinstatement of original balustrade and brise-soleil details will be an overwhelmingly positive impact.

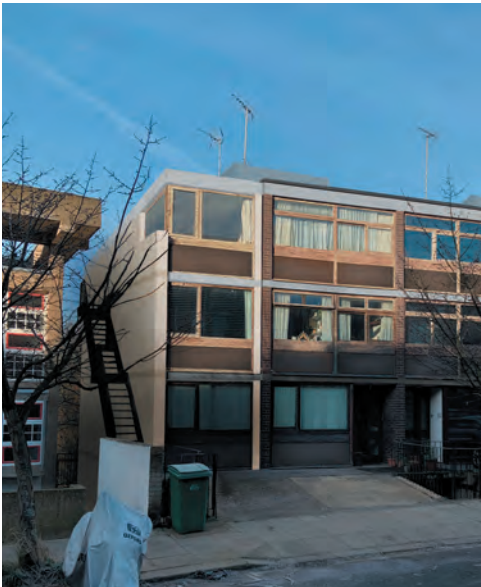
Rendered view of no. 80 extension and externally insulated flank wall

External insulation to the flank wall returns to the rear extension and is finished in the same lighter colour as the existing flank wall brickwork, which distinguishes it from the darker colour of the brickwork party walls of the main terrace.

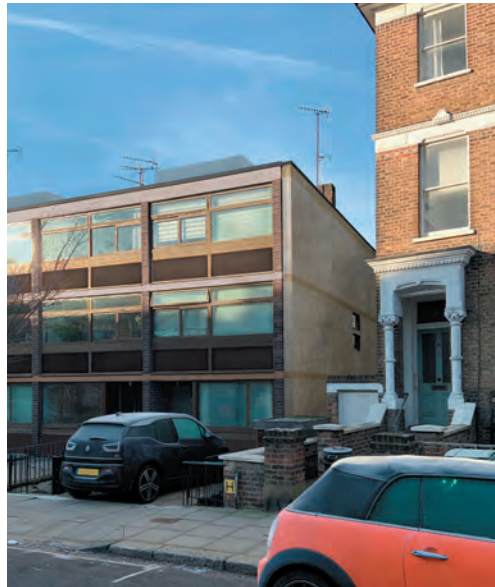
Rendered view of flank wall with external insulation at no90 end of terrace

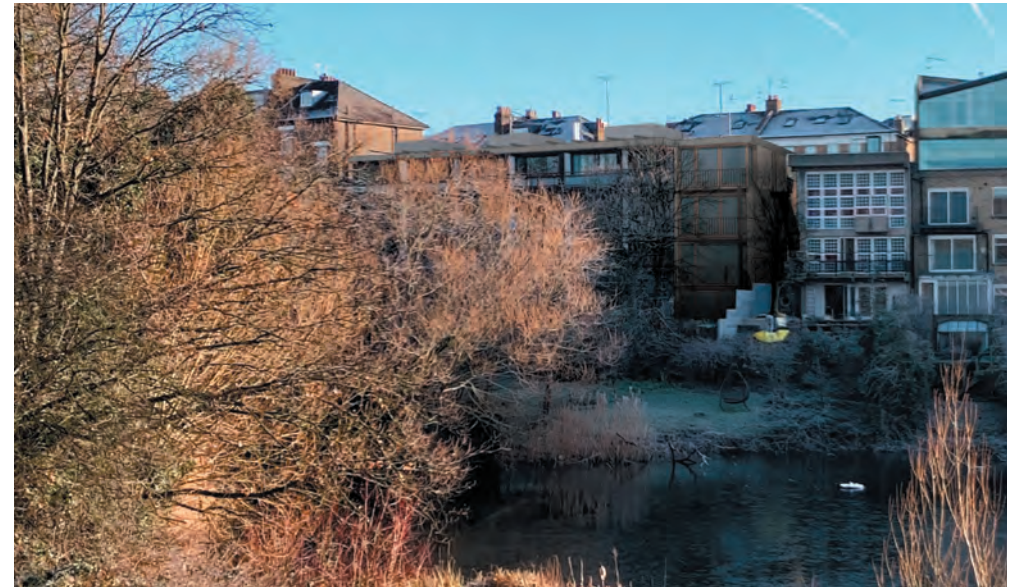
Proposed rendered view of the terrace from Hampstead Heath

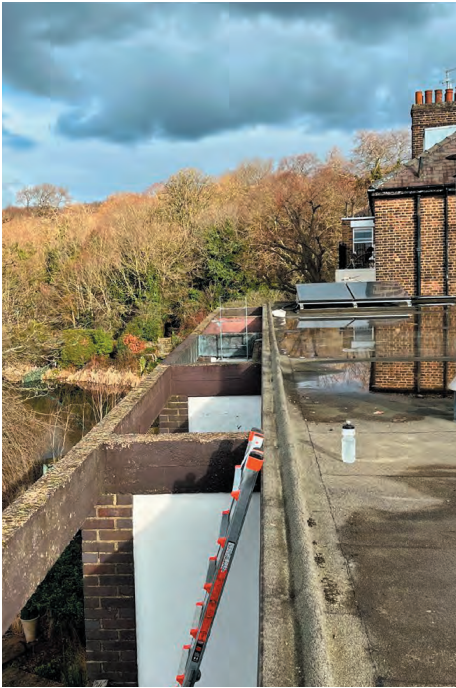
Existing roof towards rear garden

The ASHP's are enclosed by metal louvred screens which provide acoustic attenuation for air-borne sound as well as visual screening (refer to the acoustic engineer's report).
