Design, Access & Heritage Statement

Listed Building Consent

Primrose Hill Primary School
Princess Road
London
NW3 6NP

Primrose Hill Primary School, Princess Road, London, NW1 8JS

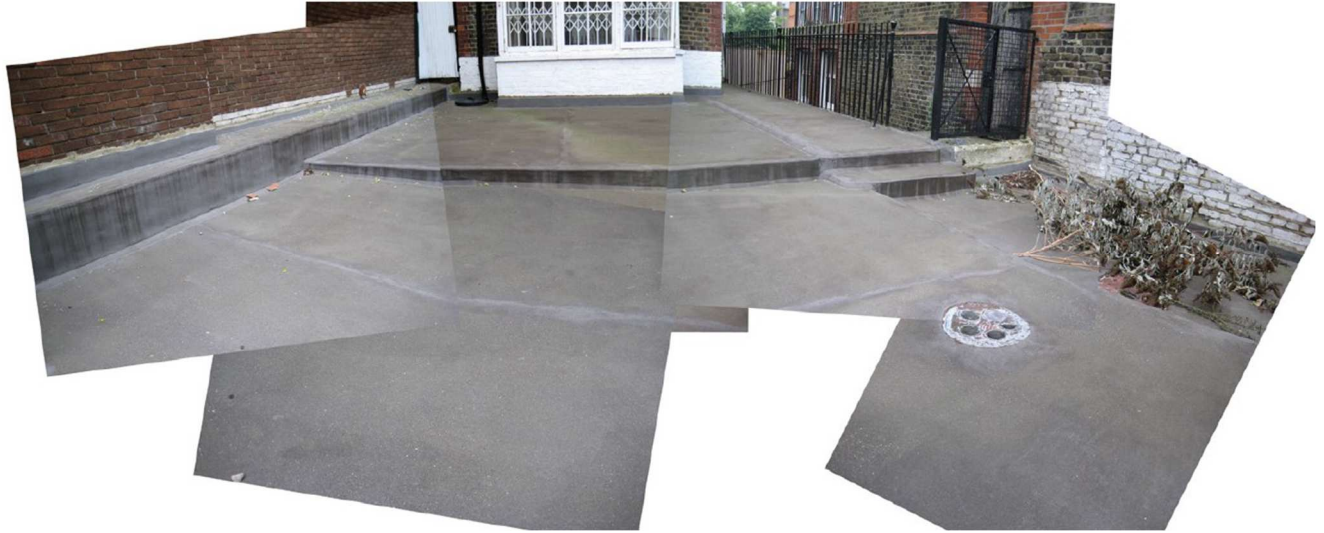
Figure 3: View of external area prior to paving, circa 2011.

- 2.1.3 The paved finish to the terrace is a comparatively recent addition in the context of the building ages; work which was completed in 2011 as part of a refurbishment project to the terrace area. Prior to this, the external area had an asphalt covering (Figure 3 - below). The nursery building runs beneath this at basement level.

- Stripping back brick paving and subbase to original starting point (Figure 3) pre-2011.
 - Providing a new Bauder Inverted roof system as detailed in appended specification, including new walk on roof light, finished with a spacer and paving system to improve aesthetics and ensure the proposal is in keeping with the surrounding area. Paving to be York Flagstones (see Figure 5 below, and appended datasheet). Improved surface drainage beneath pavers to aid in dissipation of water and avoid ponding and algae growth (see Figure 2).

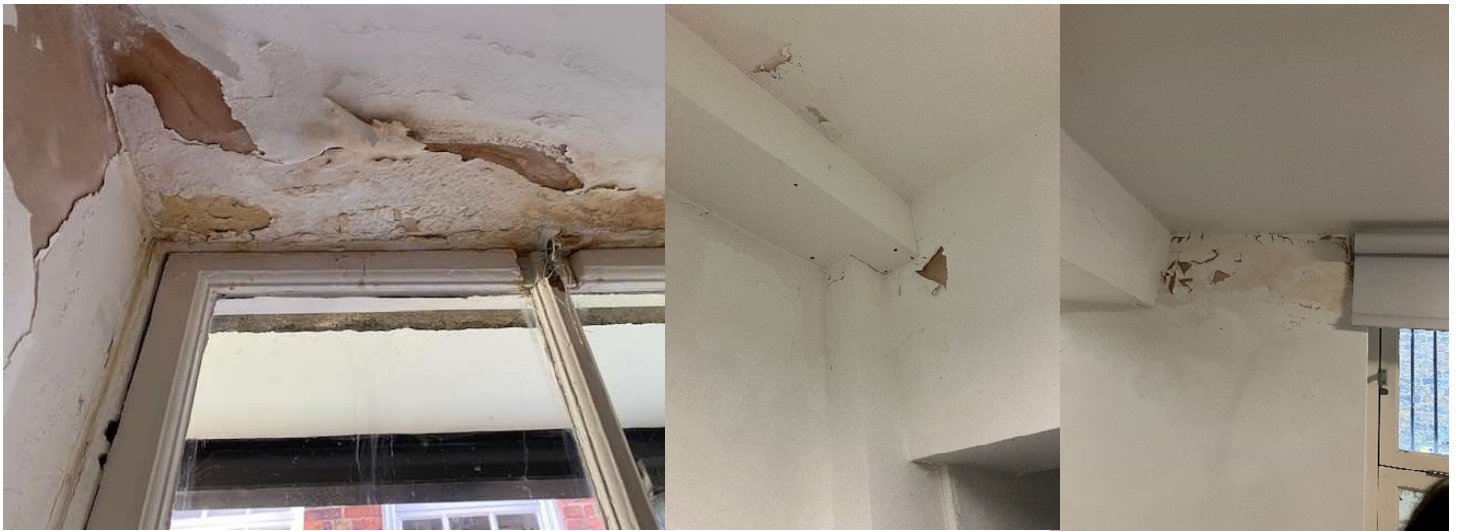
Figure 4: Photographs of internal damage.

- 2.1.4 Defects began to materialise soon after installation of the paving and other works were complete, with significant internal dampness and staining within the Nursery building at both ground floor, and basement level (Figure 4).
