Localised repair to dormer window where external material has become loose due to water damage. Proposed repair to return envelope to the original.

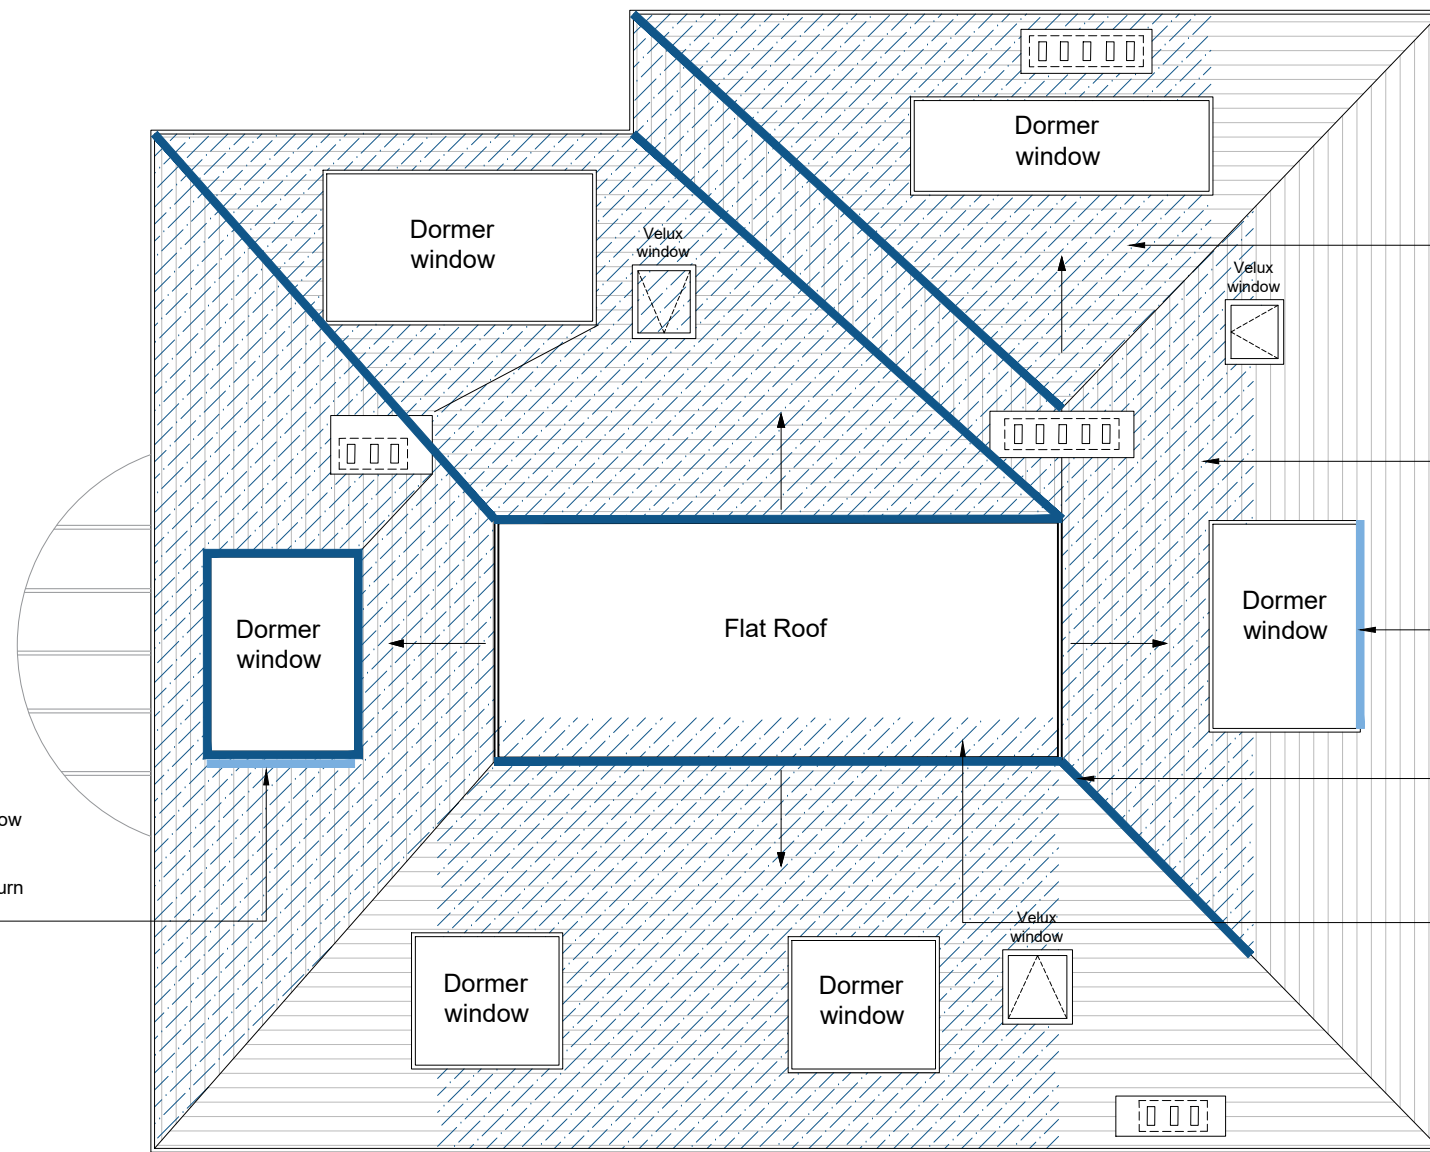
Hatched area denotes area of roof for potential repairs. Repairs to be localised where possible and where no repairs required, roof tiles are to be protected throughout the duration of the works. Damaged tiles only are to be replaced to match existing adjacent aging and staining.

Where works to roof are to be carried out, roof tiles are to be carefully removed and stored for reuse once waterproofing repairs have occurred.

Rainwater gutter to entire perimeter to remain as existing and repaired locally where necessary.

Localised repairs to RH french window due to water damage to the timber frame.

Lines denote areas of flashing to ridges and flat roofs to be repaired. Repairs are to be localised and new lead flashing to match existing adjacent.

Repairs to lead roof where damage has occurred. Lead flashing to match existing. Where damage discovered to structure, to be repaired and resealed prior to laying the new flashing.
