100 chalk farm road  
london NW1 8EH

refurbishment feasibility report  
gl hearn

august 2013

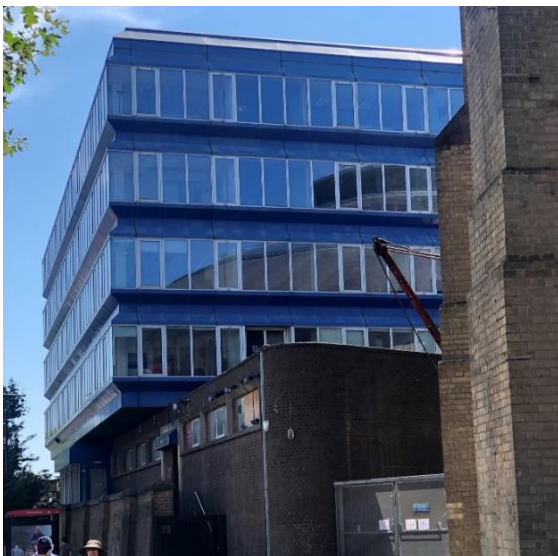
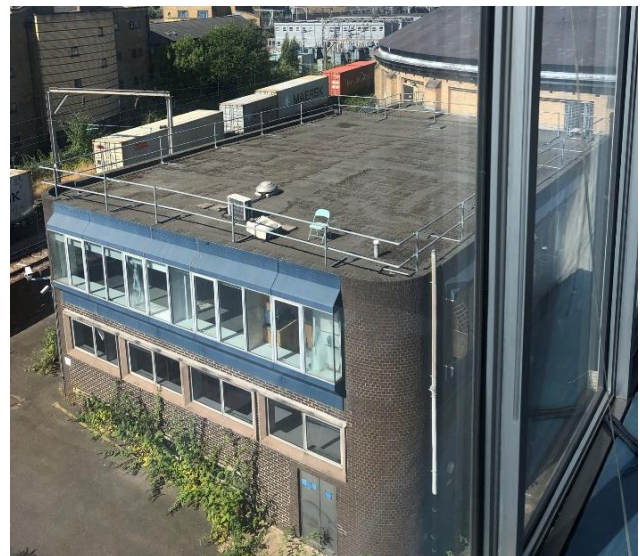
**Figure 19 Glazed façades**

The figures below illustrate the glass sources.

Office Building and Dressing rooms

Rehearsal Room

Whilst some schemes will take back flat glass for recycling unless the glass is reclaimed as part of components (say external glazing or doors), it is recommended to be crushed into aggregate with the other inert waste. If it is to be segregated on-site for reuse/recycling, health and safety considerations are required for the workforce as it needs to be handled carefully.

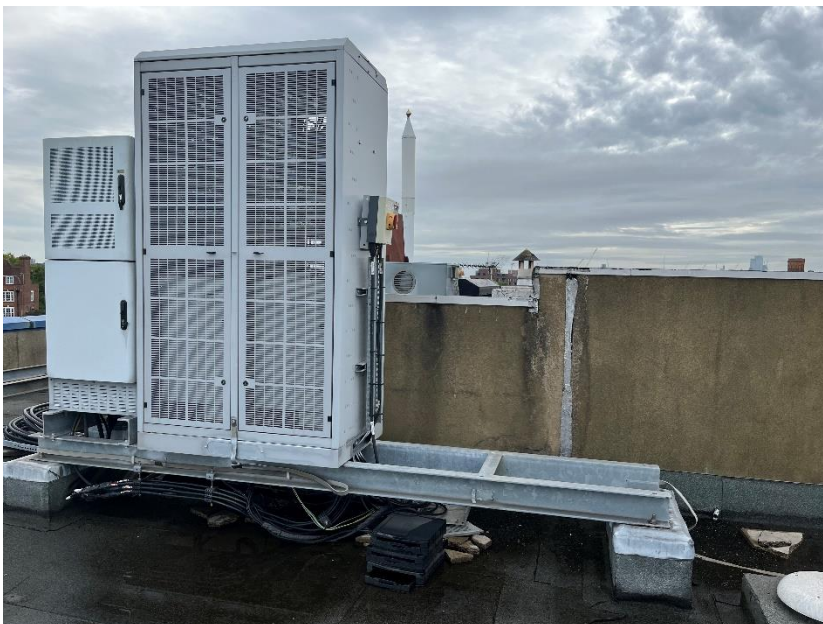
**Figure 25 M&E equipment (office roof)**

The figures below illustrate the WEEE sources arising from demolition.
