1MCo3 Main Works – Contract Lot S1

Heritage Agreement Method Statement

HAMS - Monitoring and Conservation

Management of Ground Movement due to

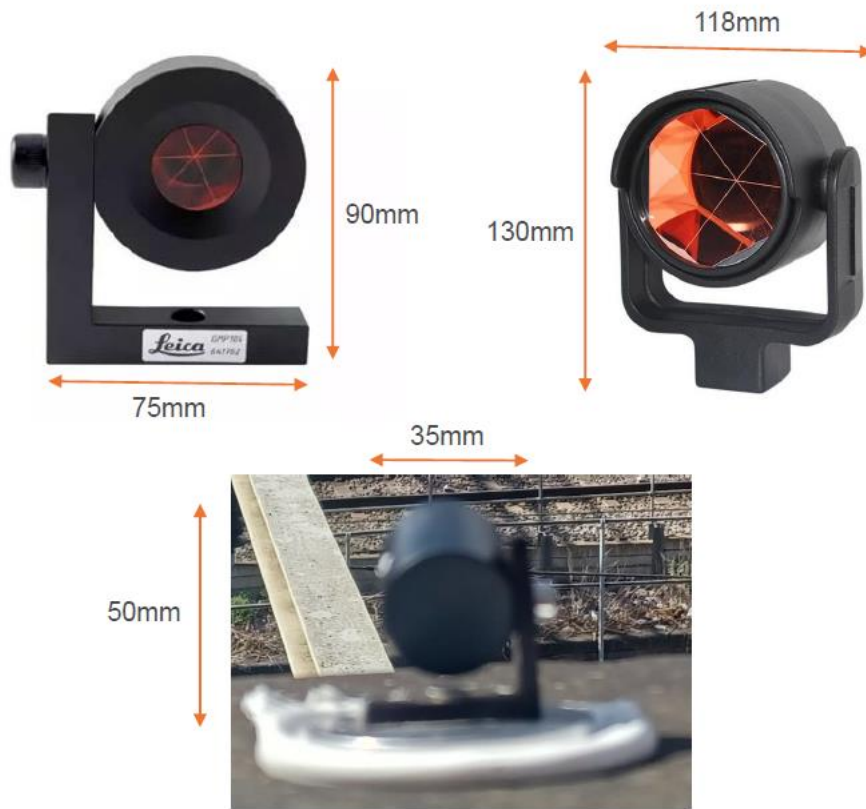
Figure 10- Example of a 3D prism

- 7.5.4 3D prisms (data recorded using mechanical Total Station) attached to external walls at the top and bottom of each façade. (If colour options can be sourced and are available, instruments that best match the external building appearance will be installed).

- 7.5.1 Monitoring instruments will measure:
 - settlement and horizontal displacement
 - relative movement between each side of a crack
- 7.5.2 Primarily 3 D prisms of various sizes (Figure 10) and tiltmeters fitted to 0.5m beam (Figure 11) will be used. Devices will measure movements affecting both properties that form the semi-detached building and adjoining ground surfaces. The devices illustrated are typical examples, but specific instruments used may vary according to situation.
- 7.5.3 Table 3 details the minimum monitoring system instruments required at 57 Mornington Terrace.

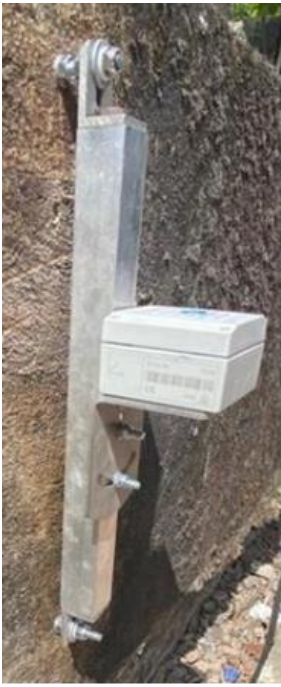
Figure 11– Example of a tiltmeter

7.5.5 Tiltmeters are in areas that are less accessible, specifically the enclosed external walls forming the later rear extension (Appendix A).

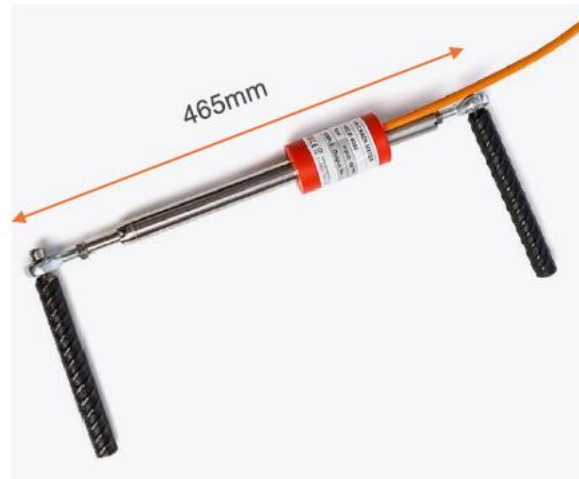
Figure 12 Example manual crack monitor (top) and automatic crack sensor (bottom)

7.5.6 On appearance, internal and external cracks will be monitored using tell tales or monitoring studs (Figure 12).
