— Design Note

Client:	The British Museum
Project:	Health and Safety Lighting - External
Project No:	113
Date:	24 April 2024
Author:	Joe Dent

This design note has been produced to support the planning and listed building applications for new health and safety lighting at the British Museum.

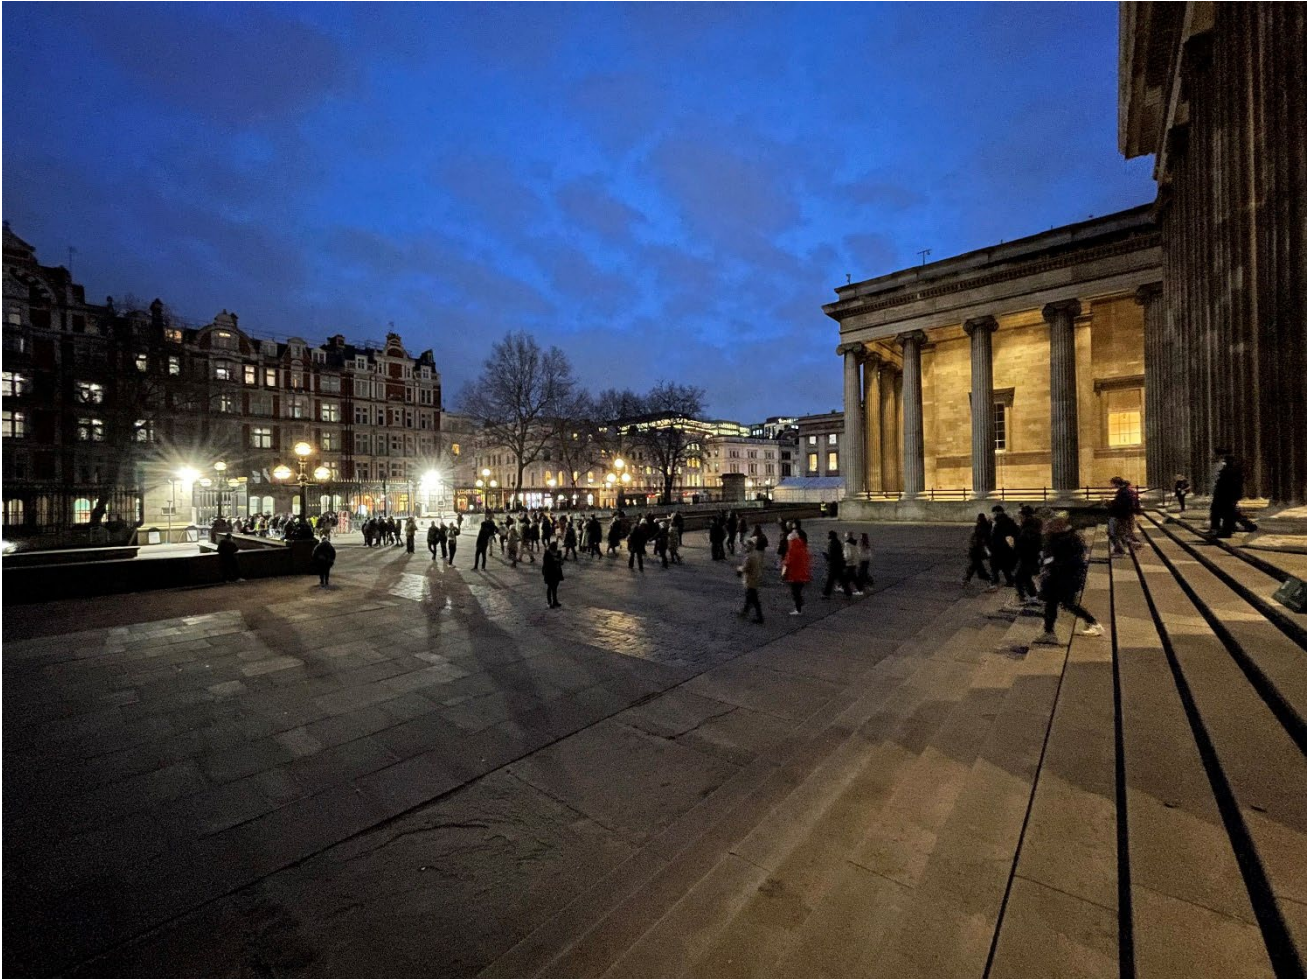
Figure 1: View of visitors departing via the colonnade steps and south forecourt, glare from 2no.existing floodlights

1. The area is currently inadequately lit – with readings between 1.0 - 5.6 lux on the steps and forecourt – below the minimum mean illuminance of 5 lux for pedestrians cited in BS EN 12464-2 and the SLL Lighting Handbook.
2. This area is currently partially lit by two floodlights mounted to the gatehouses on the south fence. These lights are both low quality design and are very bright, causing glare to visitors leaving the museum. Their removal, allowed by the new floodlights, would provide benefit to the existing building both by day and night.

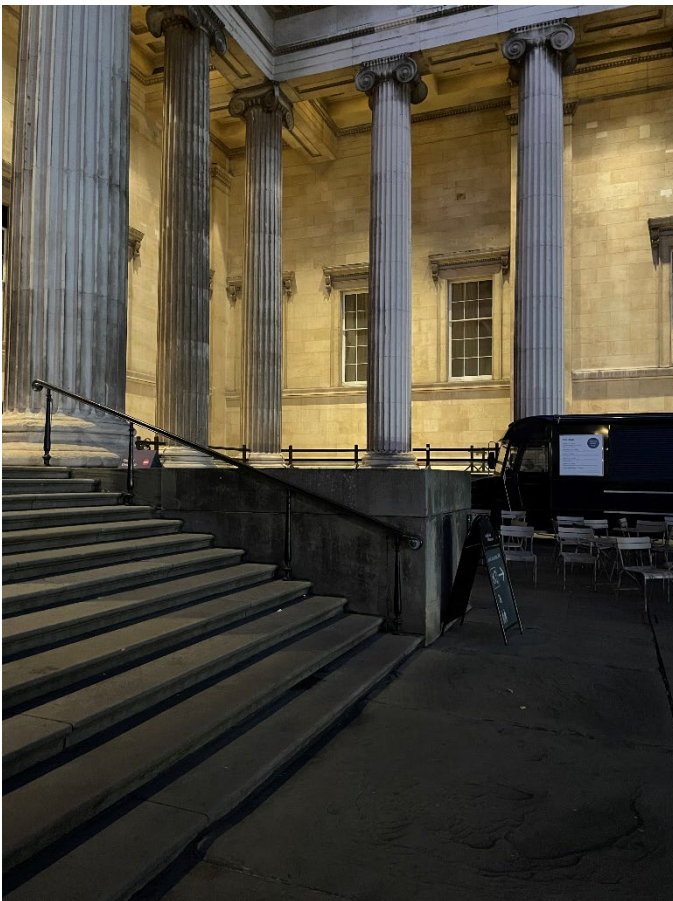
Figure 2: View of existing colonnade steps

It is worth noting that the south colonnade steps do not have any nosings or demarcation strips, and so are not compliant with the current Approved Documents of the Building Regulations. Of course, the steps heritage value provides good reason for them not to be harmed with additional nosings or demarcation, but we believe that taking the opportunity to improve their lighting in a sympathetic and reversible manner, provides benefit to users of the building within little to no harm to the building.

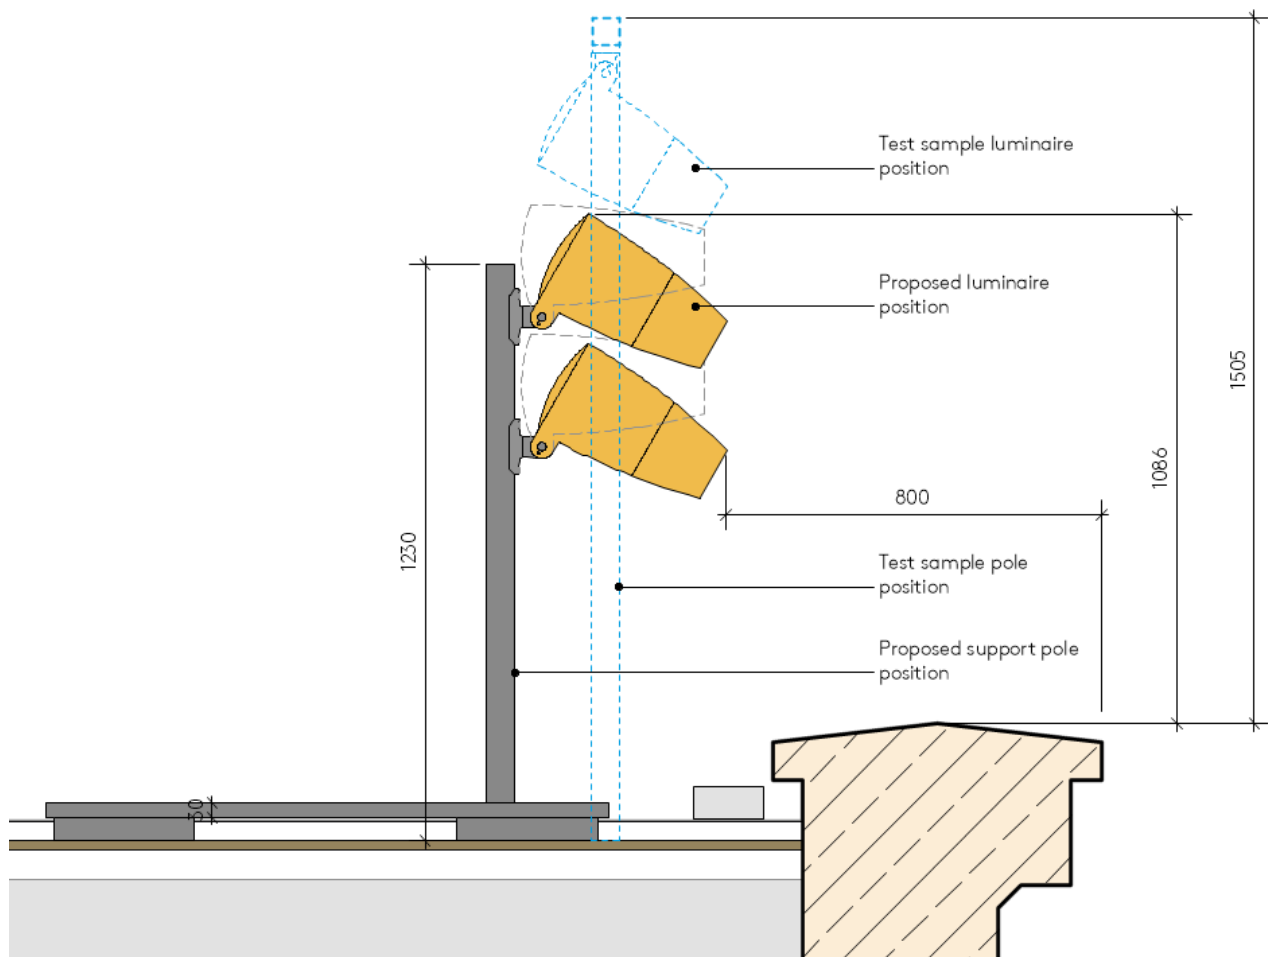
Figure 3: Diagram showing height of mock up flood light position and proposed flood light positions

The new floodlights are proposed to be fitted closer to the coping line than the location that one was installed in for the mock up shown to officers, per the sketch below. The two lights on each roof will also be supported of a single pole on each side, rather than hanging from the temporary 'T' bar which the lights were fixed onto for the mockup. This, and the light grey tone of the fixtures and mounting pole will give the lights a subtle profile during the day.

At night, the lights will be directed across the south elevation, with deep honeycomb louvres shading the bulbs, meaning there will be very limited glare, especially when the elevation is viewed from the street and the southern areas of the south forecourt.
