Architectural elevation drawing of a three-story brick building, identified as 39 Marchmont Street. The drawing shows the front facade with a mansard roof, dormers, and a terrace. Annotations specify repair and replacement work for the parapet, roof tiles, dormers, windows, air bricks, terrace door, and railings. Section lines A-A and B-B are indicated at the top.

Address: 39 Marchmont Street

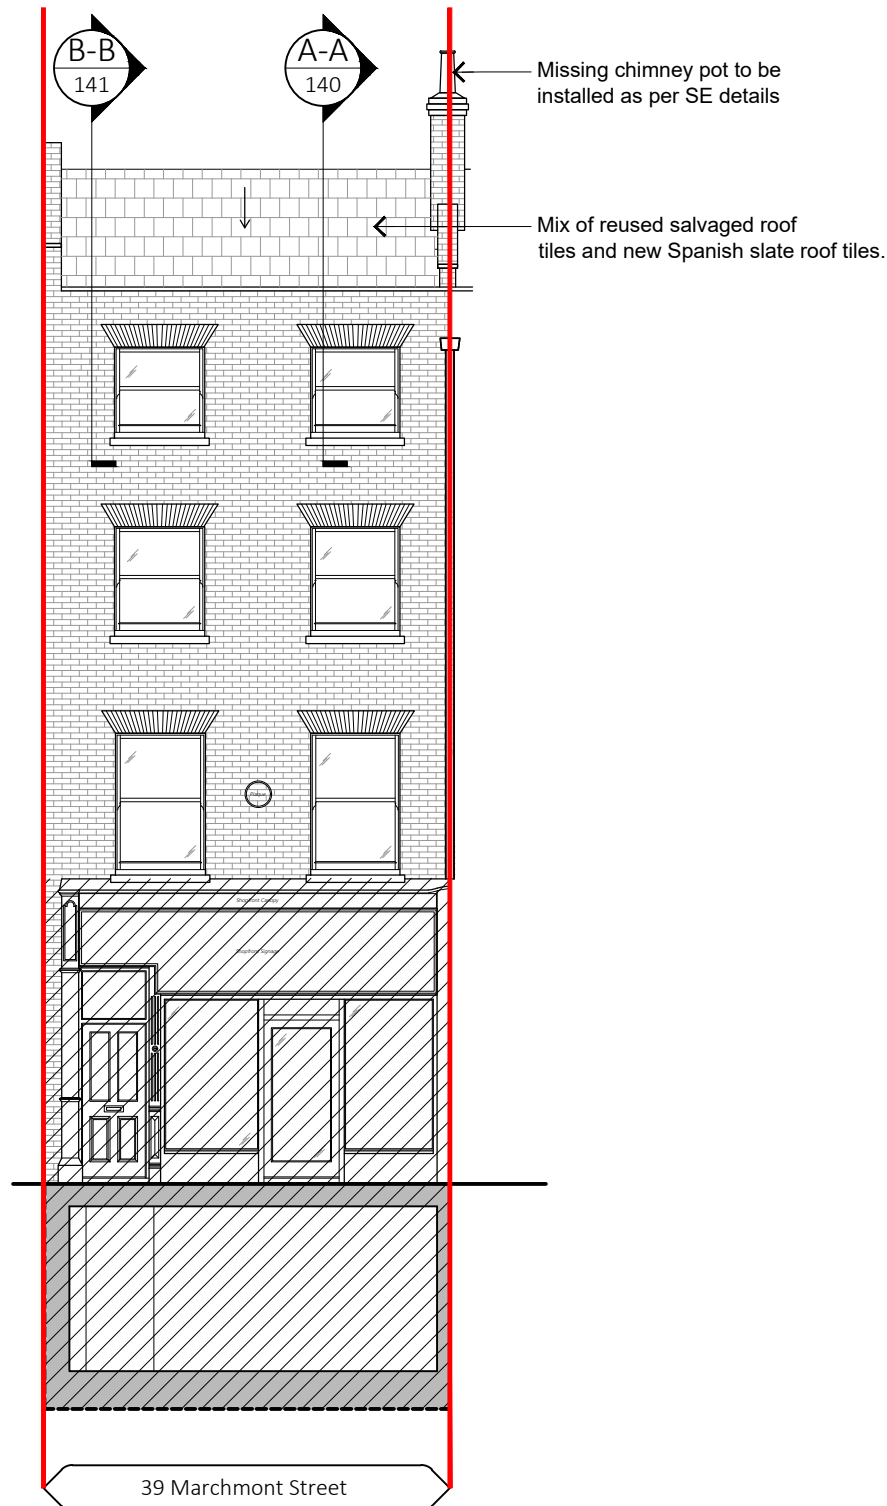
- Existing parapet to be repaired/ replaced to match existing where required due to damage
- Mix of reused salvaged roof tiles and new Spanish slate roof tiles to main and mansard roofs

- New dormers to replace the rotten dormers with new slim line white painted timber frame double glazed sash windows. Dormer cheeks, front and roof to be clad in Lead.

- Existing parapet to be repaired/ replaced to match existing where required due to damage
- New heritage range aluminium hopper & RWP, black
- Parapet to be rebuilt to match existing as per SE proposals

- Existing parapet to be repaired/ replaced to match existing where required due to damage
- New air bricks to match brick colour
- New air bricks to match brick colour

- New air bricks to match brick colour
- New white slim frame timber terrace door with fanlight to replace the existing unoriginal terrace door
- New black iron railing to existing roof terrace. Railing to be min 1100mm from terrace FFL
