2 Willow Road, London NW3 1TH

**Renewal of Roof Coverings and
upgrading of insulation**

Design, Access and Heritage Statement

September 2024

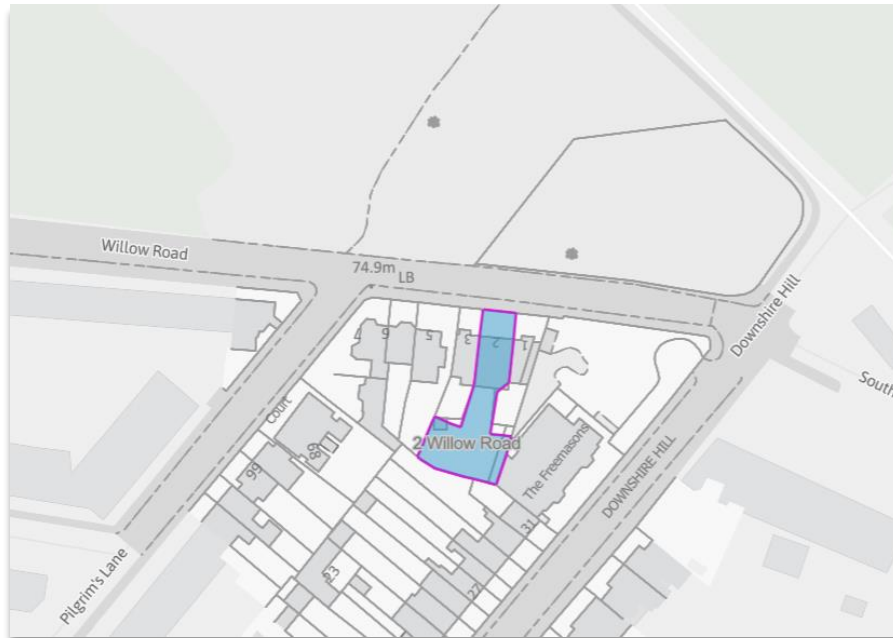
Figure 2.1 – Application site location plan (not to scale)

Figure 2.1 shows the location of the application site and figure 2.2 is an aerial view of 1,2, 3 Willow Road showing the application site location.

The application site is the roof of no. 2 Willow Road and the extent of the National Trust's ownership is shown in the pink/blue outline of figure 2.1. Willow Road is in Hampstead off Downshire Hill and within close proximity to Hampstead Heath.

The extent of the building and National Trust ownership is shown in figure 2.1.

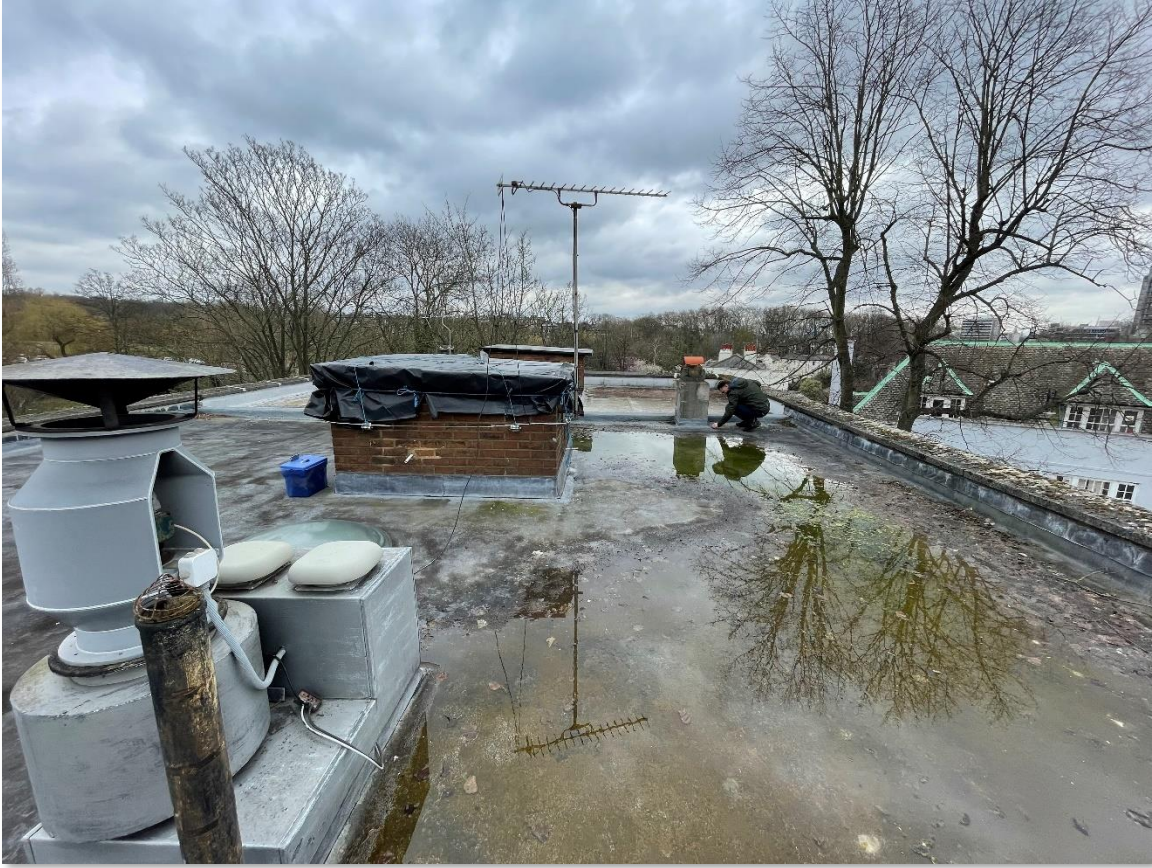
Photograph 1 – Water pooling on roof and tarpaulin cover to tank roof

The roof is starting to fail with leaks and water ingress over the last couple of years, water staining is visible on the top floor ceiling.

Access onto the roof is difficult and addition of grab rails will help aim access via the tank housing. The roof of the tank housing has been installed incorrectly and also leaks and should be replaced at the same time as the renewal of the roof coverings.
