1MCo3 Main Works – Contract Lot S1

Heritage Agreement Method Statement (HAMS) for Monitoring and Conservation Management of Ground Movements due to Below Ground Construction at York & Albany Hotel, 127-129 Parkway – ADP-ESCT-02

Document no: 1MCo3-SCJ-EV-MST-SSo1_SLo3-000011

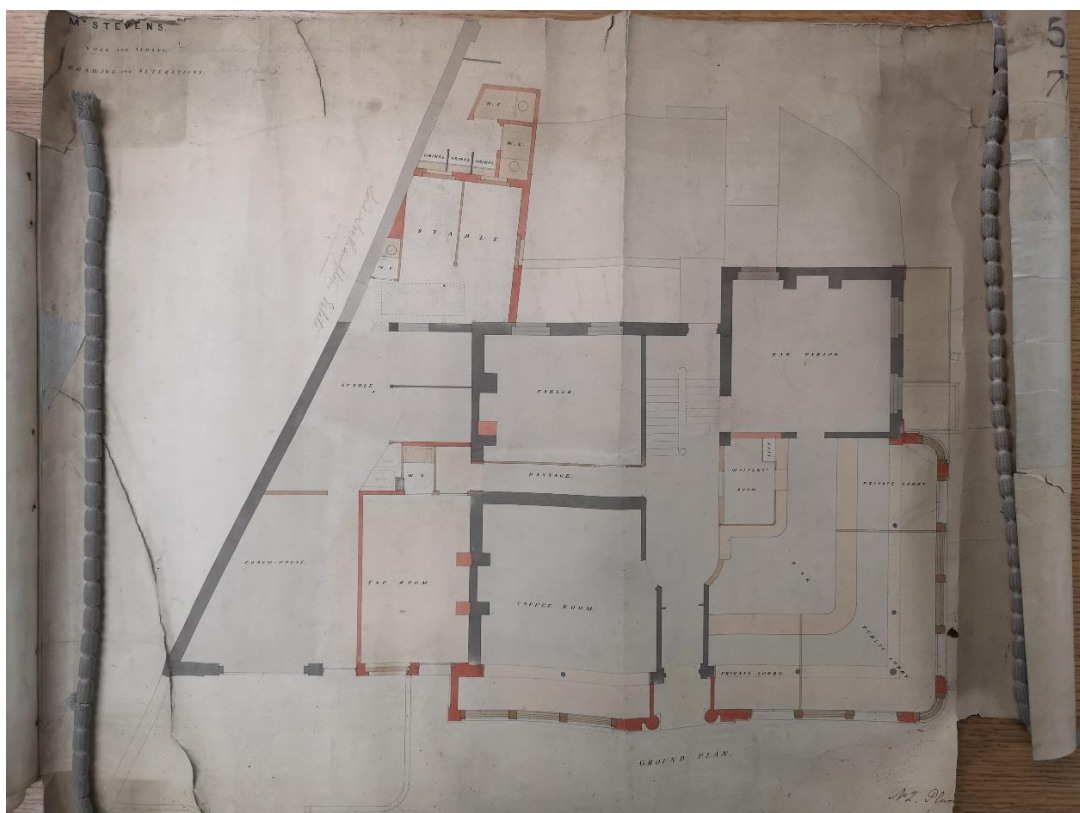
Figure 8 1854 proposals by James Pennethorne

- 4.2.8 Proposals in 1854 by Nash's successor, architect James Pennethorne, show a series of alterations that expand the ground floor of the York & Albany (Figure 8). The most substantial change is the demolition of the west exterior wall and two bay windows, located behind the street-facing portico, and subsequent westward and southward extension of the ground floor up to the line of the former portico. To carry the load of the demolished ground-floor walls, five cast-iron columns were evenly interspersed along the building's former exterior wall line. The evolution of the stables occupying the adjoining triangular plot to form no. 127 progresses through insertion of a tap room within a single storey structure.

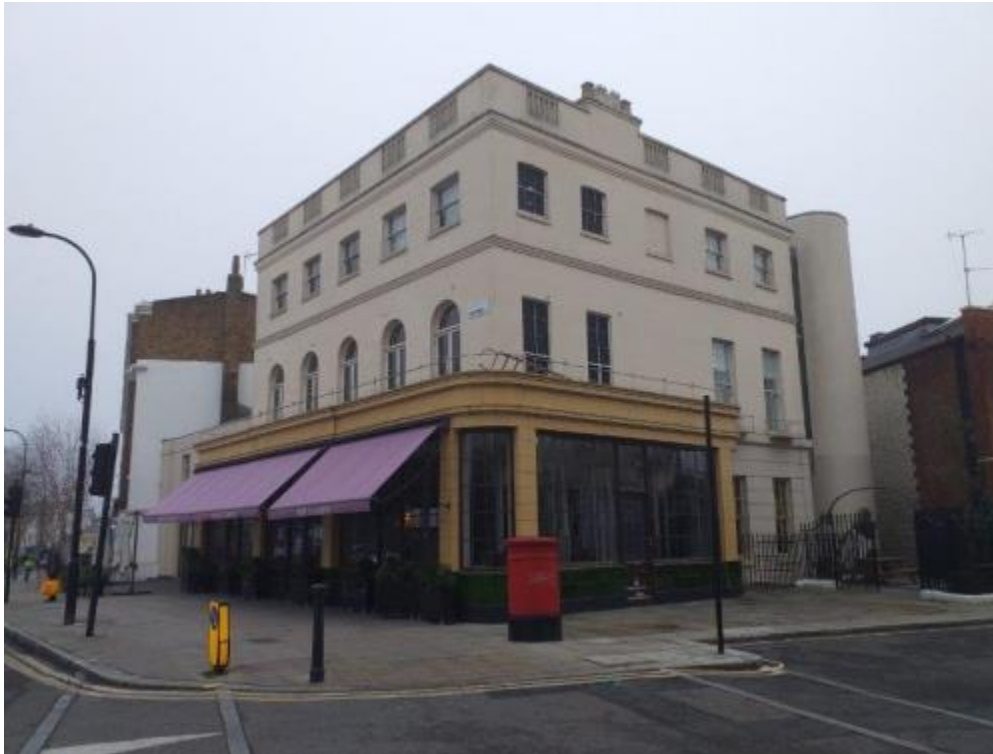
Figure 12 faience-tiled inter-war pub frontage

- 4.2.14 A ground-floor plan of the pub present in the deeds of 1937 shows that, by this date, the ground-floor pub front had been replaced with the faience elevation that can be seen today (Figure 12).

- 4.1.4 The primary façade and floor plans to 129 Parkway remains unaltered at first floor level and above. However, a notable alteration that contributes to the significance of the building is the early 20th century four-bay faience tile clad entrance frontage with large windows and integral doorways. This replaced a previous façade installed when the ground floor was extended creating a first-floor balcony that overlooks Parkway and wraps around the return into Park Village East, following the line of an original external colonnade. Corresponding sections of the original external load bearing masonry wall have been replaced with internal cast-iron columns supporting a metal beam inserted at first floor.

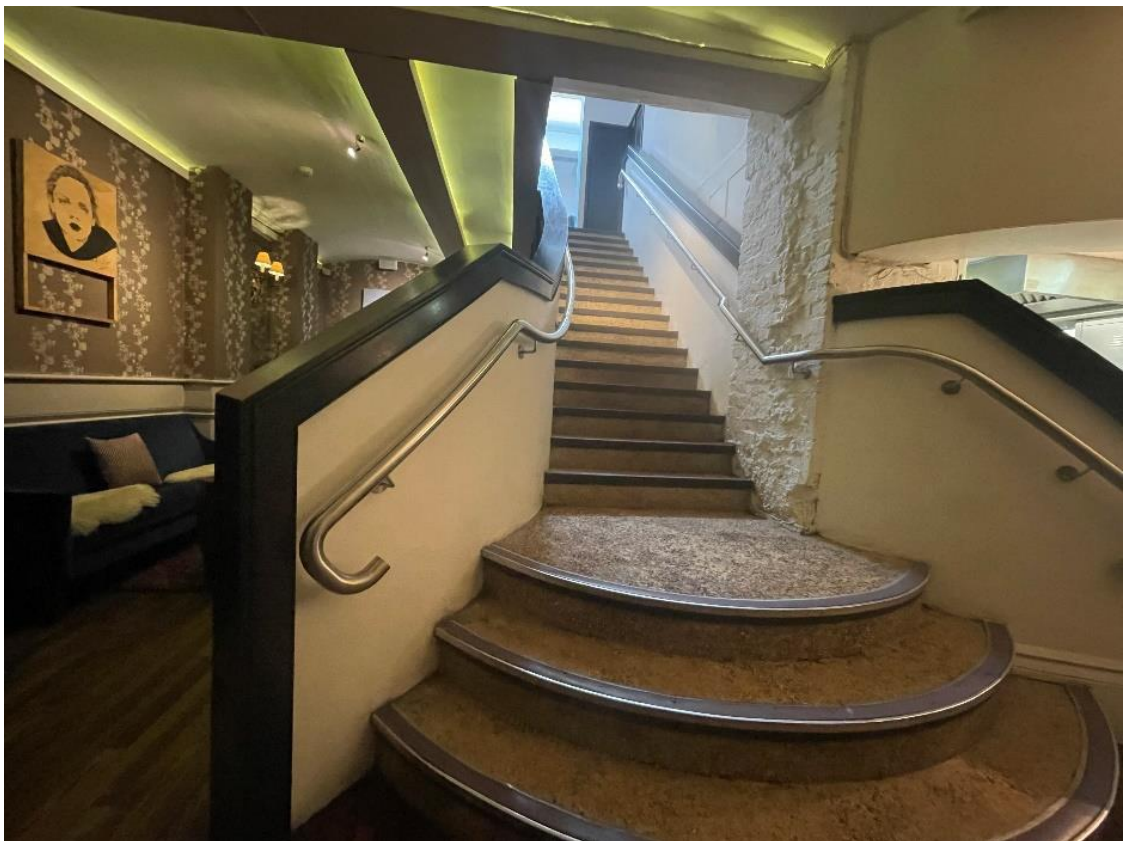
Figure 14 historic staircase

- 4.3.15 The iron columns at ground-floor level, first inserted in the mid-nineteenth century, are visible. The timber flooring is a recent replacement. To the rear of the pub, the floor plan has been curtailed by the addition of the c.2006 modern hotel extension.
- 4.3.16 The most prominent survival of historic fabric in the building is the dog-leg staircase in No. 129 which continues up through the building and dates to the early-nineteenth-century construction of the public house and survive intact with timber treads, rectangular spindles, and a curved timber handrail (Figure 14).

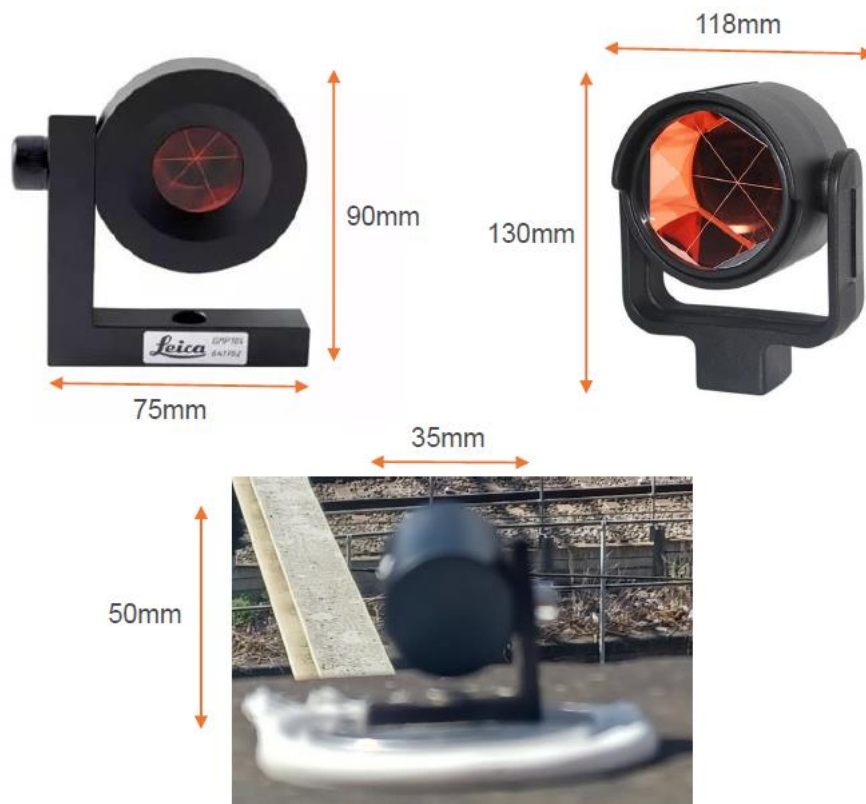
Figure 16- Example of a 3D prism

- 7.5.5 3D prisms (data recorded using mechanical Total Station) attached to external walls at the top and bottom of each façade. (If colour options can be sourced and are available, instruments that best match the external building appearance will be installed.)

- 7.5.2 Primarily 3 D prisms of various sizes (Figure 16) and tiltmeters fitted to 0.5m beam (Figure 17) will be used. Devices will measure movements affecting the composite building and adjoining ground surfaces. The devices illustrated are typical examples, but specific instruments used may vary according to situation.
- 7.5.3 Table 3 details the maximum monitoring system instruments required.
- 7.5.4 Proposed locations across both properties are shown in full in Appendix A Instrumentation Design Drawings. Subject to SCS I&M Team recommendations, minor variations to the monitoring scheme design may be necessary to ensure effective data capture through the duration of the monitoring period.

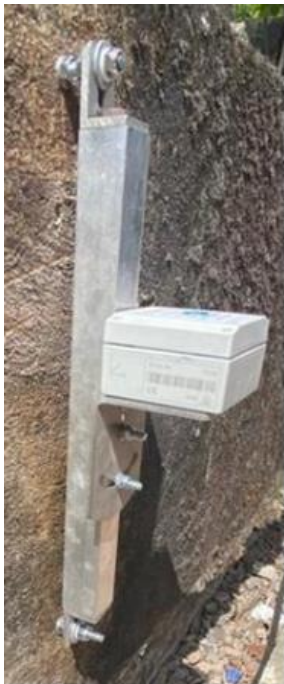
Figure 17– Example of a tiltmeter

- 7.5.6 Tiltmeters are in areas that are less accessible, specifically the enclosed external walls forming the later rear extension (Appendix A).

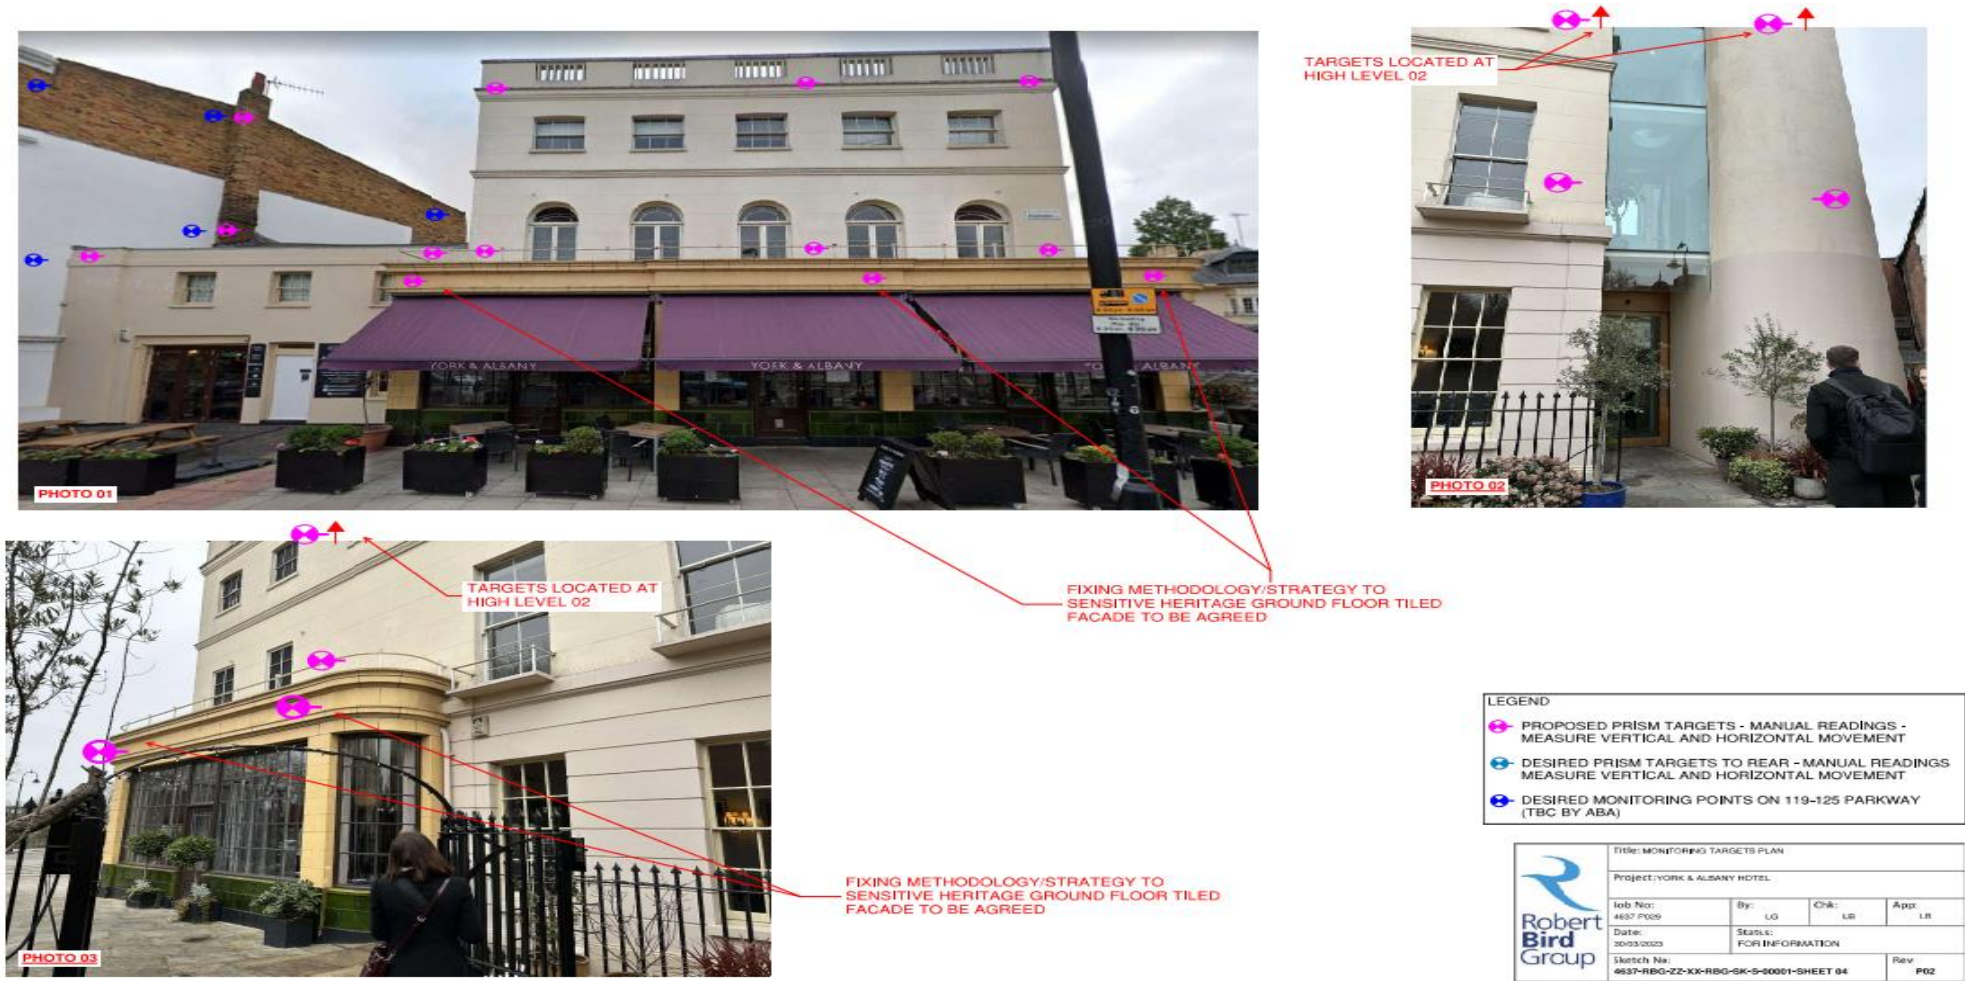
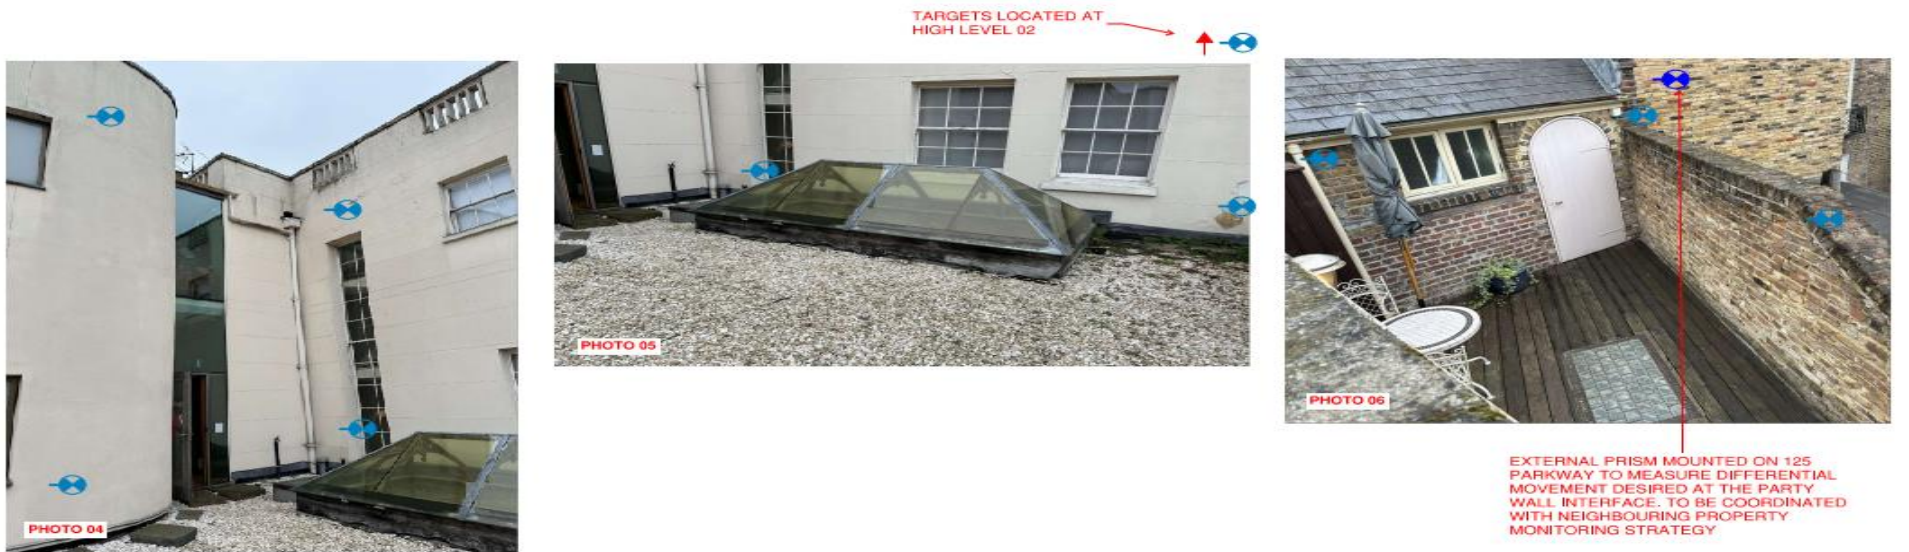
FILE: MONITORING TARGETS PLAN				
Project: YORK & ALBANY HOTEL				
Job No:	4637-P009	By:	LB	App: LB
Date:	30/03/2023	Status:	FOR INFORMATION	
Sketch No:	4637-RBG-22-KX-RBG-SK-9-00001-SHEET 05	Rev:	P02

(as proposed in SCSjv ASSET SPECIFIC MITIGATION DESIGNERS MONITORING PLAN AREA EAST ASSET PROTECTION SECTION 1-YORK AND ALBANY HOTEL - APD-ESCT-01 (1MCo3-SCJ_RBG-ST-PLN-SSo1_SLo3-000003))

- an up-to-date location plan (Figure 1)
- statement describing the heritage significance of the listed building (section 4 Building Information)
- a description of the relevant HS2 below ground construction works and predicted building damage (section 5.3 Phase 3 Ground Movement Assessment (GMA))
- a specification for the proposed monitoring instrumentation and a method statement for installation, maintenance, removal and conservation repairs (sections 7 Monitoring)
- drawings at a suitable scale showing the specified instrumentation locations (Appendix A).
