1-11 NEW SQUARE, LINCOLN'S INN
Historic Building Assessment
March 2012

This Historic Buildings Assessment (HBA) was prepared by Donald Insall Associates for the Honourable Society of Lincoln's Inn.

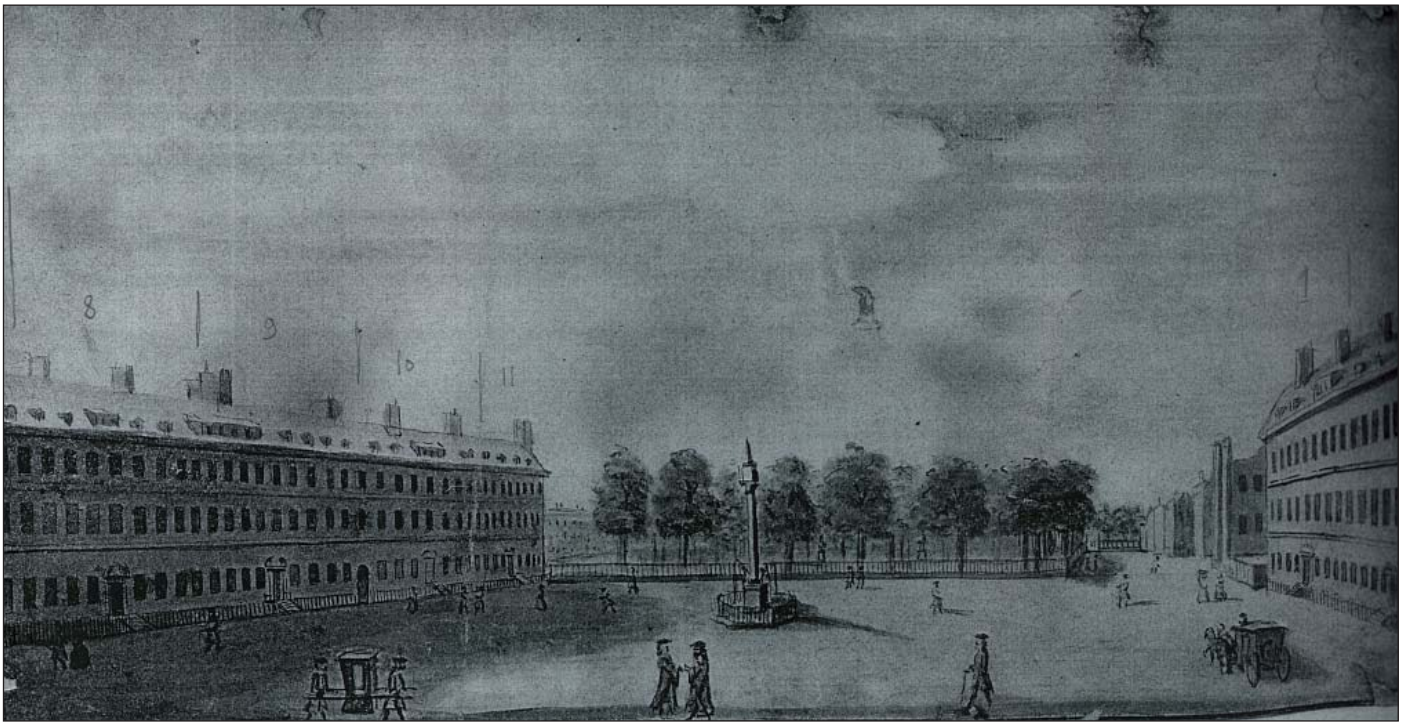
1. A sketch of New Square c1740.

Ralph, writing in 1734, allowed the Society to boast of one of the neatest squares in town, “though it is imperfect on one side, yet that very defect produces a beauty, by giving a prospect to the gardens, which fill the space to abundantly more advantage. I may safely add that no area anywhere is kept in better order, either for cleanliness and beauty by day, or illumination and decorum by night”. For a description of this Square in 1804 there is no

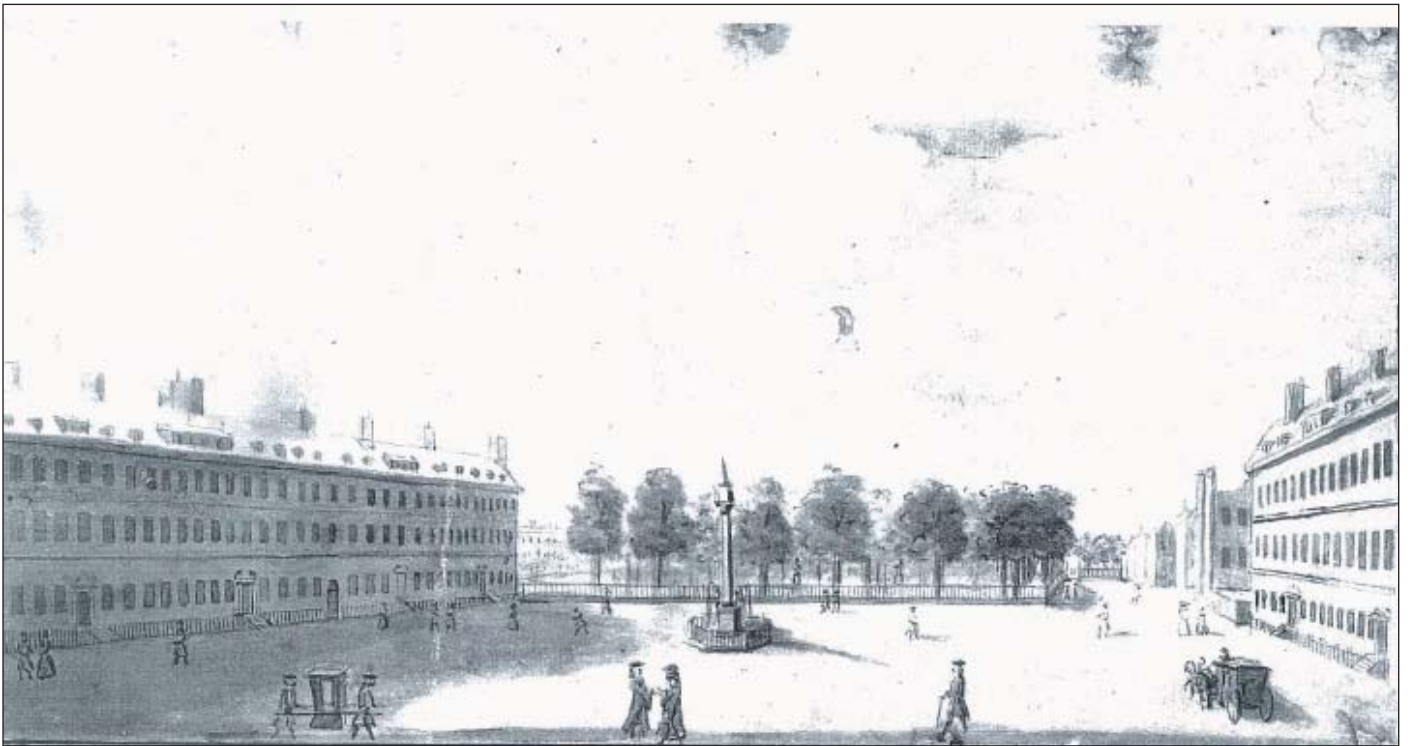
2. New Square in the mid-18th century.

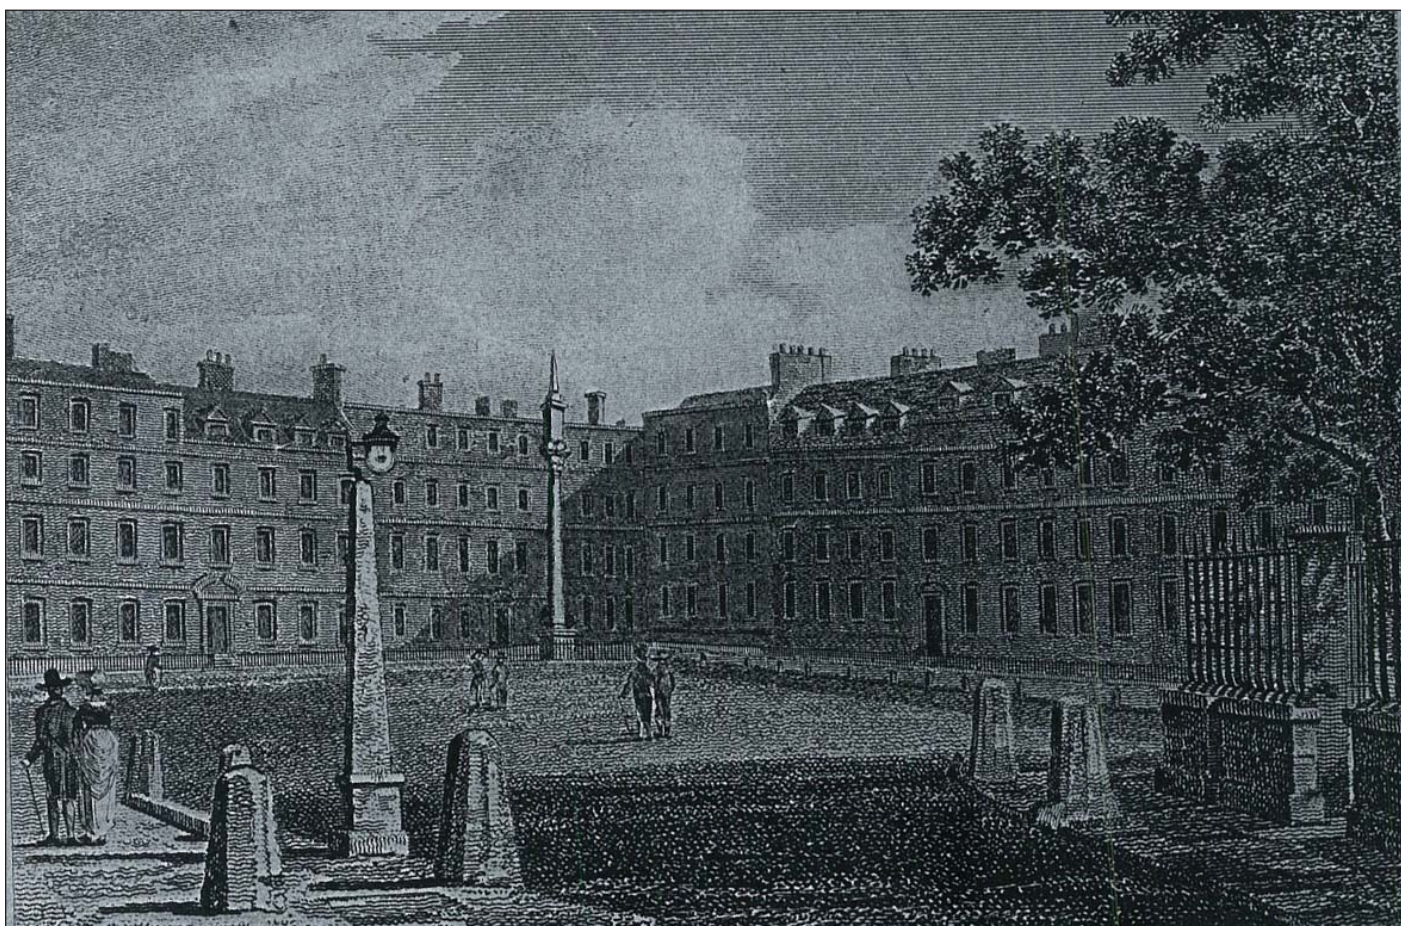
3. New Square c1804.

In 1804, Mary Andrews of Turnstile having twice fallen into an area, and broken first a leg, and then a thigh, directions were given for a lamp to be mounted over the arch of the passage into Serle Street, and for half-gates to be put up at the top of the areas on each side of the passage "in the same manner as the one erected at No. 4 in Serle Court". In 1807 the Society bought the shops in "Serle Passage", leading from the west side of Serle Court into Serle Street, and in 1845 closed it altogether and converted it into Chambers. The Society in 1818 made some alterations to the Serle Gateway, as appears from the tablet designating N.G. Clarke as Treasurer. In 1824 it bought the piece of ground below the Gate, and in 1848 modified it so as to exclude vehicular traffic, as by then the new principal entrance from Lincoln's Inn Fields was available.

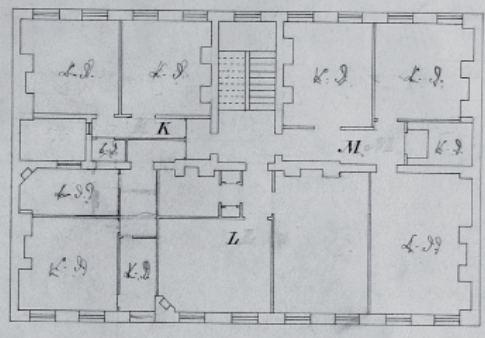
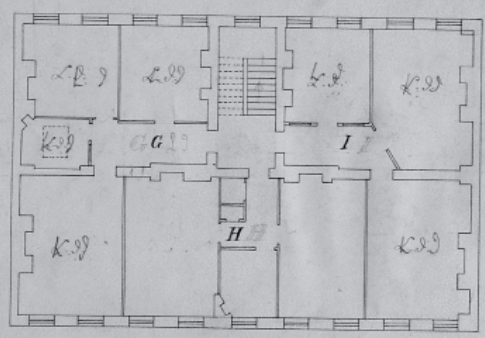
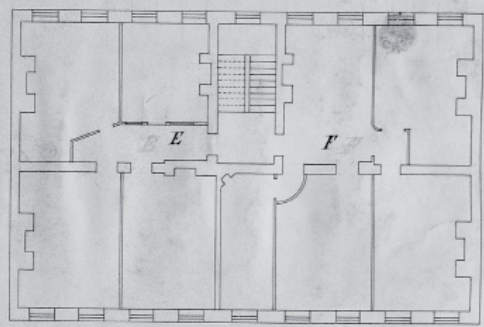
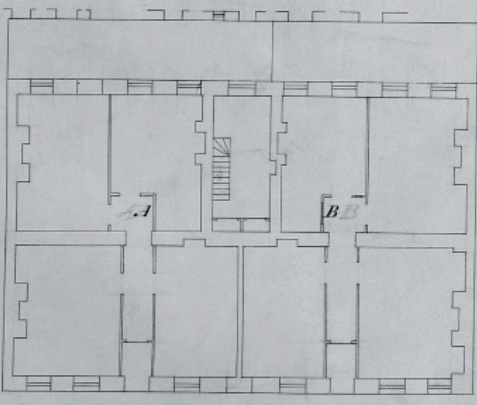
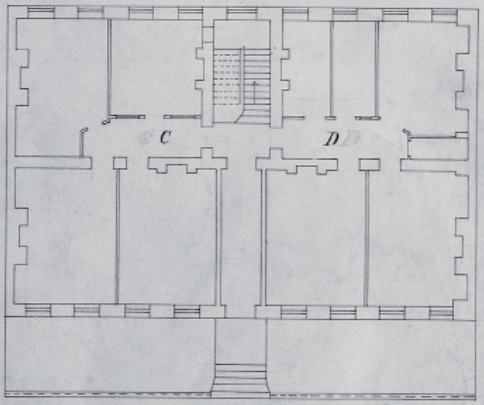
N^o 11

Three Pair Floor

Two Pair Floor

One Pair Floor

Basement

Ground Floor

By 1860 the difficulties of managing and keeping in repair the common roofs, staircases, entrances and areas of the ranges of buildings still officially known as Serle's Court, but endowed by the public with the name of New Square, had become so acute that the Society promoted the Lincoln's Inn Act 1860. The short effect of this Act was to vest all the Chambers built on land which had belonged to Serle in the persons who owned them in 1860, subject to rent charges in favour of the Society to cover paving, lighting and watching charges, and to vest the garden and the rest of the Square in the Society's trustees.

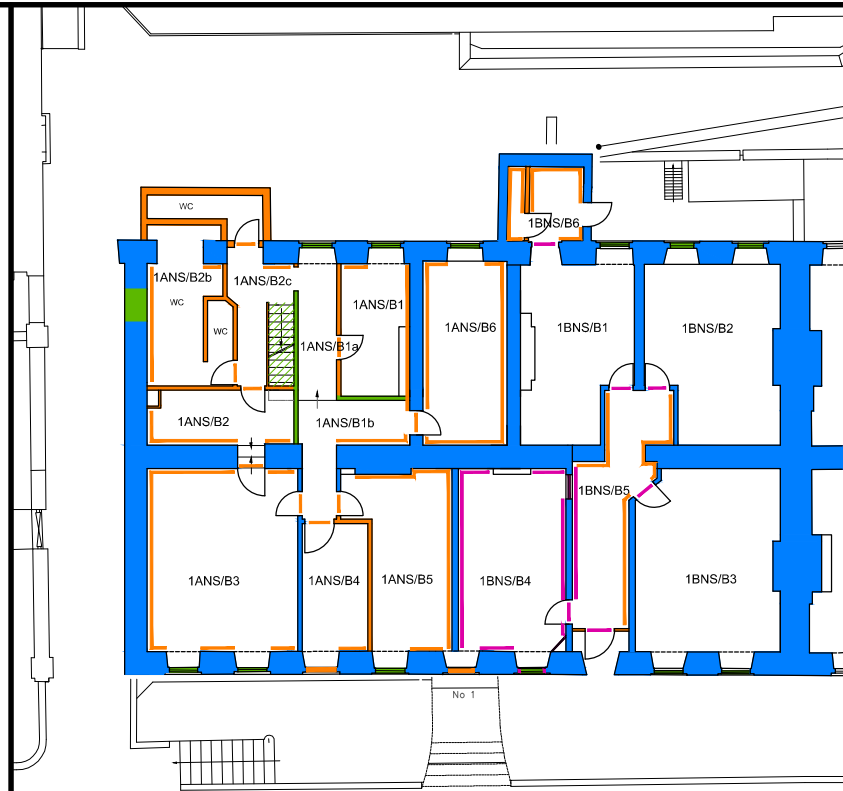
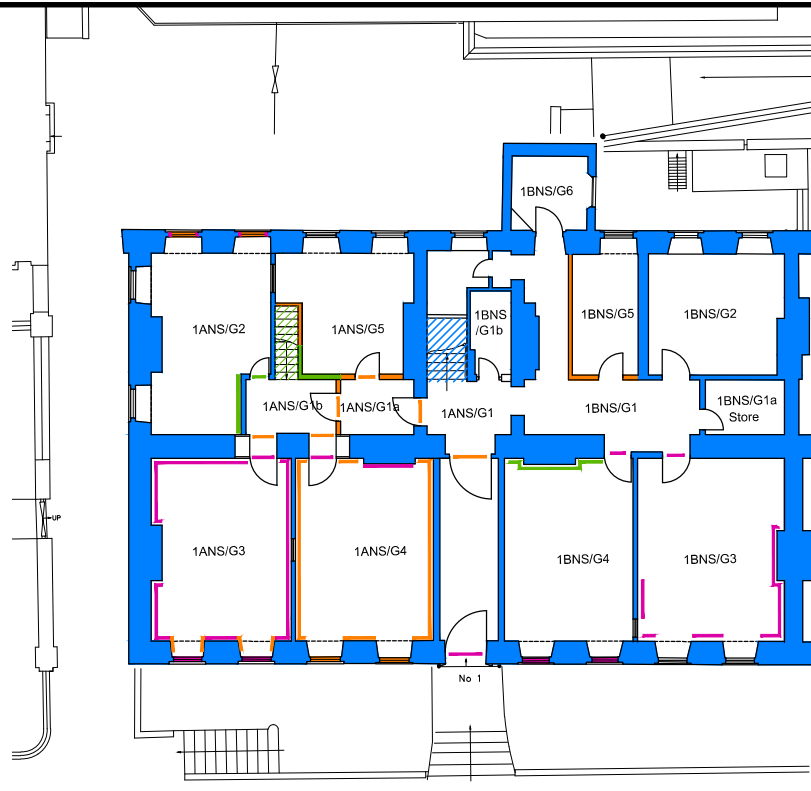
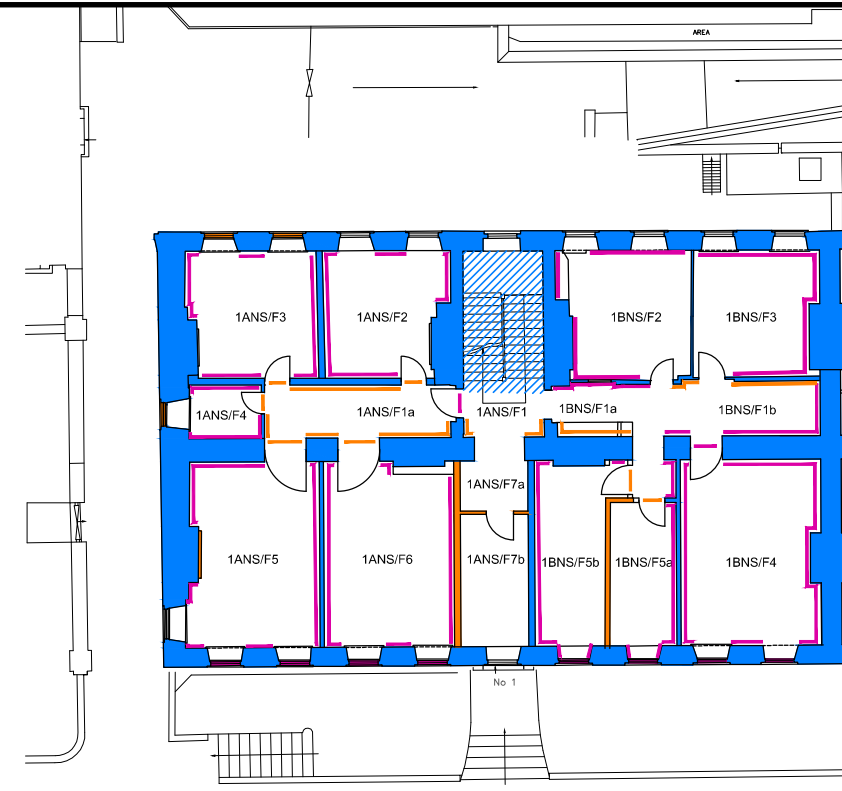
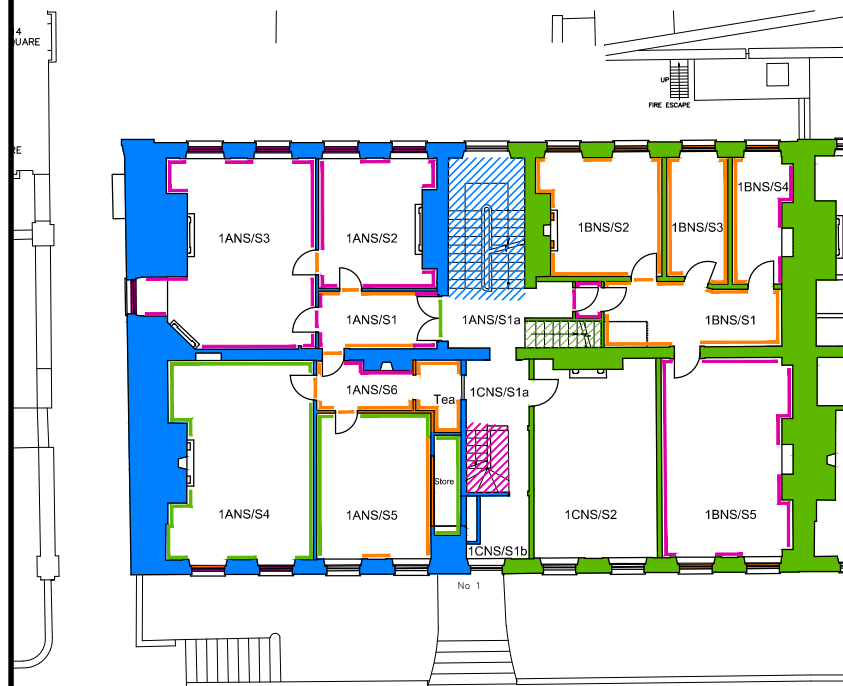
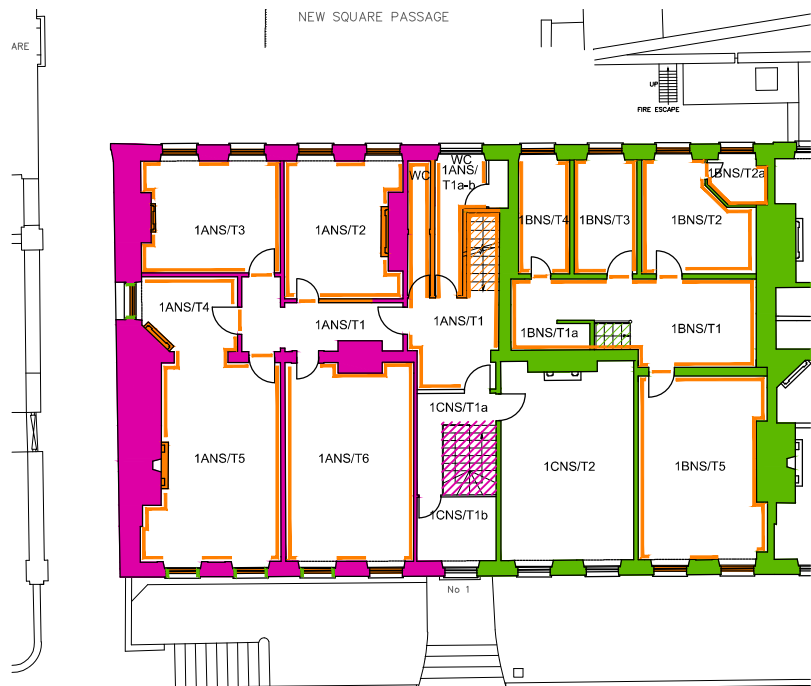
Title No. 1 New Square

Note: Indicative layouts only, for room reference numbers

Basement

Ground Floor

First Floor

Second Floor

Third Floor

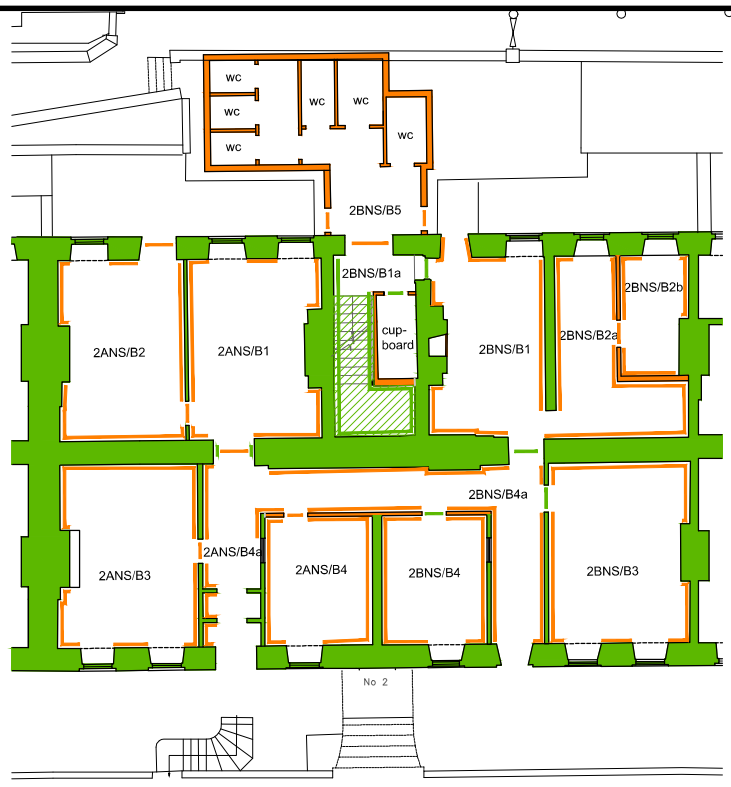
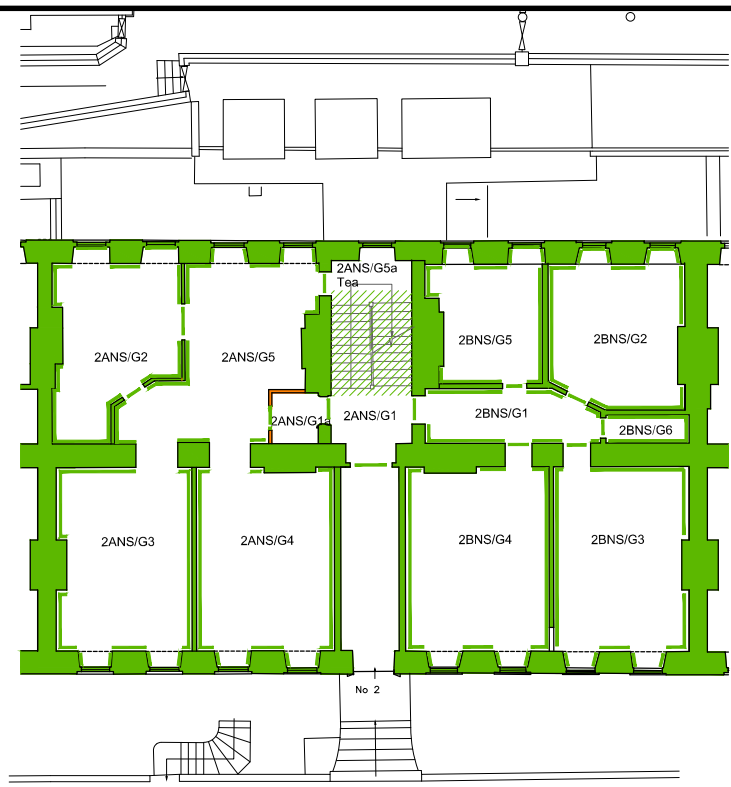
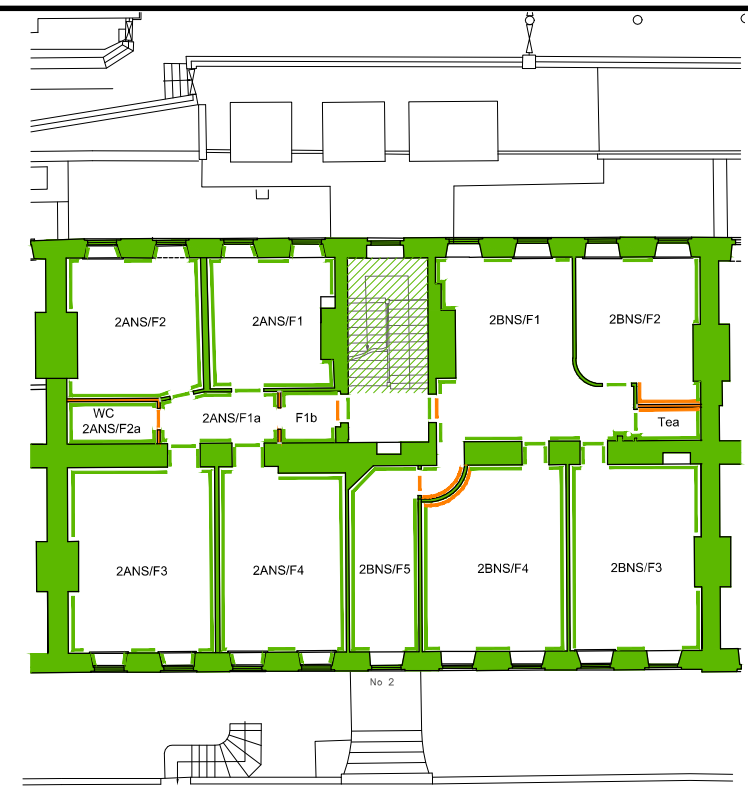
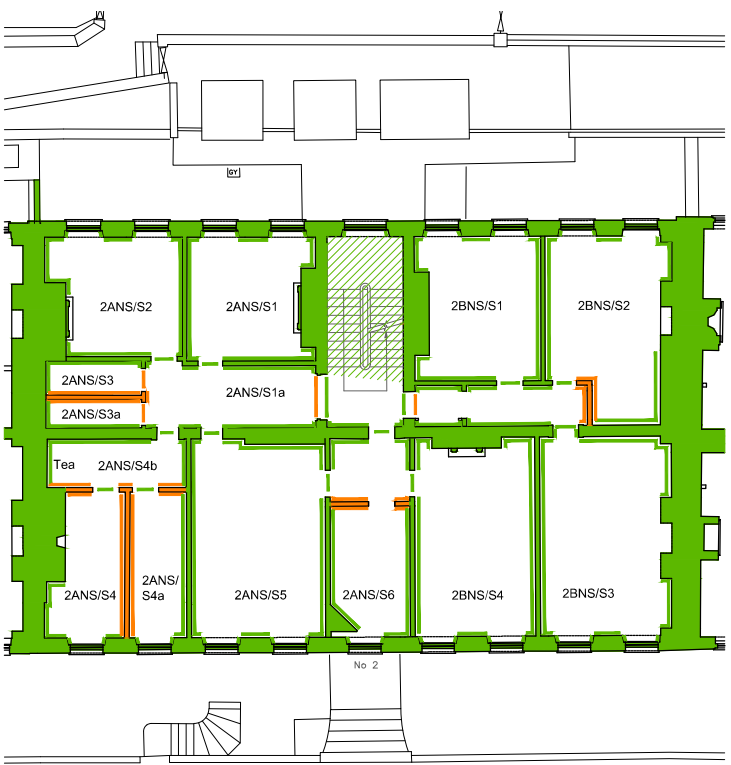
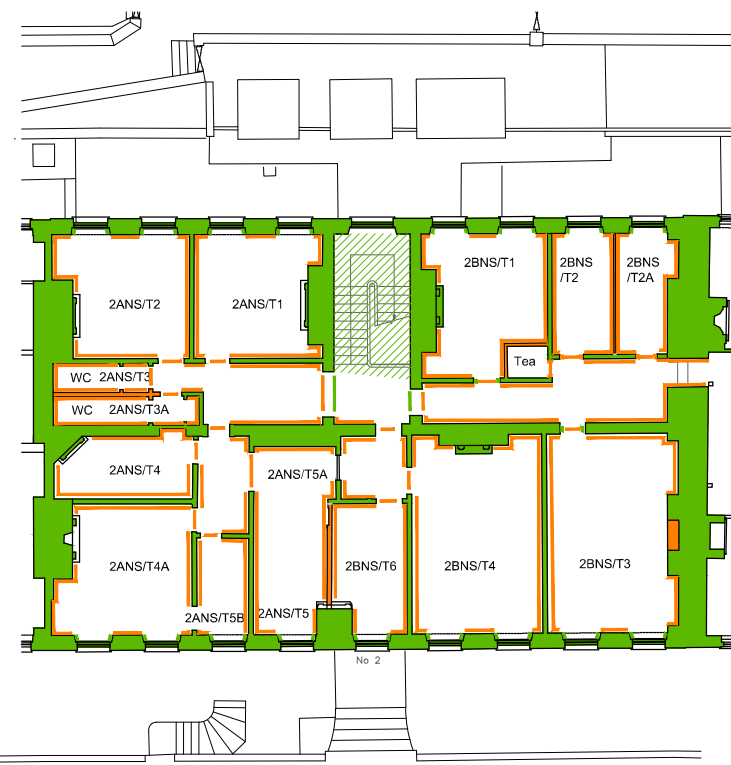
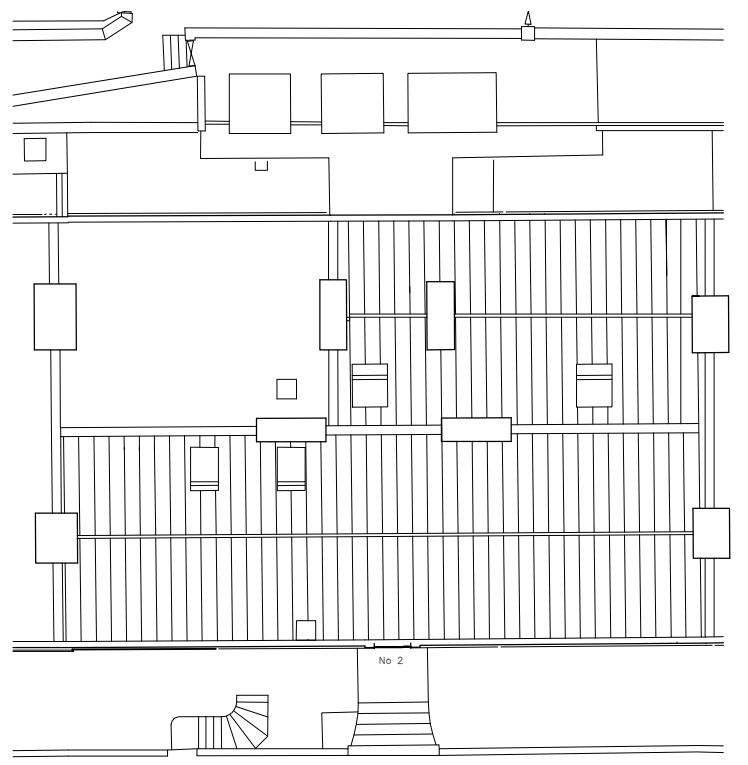
Job	LI.HBA	Status	R
No	1002	Rev	A
Scale (A3)	1:	2	5
		0

Basement

Ground Floor

First Floor

Second Floor

Third Floor

Roof

2 New Square was re-built following a fire. The plan form is as before though the central wooden staircase was replaced with stone.

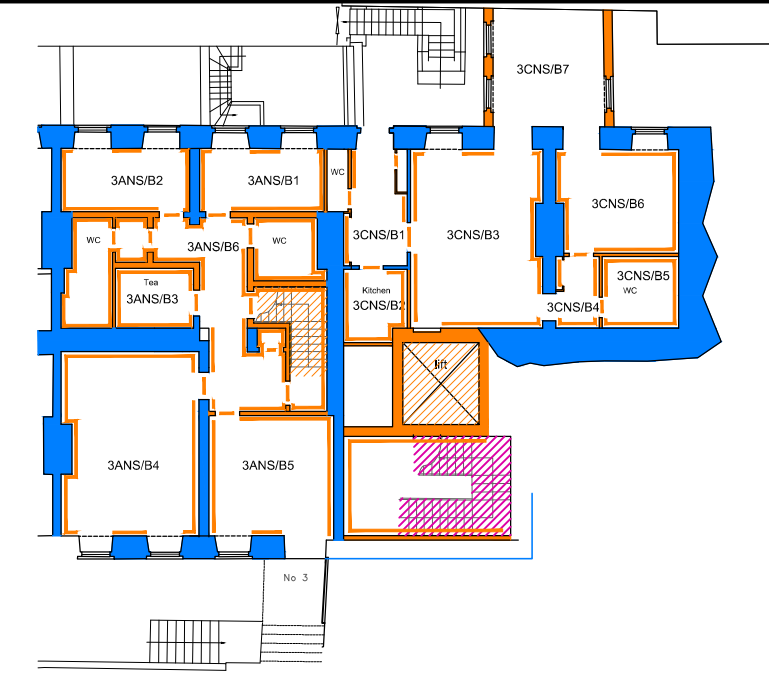
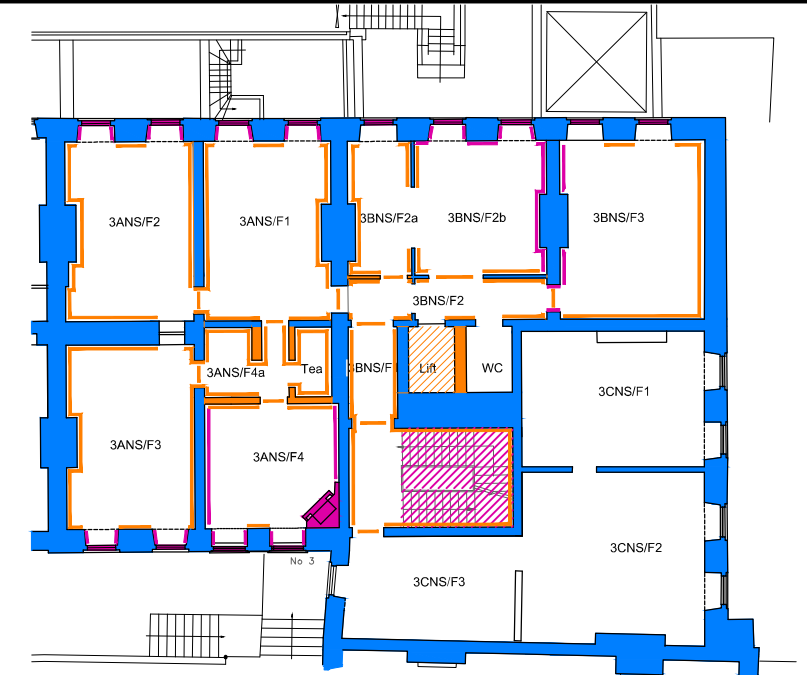
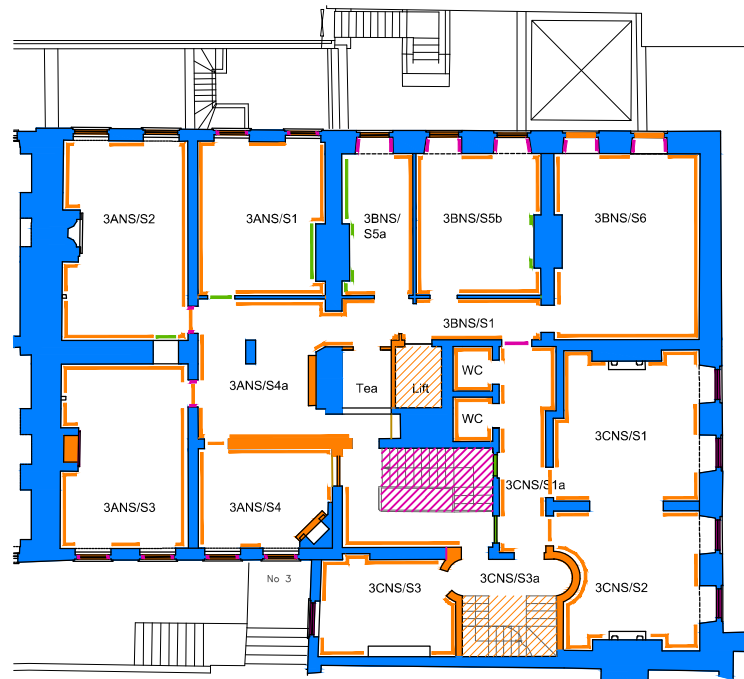
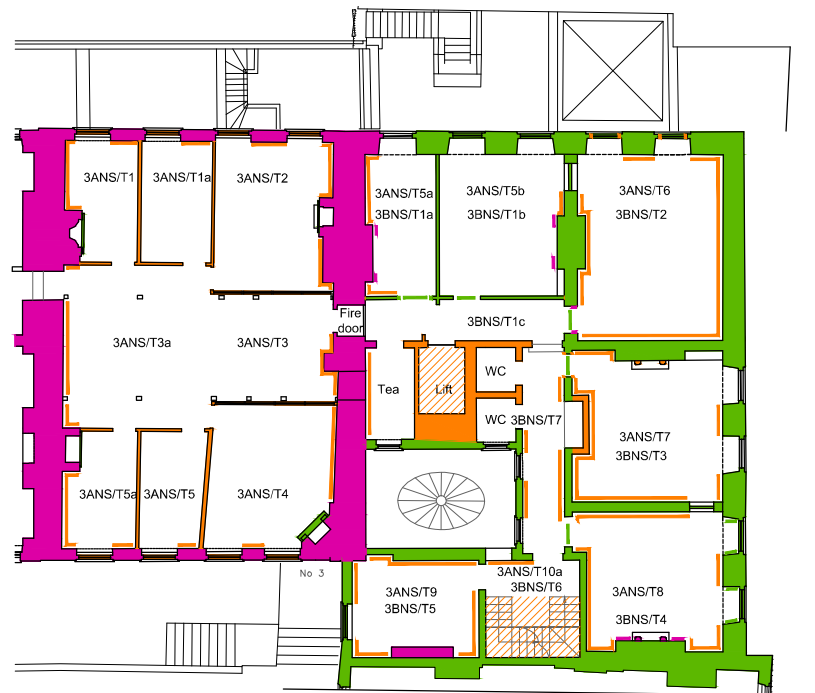
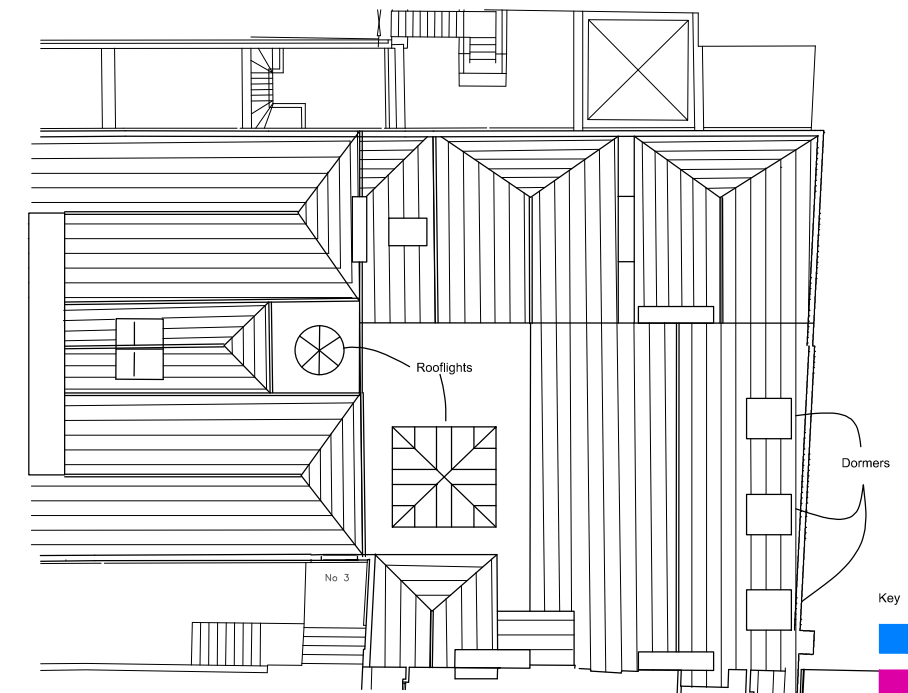
DONALD INSALL ASSOCIATES LIMITED CHARTERED ARCHITECTS
 PLANNING CONSULTANTS
 19 West Eaton Place Eaton Square London SW1X 8LT Tel: 020 7245 9888 Fax: 020 7235 4370 Email: london@insall-architects.co.uk
Job LINCOLN'S INN
Title No. 3 New Square

basement

Ground Floor

First Floor

Second Floor

Third Floor

Roof Plan

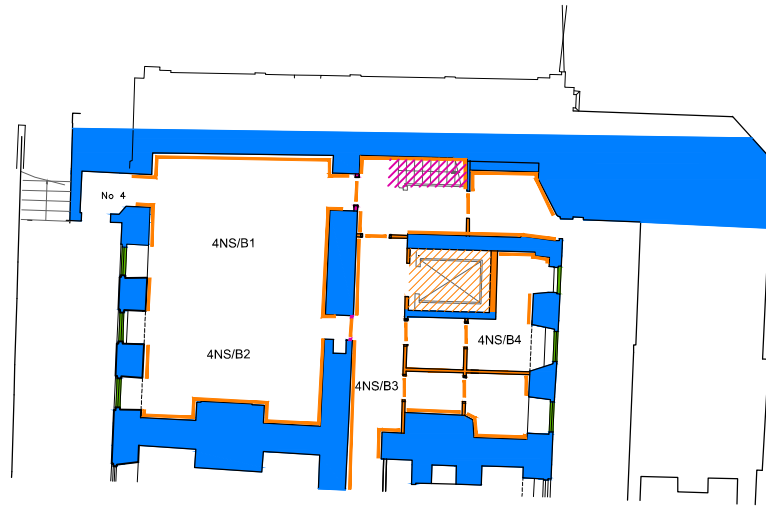
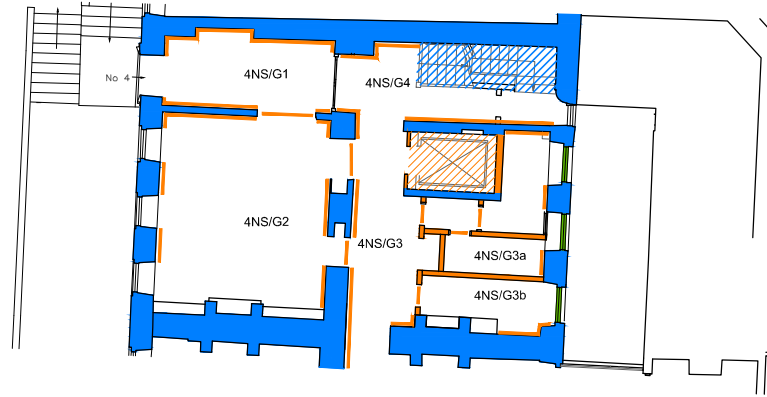
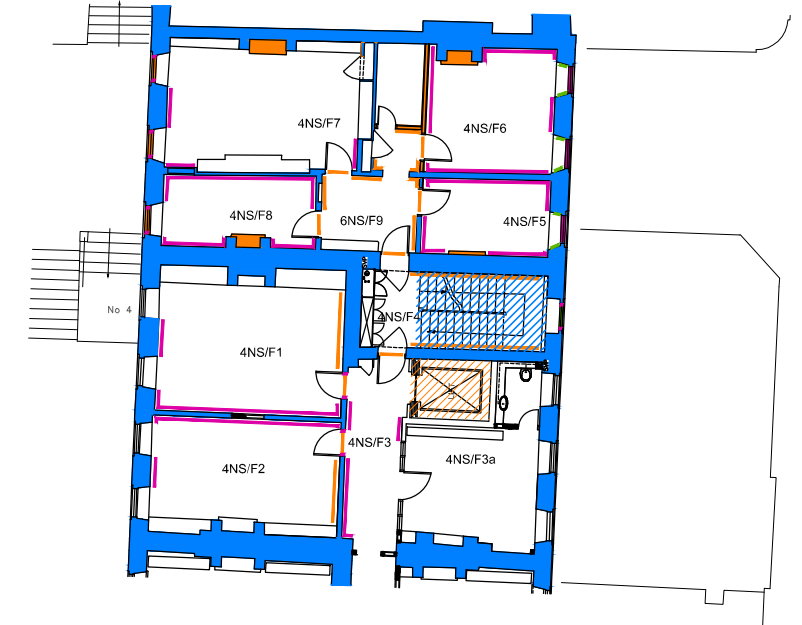
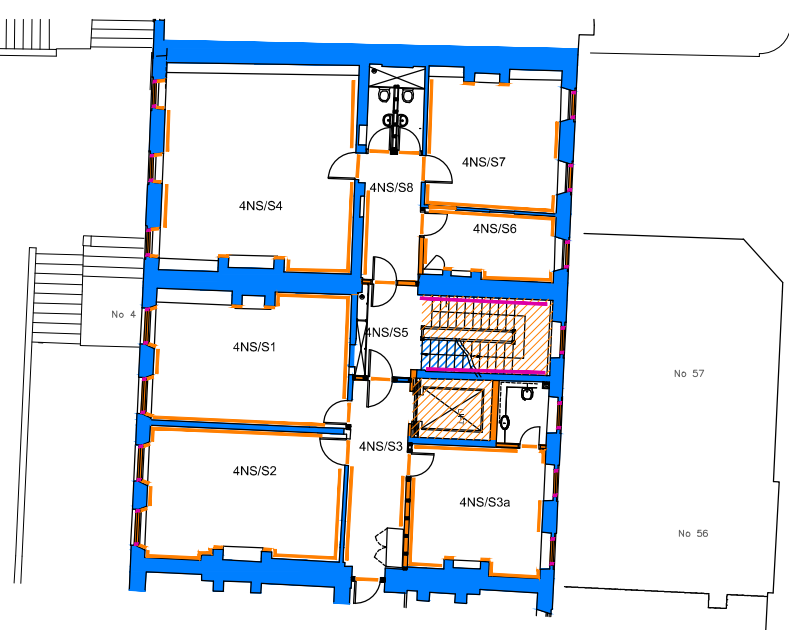
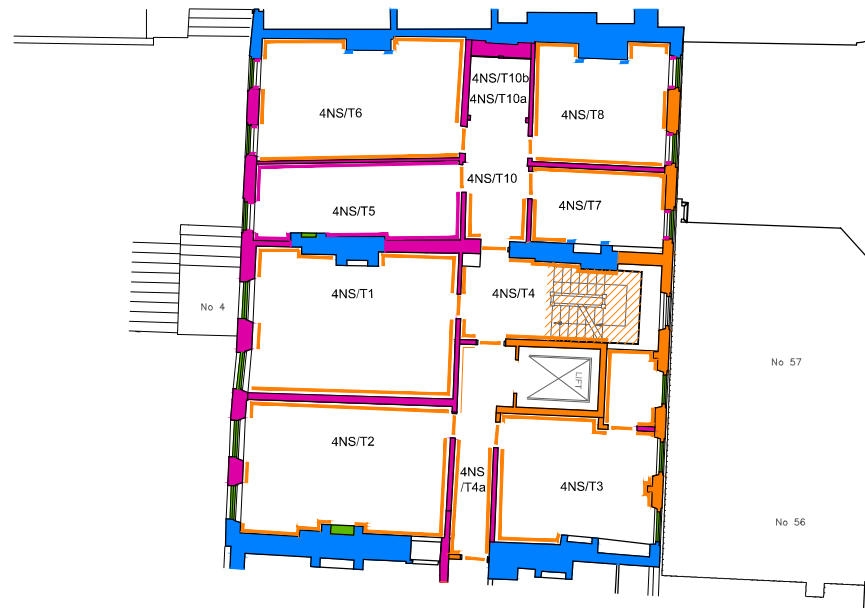
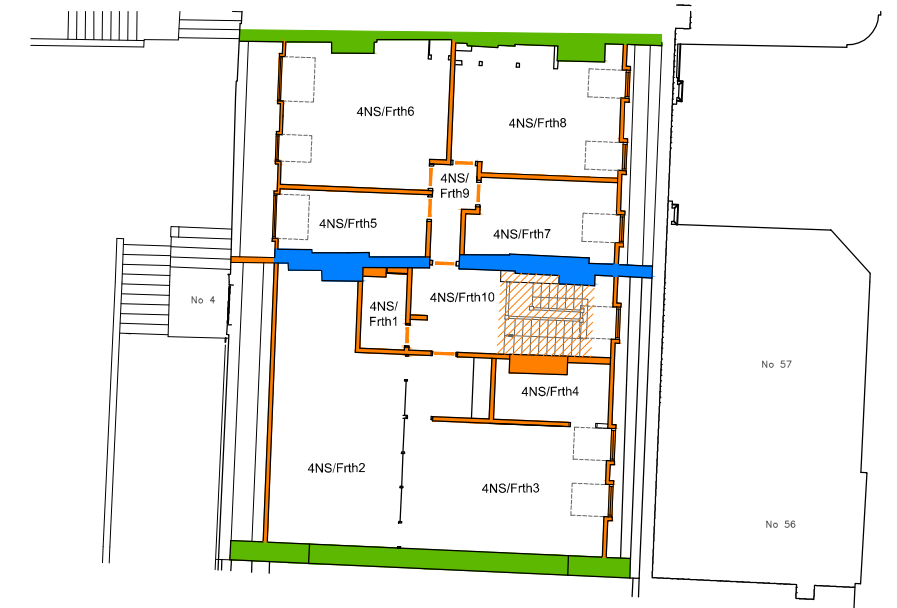
Title No. 4 New Square

Basement

Ground Floor

First Floor

Second Floor

Third Floor

Fourth Floor

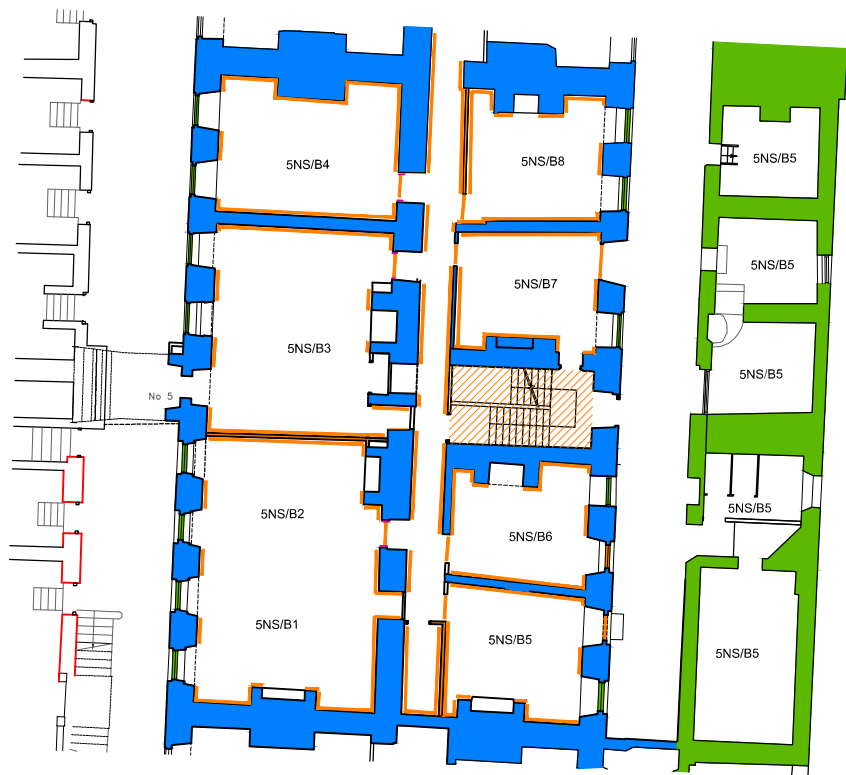
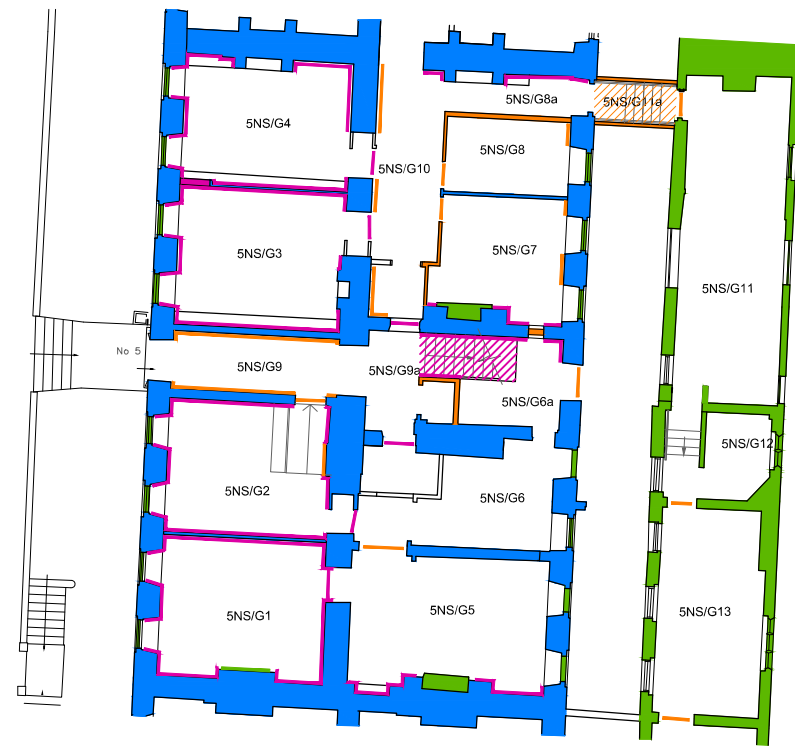
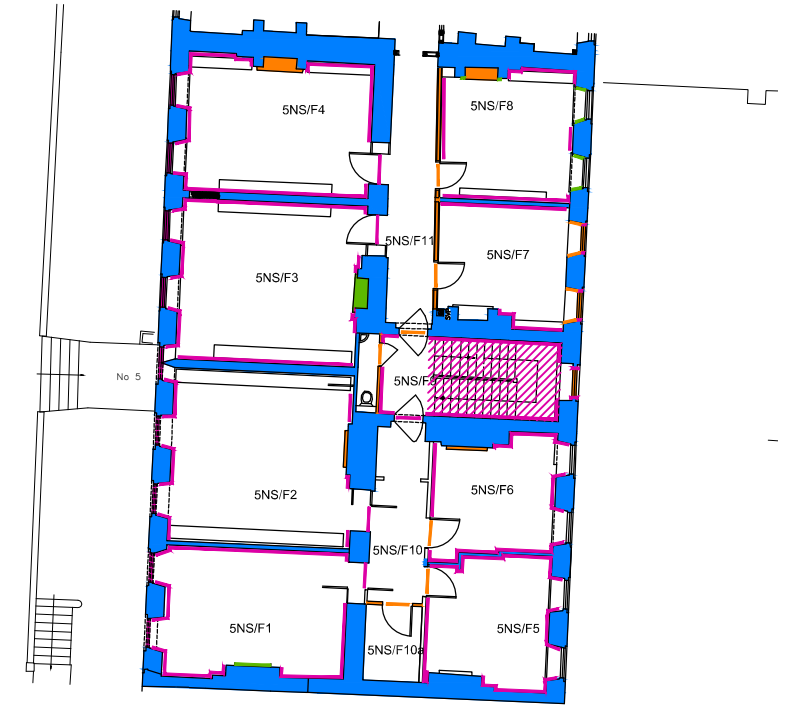
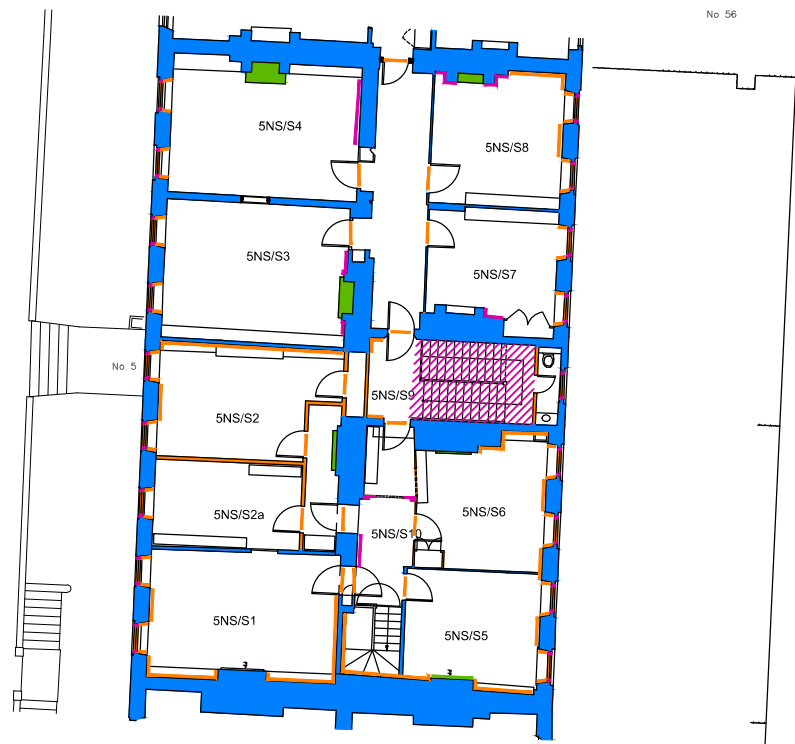
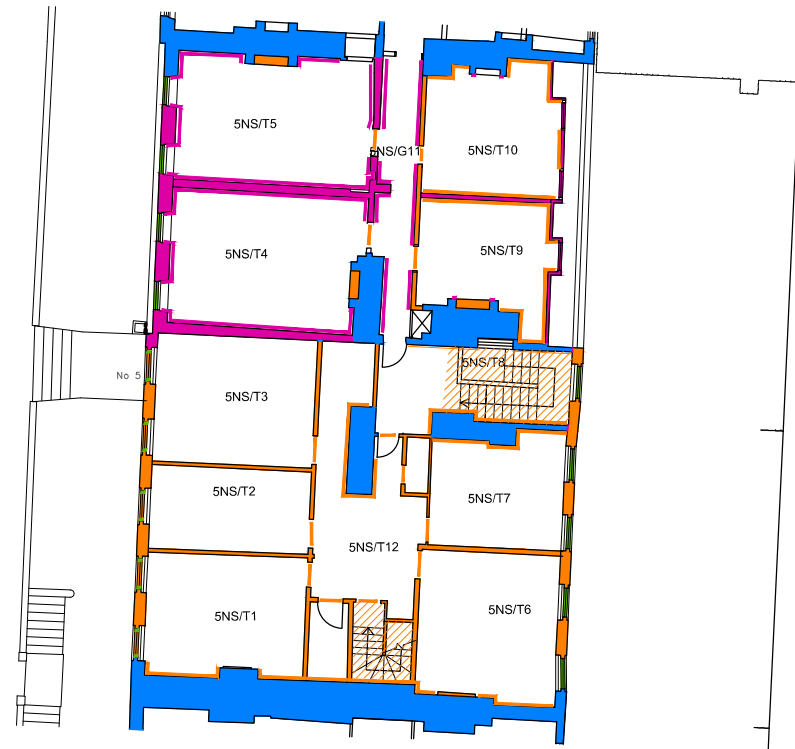
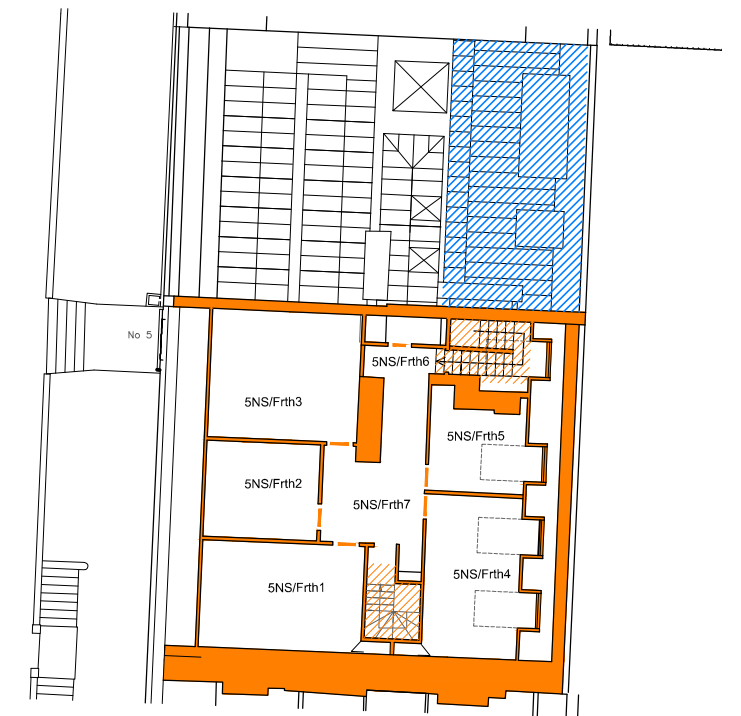
Title No. 5 New Square

Basement

Ground Floor

First Floor

Second Floor

Third Floor

Fourth Floor
