**New Square No.1 1:50**  
Side North Elevation  
PROPOSED

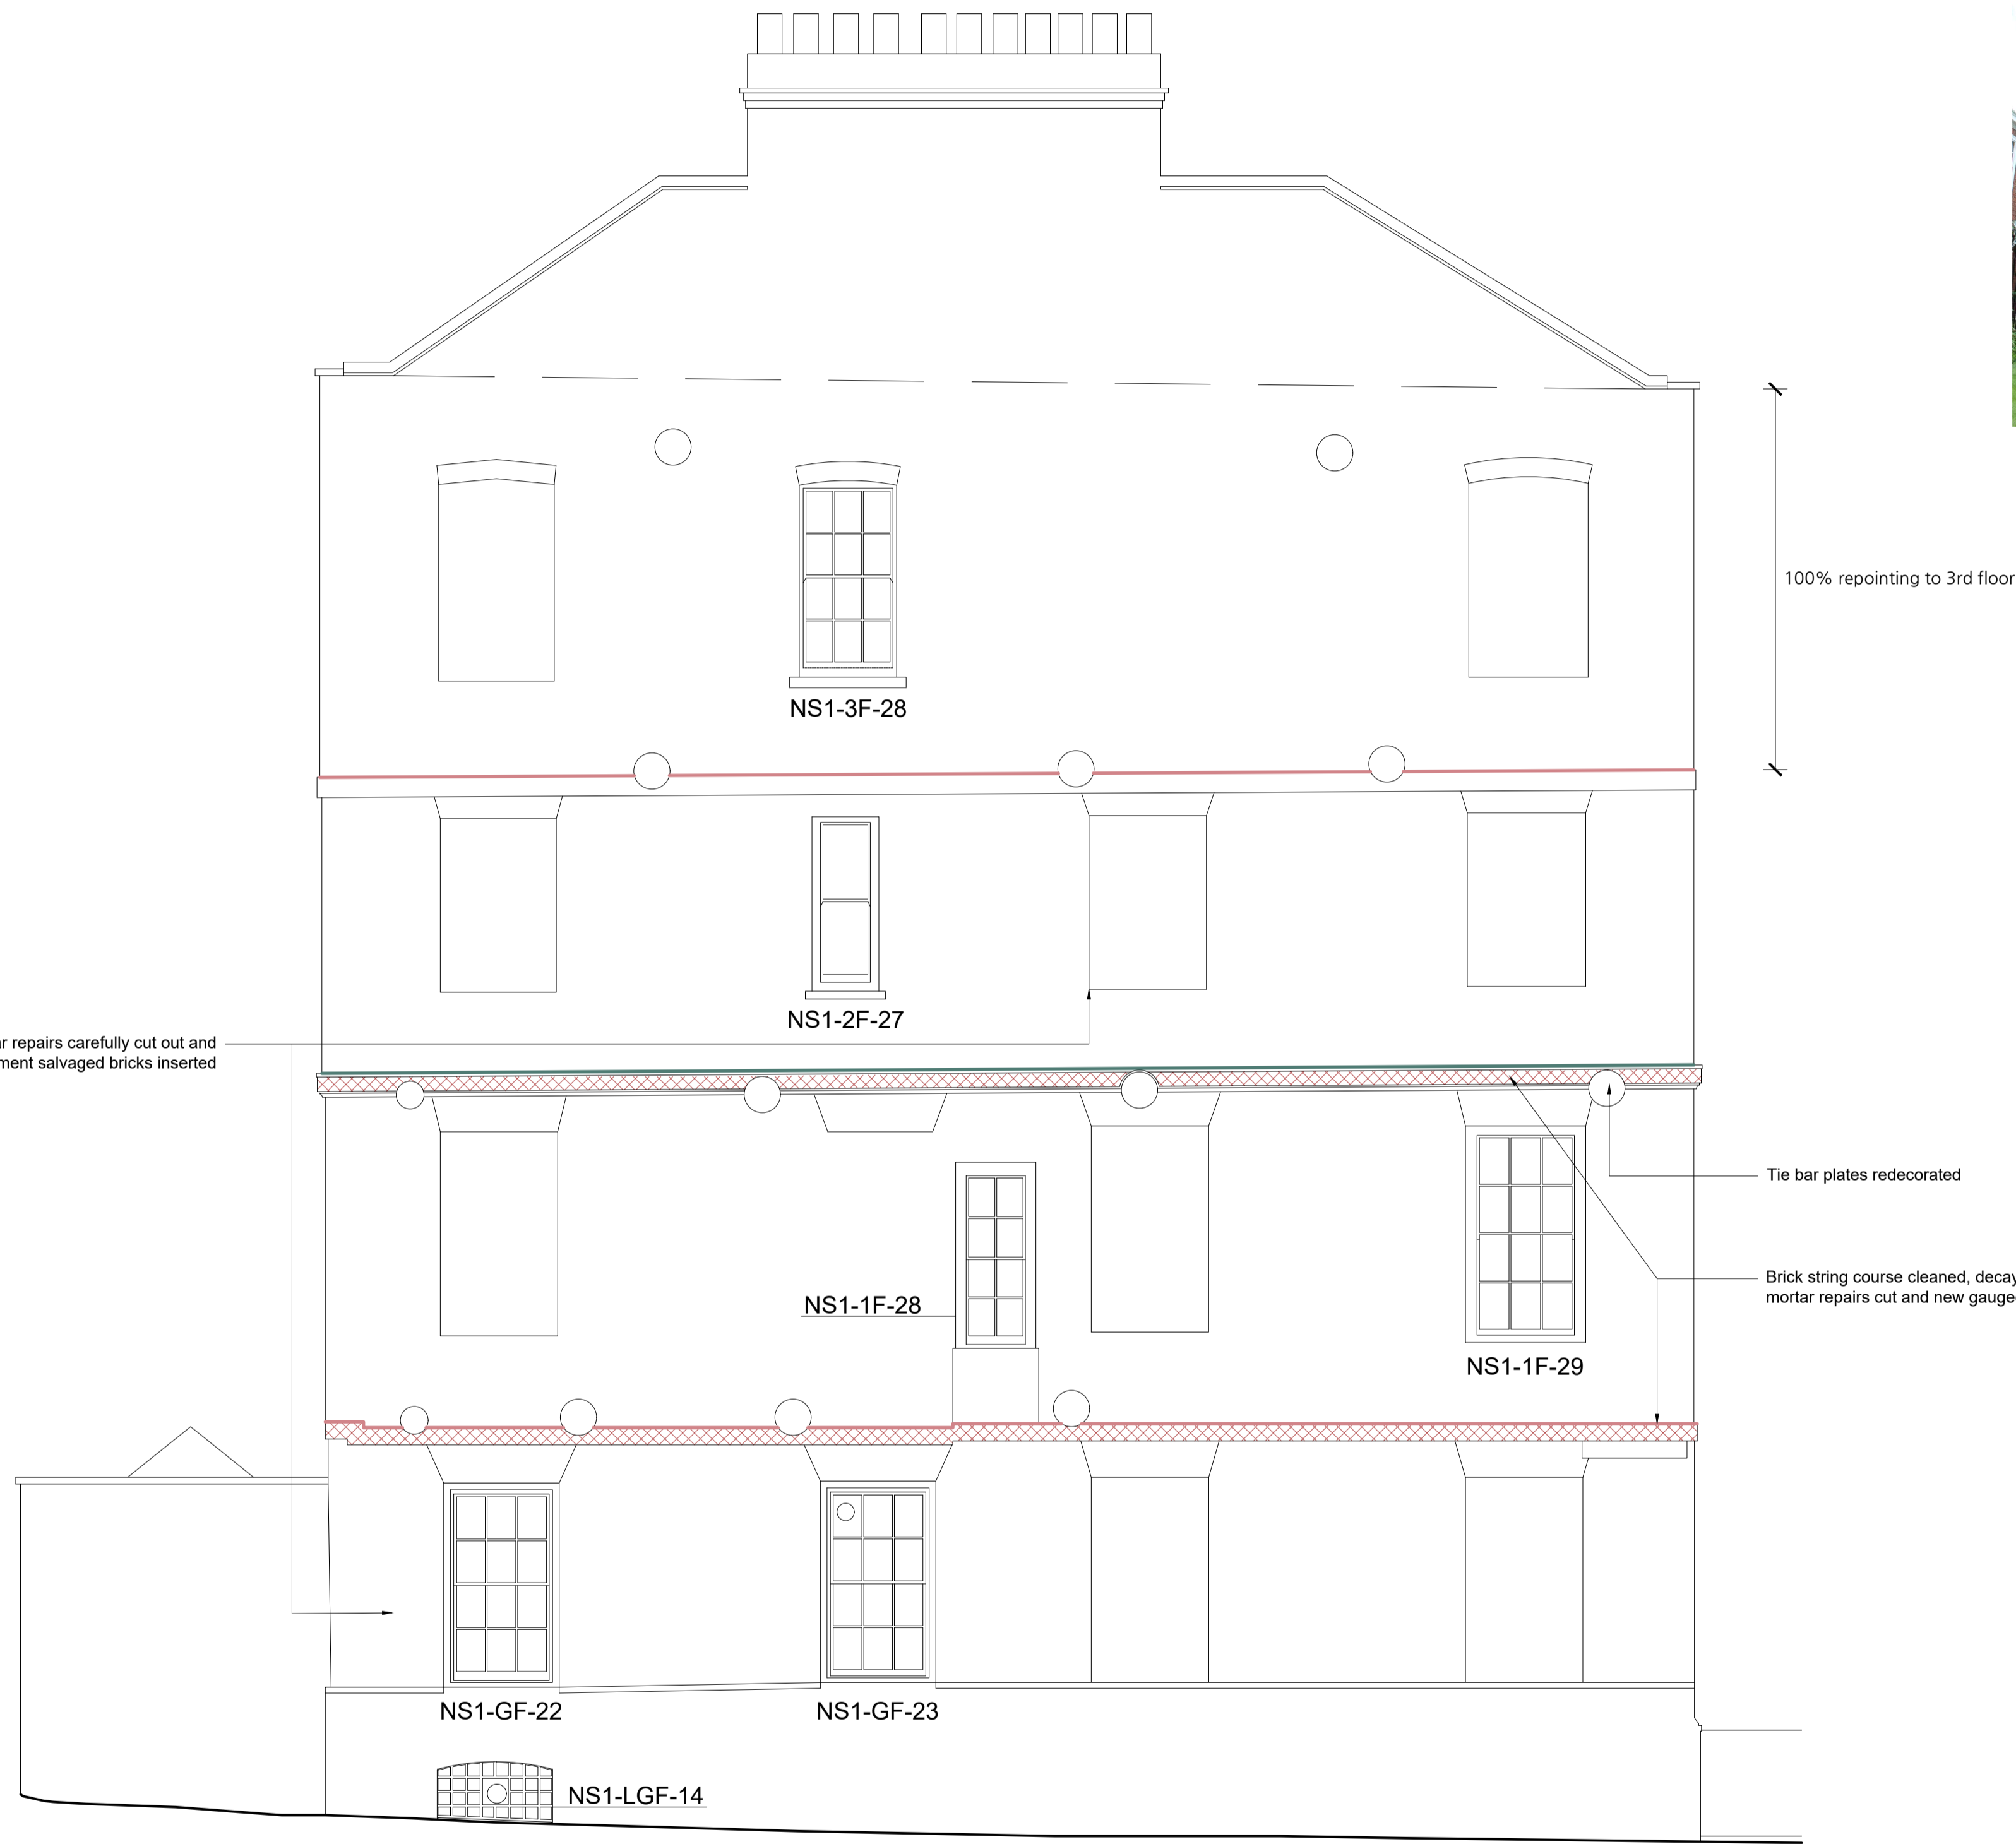
Brickwork is to be repointed where missing or failing. Cement mortars where failing will be replaced with a hydraulic lime mortar (NHL 2.0). Mortar mix to be agreed. Badly damaged or mortar repaired bricks are to be cut out and replaced with salvaged bricks sourced to match the existing. Assume 10% repointing unless described otherwise. All masonry lightly Thermatech cleaned. Air bricks cleaned of paint to maximise ventilation and then redecorated.

Gauged brick string courses  
Thermatech cleaned and badly decayed bricks, inappropriate cement mortar repairs, unstable areas and cement pointing removed.  
Replacement new gauged bricks installed with lime putty pointing.

New lead drip in Code 5 lengths not exceeding 1200mm

Existing lead drip renewed in Code 5 lengths not exceeding 1200mm.

New mortar fillet - NHL 5.0.

All cast-iron and lead downpipes and cast iron soil pipes require redecoration. Colour: Black to match the existing.

Shutters to be overhauled and repaired with scarf repairs. Racked shutters to be dismantled and reglued. All joinery to be thoroughly prepared and redecorated. New lead cover flashing to top rail.

Fractured and badly decayed gauged brickwork or mortar repairs to window heads to be cut out and replaced on a brick-by-brick basis. Washed out joints repointed with a non-hydraulic lime putty.

Stone window cills Thermatech cleaned and where necessary poulticed to remove extensive deposits. Mortar repairs to localised damage. All windows overhauled with scarf joinery repairs to decayed sections. Putty replaced where missing, detaching or cracked. All joinery redecorated. Draught-proofing seals and strips surface fixed to the existing windows.

New stone cills or indent repairs to stone cills.

New tiled cills.

All railings to Areas, bridges and steps to be rubbed down and repainted. Decayed ends opened up, painted and releaded. Localised damaged stonework to the bridge and plinths require a combination of pieced-in or mortar repairs. Open joints between paving slabs and steps to be repointed (NHL 5.0).

Basement Areas - Paving lifted and relaid to falls to existing channels and gully positions. New stone sourced to match existing when badly fractured or missing.

French Drain installed immediately in front of the building at basement level and concealed beneath the paving.

Basement Area walls - Decayed bricks and cement mortar repairs are to be repaired with salvaged bricks to match the originals. Wall surfaces cleaned of loose paint and relime-washed. Scarf repairs to existing doors and redecoration.
