New Square No.2 1:50 Rear East Elevation PROPOSED

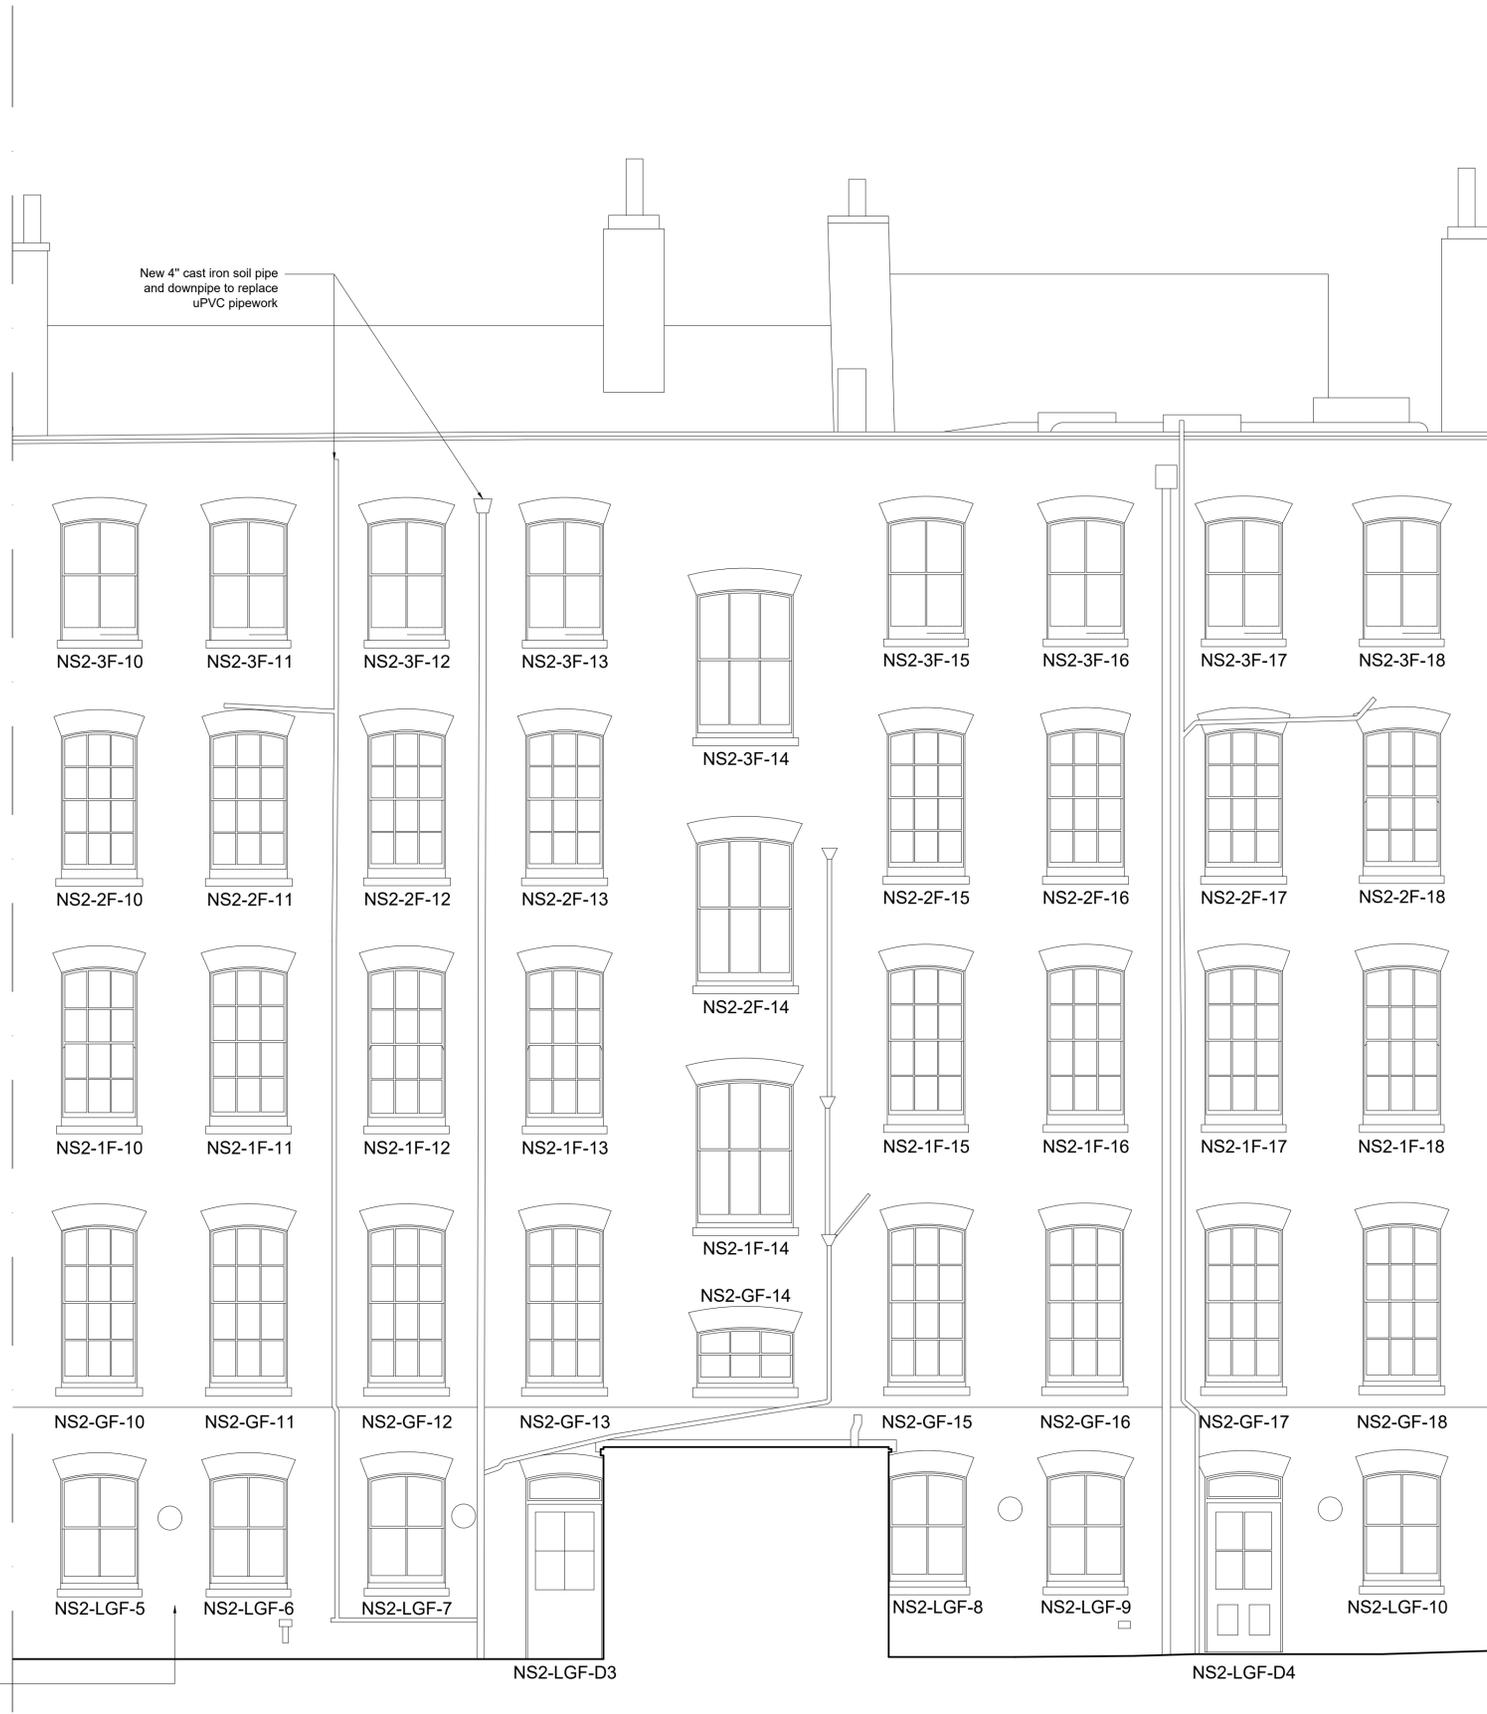
Brickwork is to be repointed where missing or falling. Cement mortars where failing will be replaced with a hydraulic lime mortar (NHL 2.0). Mortar mix to be agreed. Badly damaged or mortar repaired bricks are to be cut out and replaced with salvaged bricks sourced to match the existing. Assume 10% repointing unless described otherwise. All masonry lightly Thermatech cleaned. Air bricks cleaned of paint to maximise ventilation and then redecorated.

Gauged brick string courses
Thermatech cleaned and badly decayed bricks, inappropriate cement mortar repairs, unstable areas and cement pointing removed.
Replacement new gauged bricks installed with lime putty pointing.

New lead drip in Code 5 lengths not exceeding 1200mm

Existing lead drip renewed in Code 5 lengths not exceeding 1200mm.

New mortar fillet - NHL 5.0.

All cast-iron and lead downpipes and cast iron soil pipes require redecoration. Colour: Black to match the existing.

Shutters to be overhauled and repaired with scarf repairs. Racked shutters to be dismantled and reglued. All joinery to be thoroughly prepared and redecorated. New lead cover flashing to top rail.

Fractured and badly decayed gauged brickwork or mortar repairs to window heads to be cut out and replaced on a brick-by-brick basis. Washed out joints repointed with a non-hydraulic lime putty.

Stone window cills Thermatech cleaned and where necessary poulticed to remove extensive deposits. Mortar repairs to localised damage. All windows overhauled with scarf joinery repairs to decayed sections. Putty replaced where missing, detaching or cracked. All joinery redecorated. Draught-proofing seals and strips surface fixed to the existing windows.

New stone cills or indent repairs to stone cills.

New tiled cills.

All railings to Areas, bridges and steps to be rubbed down and repainted. Decayed ends opened up, painted and releaded. Localised damaged stonework to the bridge and plinths require a combination of pieced-in or mortar repairs. Open joints between paving slabs and steps to be repointed (NHL 5.0).

Basement Areas - Paving lifted and relaid to falls to existing channels and gully positions. New stone sourced to match existing when badly fractured or missing.

French Drain installed immediately in front of the building at basement level and concealed beneath the paving.

Basement Area walls - Decayed bricks and cement mortar repairs are to be repaired with salvaged bricks to match the originals. Wall surfaces cleaned of loose paint and relimewashed. Scarf repairs to existing doors and redecoration.

Basement level walls painted with Keim Soldalit or limewash if currently limewashed
