**New Square No.3 1:50**  
Rear East Elevation  
PROPOSED

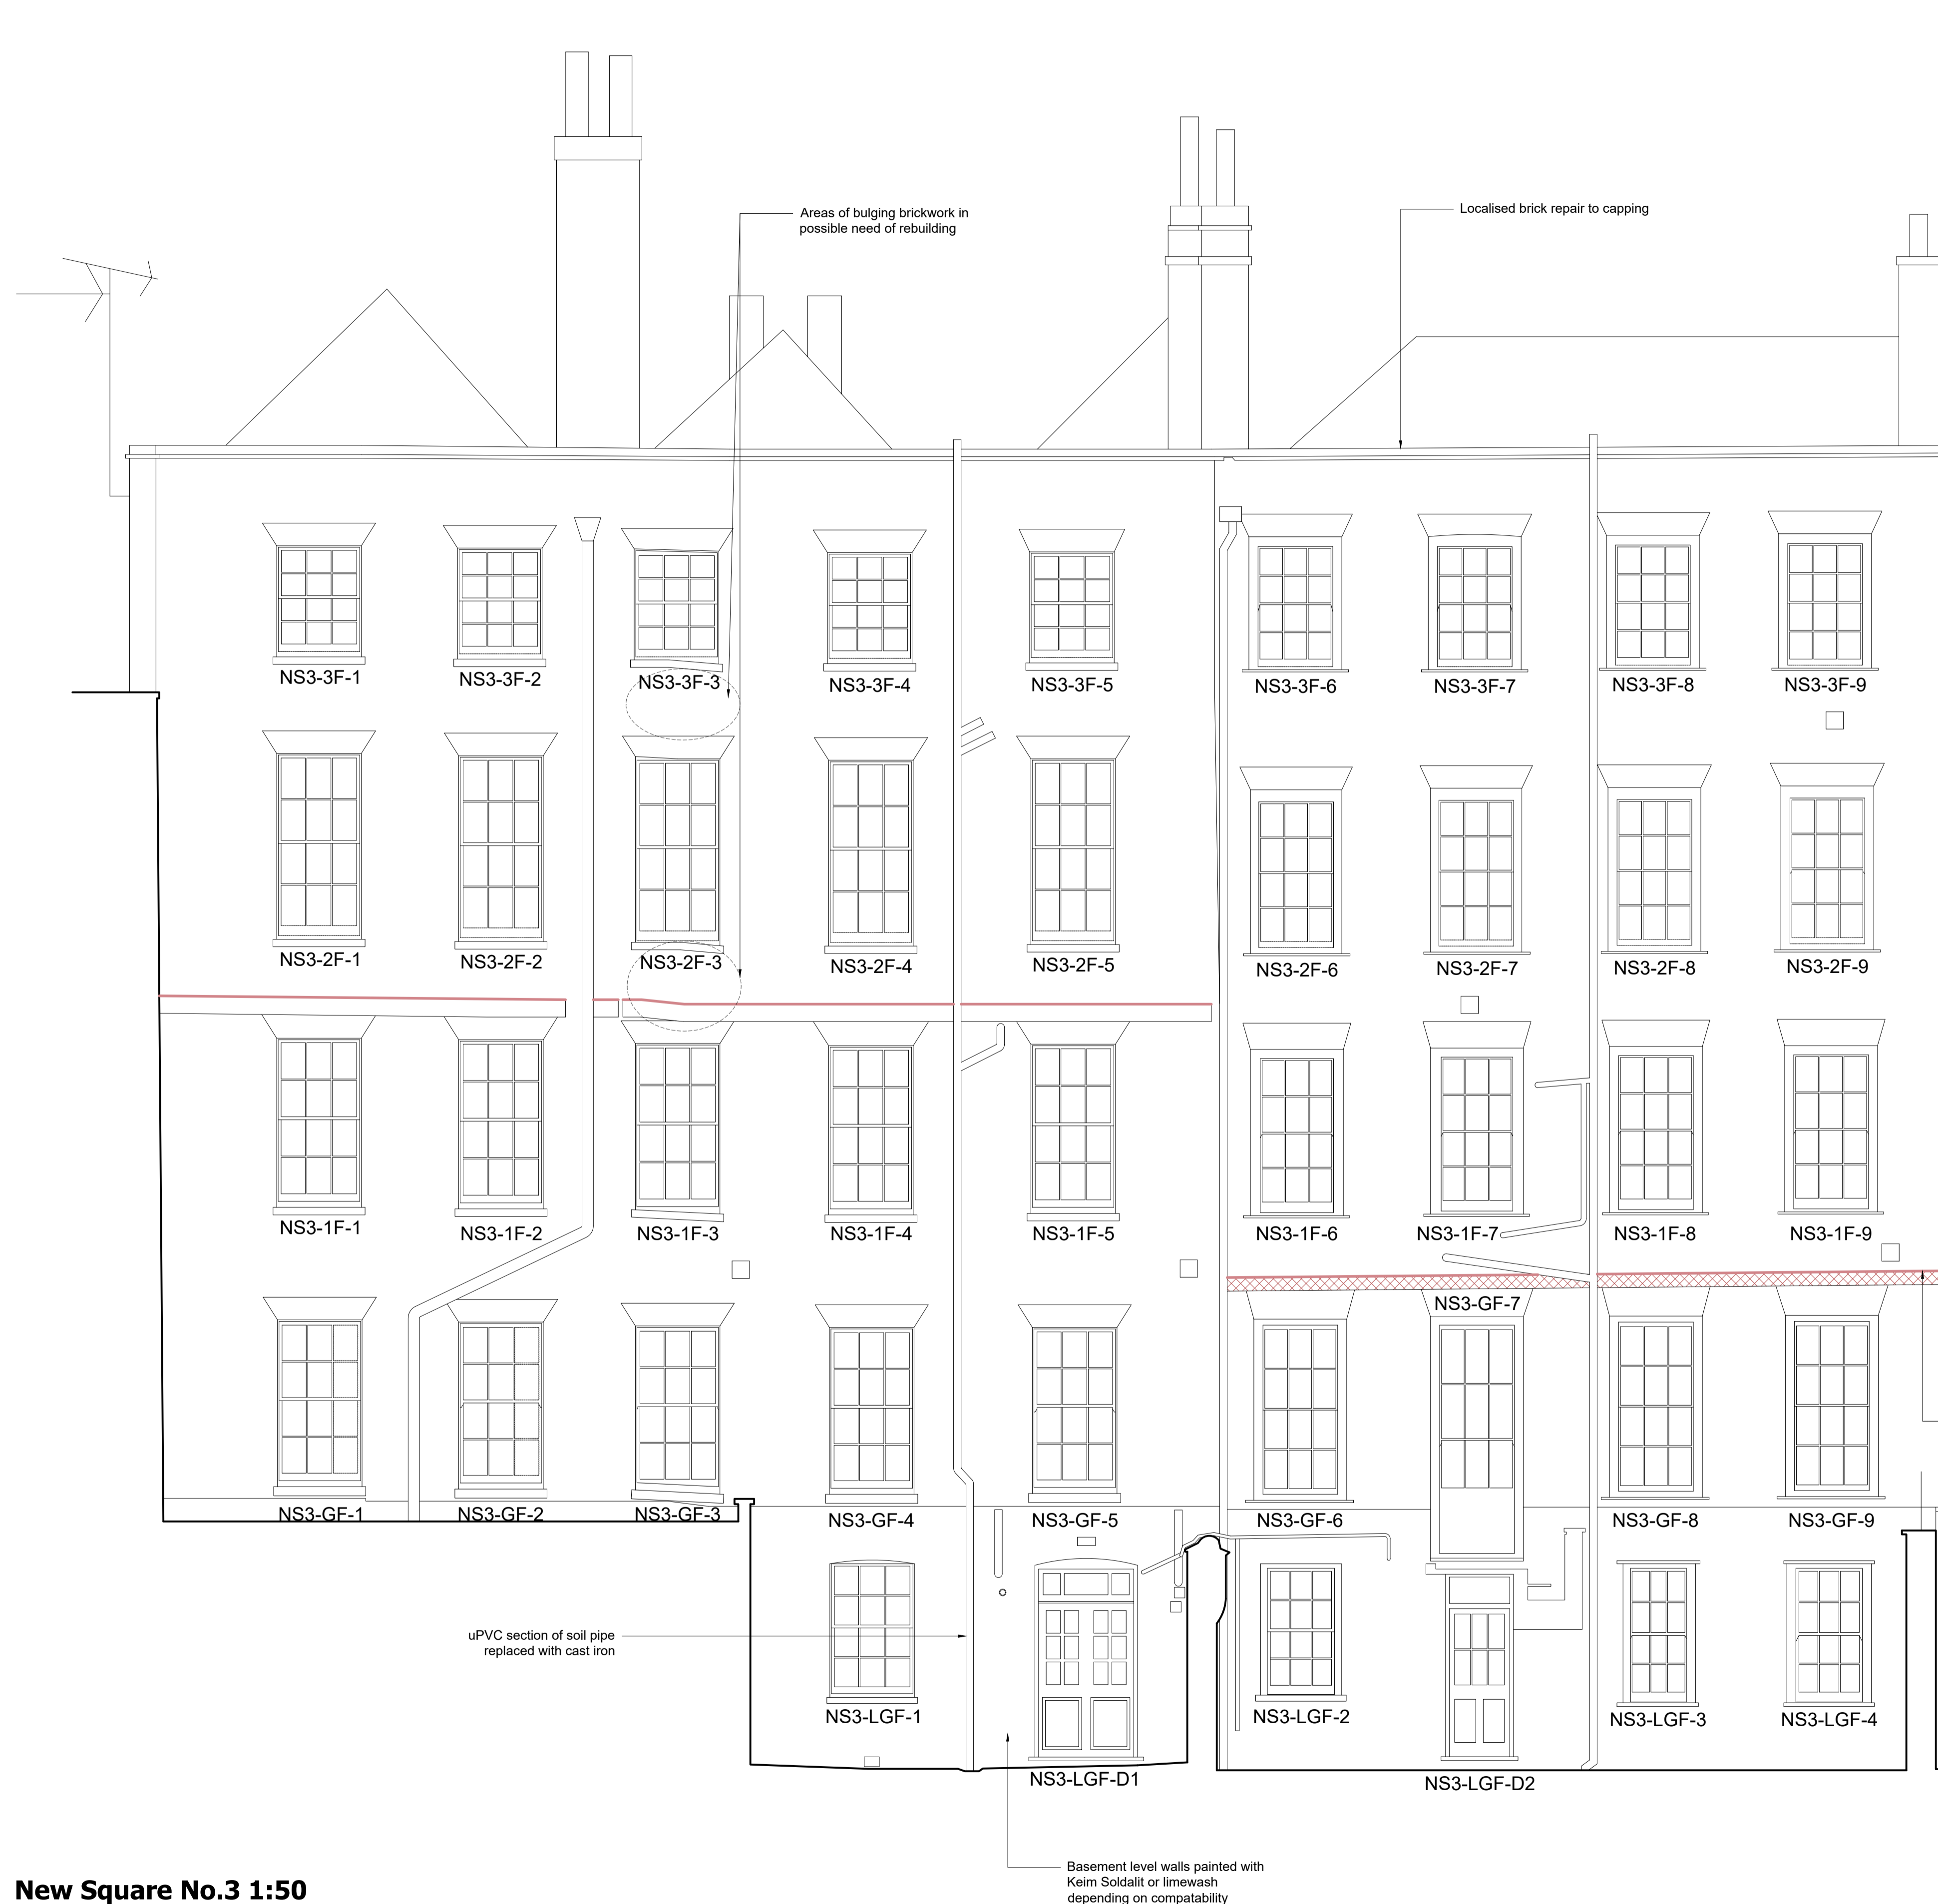
Brickwork is to be repointed where missing or falling. Cement mortars where failing will be replaced with a hydraulic lime mortar (NHL 2.0). Mortar mix to be agreed. Badly damaged or mortar repaired bricks are to be cut out and replaced with salvaged bricks sourced to match the existing. Assume 10% repointing unless described otherwise. All masonry lightly Thermatech cleaned. Air bricks cleaned of paint to maximise ventilation and then redecorated.

Gauged brick string courses  
Thermatech cleaned and badly decayed bricks, inappropriate cement mortar repairs, unstable areas and cement pointing removed.  
Replacement new gauged bricks installed with lime putty pointing.

New lead drip in Code 5 lengths not exceeding 1200mm

Existing lead drip renewed in Code 5 lengths not exceeding 1200mm.

New mortar fillet - NHL 5.0.

All cast-iron and lead downpipes and cast iron soil pipes require redecoration. Colour: Black to match the existing.

Shutters to be overhauled and repaired with scarf repairs. Racked shutters to be dismantled and reglued. All joinery to be thoroughly prepared and redecorated. New lead cover flashing to top rail.

Fractured and badly decayed gauged brickwork or mortar repairs to window heads to be cut out and replaced on a brick-by-brick basis. Washed out joints repointed with a non-hydraulic lime putty.

Stone window cills Thermatech cleaned and where necessary poulticed to remove extensive deposits. Mortar repairs to localised damage. All windows overhauled with scarf joinery repairs to decayed sections. Putty replaced where missing, detaching or cracked. All joinery redecorated. Draught-proofing seals and strips surface fixed to the existing windows.

New stone cills or indent repairs to stone cills.

New tiled cills.

All railings to Areas, bridges and steps to be rubbed down and repainted. Decayed ends opened up, painted and releaded. Localised damaged stonework to the bridge and plinths require a combination of pieced-in or mortar repairs. Open joints between paving slabs and steps to be repointed (NHL 5.0).

Basement Areas - Paving lifted and relaid to falls to existing channels and gully positions. New stone sourced to match existing when badly fractured or missing.

French Drain installed immediately in front of the building at basement level and concealed beneath the paving.

Basement Area walls - Decayed bricks and cement mortar repairs are to be repaired with salvaged bricks to match the originals. Wall surfaces cleaned of loose paint and relime washed. Scarf repairs to existing doors and redecoration.
