New Square No.5 1:50
Rear South Elevation PROPOSED

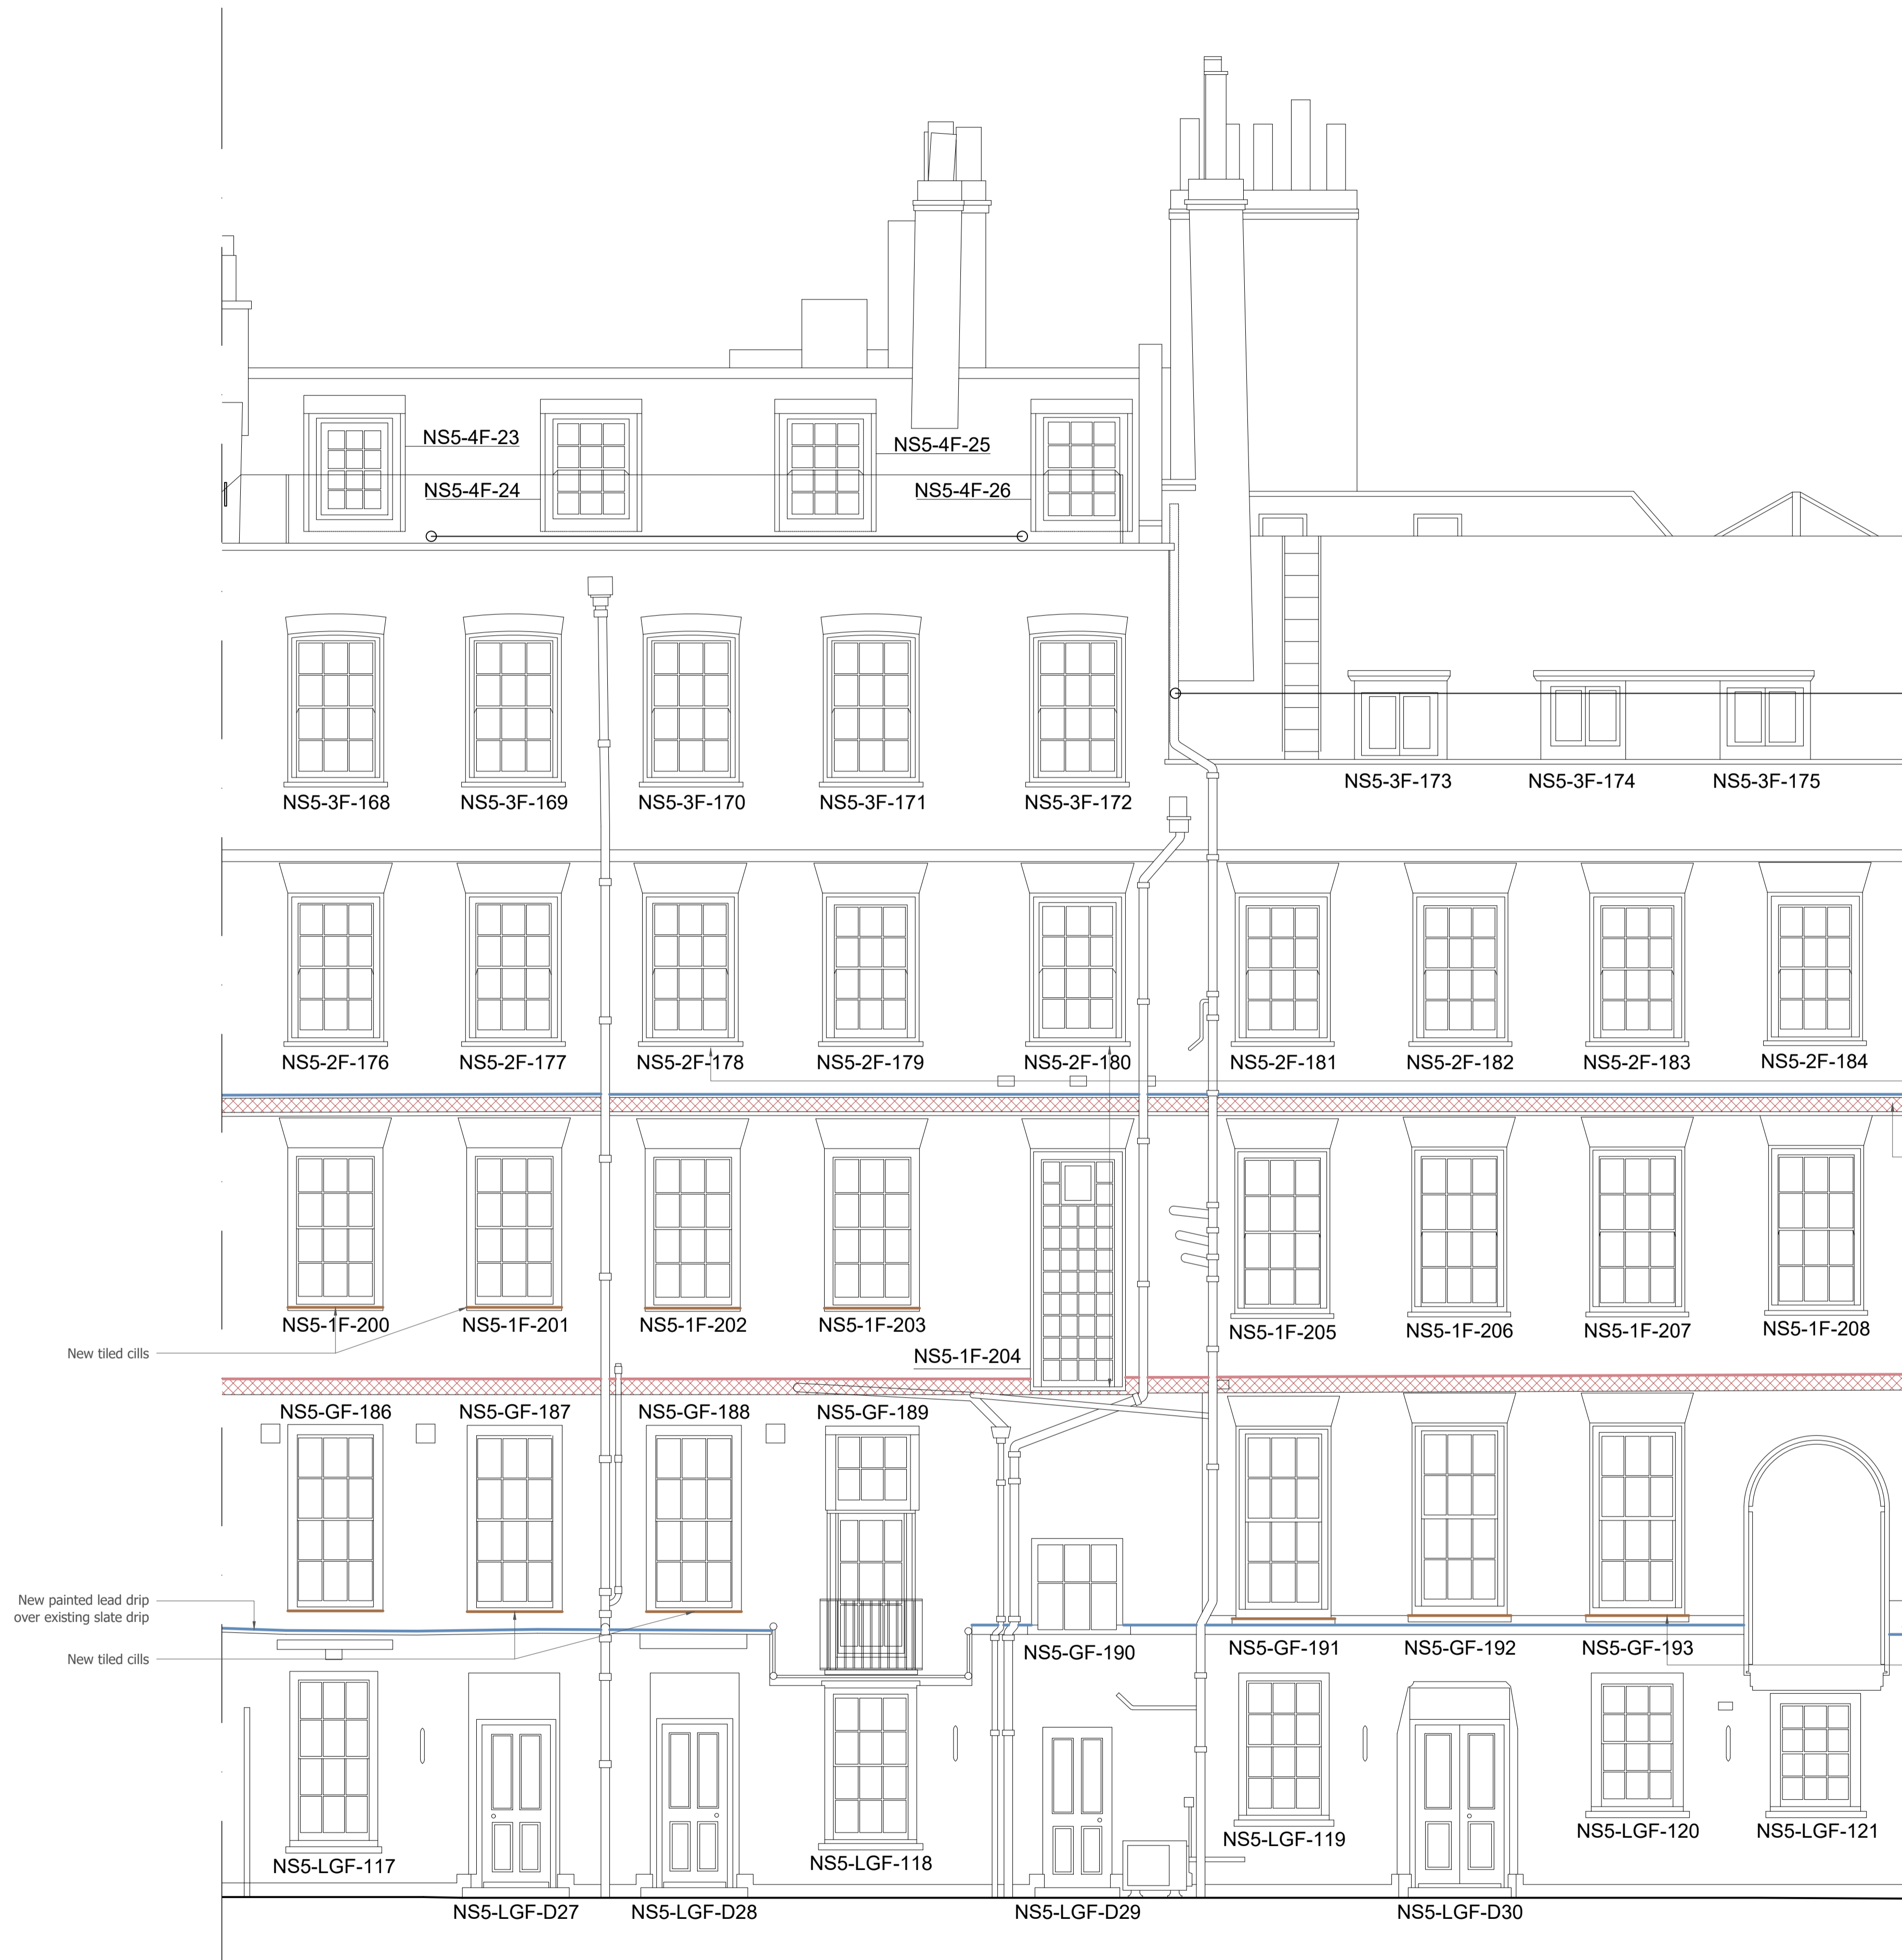
Brickwork is to be repointed where missing or failing. Cement mortars where failing will be replaced with a hydraulic lime mortar (NHL 2.0). Mortar mix to be agreed. Badly damaged or mortar repaired bricks are to be cut out and replaced with salvaged bricks sourced to match the existing. Assume 10% repointing unless described otherwise. All masonry lightly Thermatech cleaned. Air bricks cleaned of paint to maximise ventilation and then redecorated.

Gauged brick string courses Thermatech cleaned and badly decayed bricks, inappropriate cement mortar repairs, unstable areas and cement pointing removed. Replacement new gauged bricks installed with lime putty pointing.

New lead drip in Code 5 lengths not exceeding 1200mm

Existing lead drip renewed in Code 5 lengths not exceeding 1200mm.

New mortar fillet - NHL 5.0.

All cast-iron and lead downpipes and cast iron soil pipes require redecoration. Colour: Black to match the existing.

Shutters to be overhauled and repaired with scarf repairs. Racked shutters to be dismantled and reglued. All joinery to be thoroughly prepared and redecorated. New lead cover flashing to top rail.

Fractured and badly decayed gauged brickwork or mortar repairs to window heads to be cut out and replaced on a brick-by-brick basis. Washed out joints repointed with a non-hydraulic lime putty.

Stone window cills Thermatech cleaned and where necessary poulticed to remove extensive deposits. Mortar repairs to localised damage. All windows overhauled with scarf joinery repairs to decayed sections. Putty replaced where missing, detaching or cracked. All joinery redecorated. Draught-proofing seals and strips surface fixed to the existing windows.

New stone cills or indent repairs to stone cills.

New tiled cills.

All railings to Areas, bridges and steps to be rubbed down and repainted. Decayed ends opened up, painted and releaded. Localised damaged stonework to the bridge and plinths require a combination of pieced-in or mortar repairs. Open joints between paving slabs and steps to be repointed (NHL 5.0).

Basement Areas - Paving lifted and relaid to falls to existing channels and gully positions. New stone sourced to match existing when badly fractured or missing.

French Drain installed immediately in front of the building at basement level and concealed beneath the paving.

Basement Area walls - Decayed bricks and cement mortar repairs are to be repaired with salvaged bricks to match the originals. Wall surfaces cleaned of loose paint and relimewashed. Scarf repairs to existing doors and redecoration.
