Nº6

New Square No.6 1:50
Front North Elevation PROPOSED

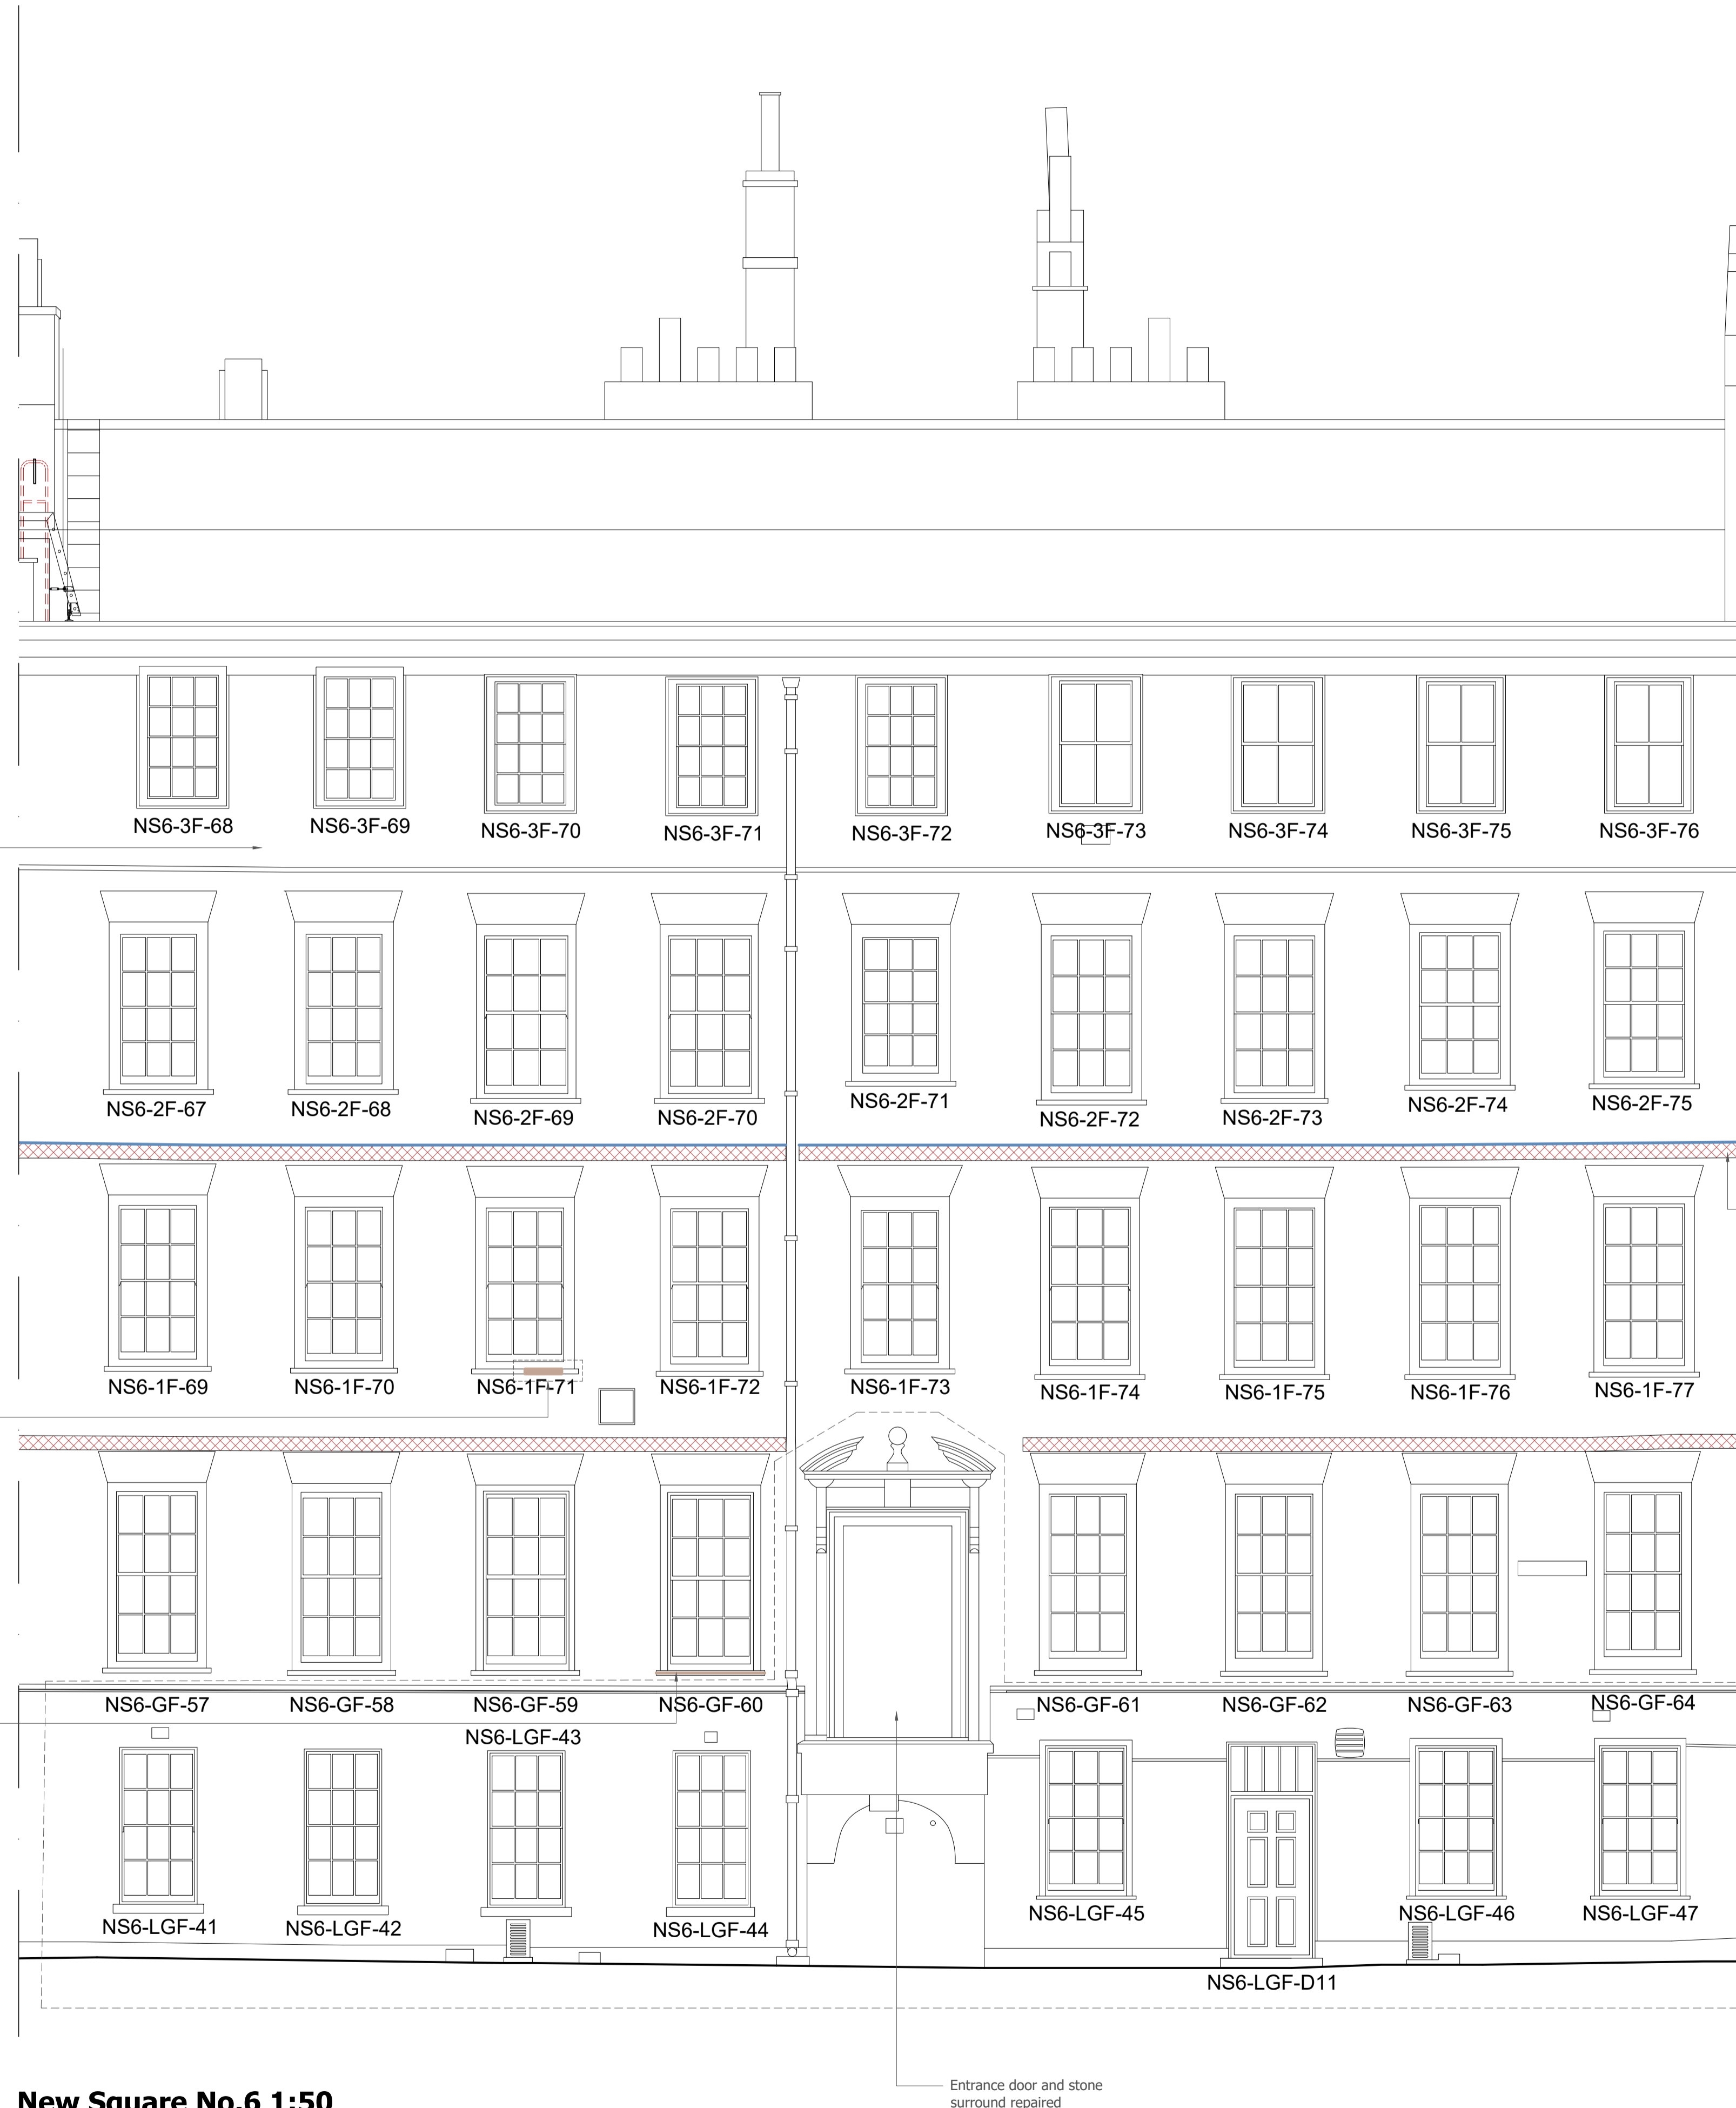
Open joints need repointing (NHL 5.0)

Railing repairs and redecoration. Pieced-in stone repair to damaged stone

Boot scraper needs repair

Render redecorated and cracks repaired

Indent repair to damaged stone cill

New stone cill

Basement steps
Open joints need repointing

Entrance door and stone surround repaired

Brick string course cleaned, decayed bricks cut out, mortar repairs cut and new gauged bricks inserted. New lead drip installed over tile course

Works to this area identified in drawing number: 400.005 and 006 and subject to a previous planning and LBC application (2024/1185/P) and (2024/2087/L)

Brickwork is to be repointed where missing or failing. Cement mortars where failing will be replaced with a hydraulic lime mortar (NHL 2.0). Mortar mix to be agreed. Badly damaged or mortar repaired bricks are to be cut out and replaced with salvaged bricks sourced to match the existing. Assume 10% repointing unless described otherwise. All masonry lightly Thermatech cleaned. Air bricks cleaned of paint to maximise ventilation and then redecorated.

Gauged brick string courses Thermatech cleaned and badly decayed bricks, inappropriate cement mortar repairs, unstable areas and cement pointing removed. Replacement new gauged bricks installed with lime putty pointing.

Fractured and badly decayed gauged brickwork or mortar repairs to window heads to be cut out and replaced on a brick-by-brick basis. Washed out joints repointed with a non-hydraulic lime putty.

Stone window cills Thermatech cleaned and where necessary poulticed to remove extensive deposits. Mortar repairs to localised damage. All windows overhauled with scarf joinery repairs to decayed sections. Putty replaced where missing, detaching or cracked. All joinery redecorated. Draught-proofing seals and strips surface fixed to the existing windows.

All railings to Areas, bridges and steps to be rubbed down and repainted. Decayed ends opened up, painted and releaded. Localised damaged stonework to the bridge and plinths require a combination of pieced-in or mortar repairs. Open joints between paving slabs and steps to be repointed (NHL 5.0).
