**New Square No.7 1:50**  
Rear South Elevation PROPOSED

Drawn	Rev	Notes
JW		For List B / Faculty and Tender
Job No	Job	Client
0400	LINCOLN'S INN - NEW SQUARE	
Dwg No	Title	
236	WF Rear Elevation 1 PROPOSED	
Scale	This document is copyright and the property of Chartery Conservation Architects Ltd. Any copies of this drawing made by any method must also include a copy of this notice.	
1:50 at A1	©Chartery Conservation Architects Ltd

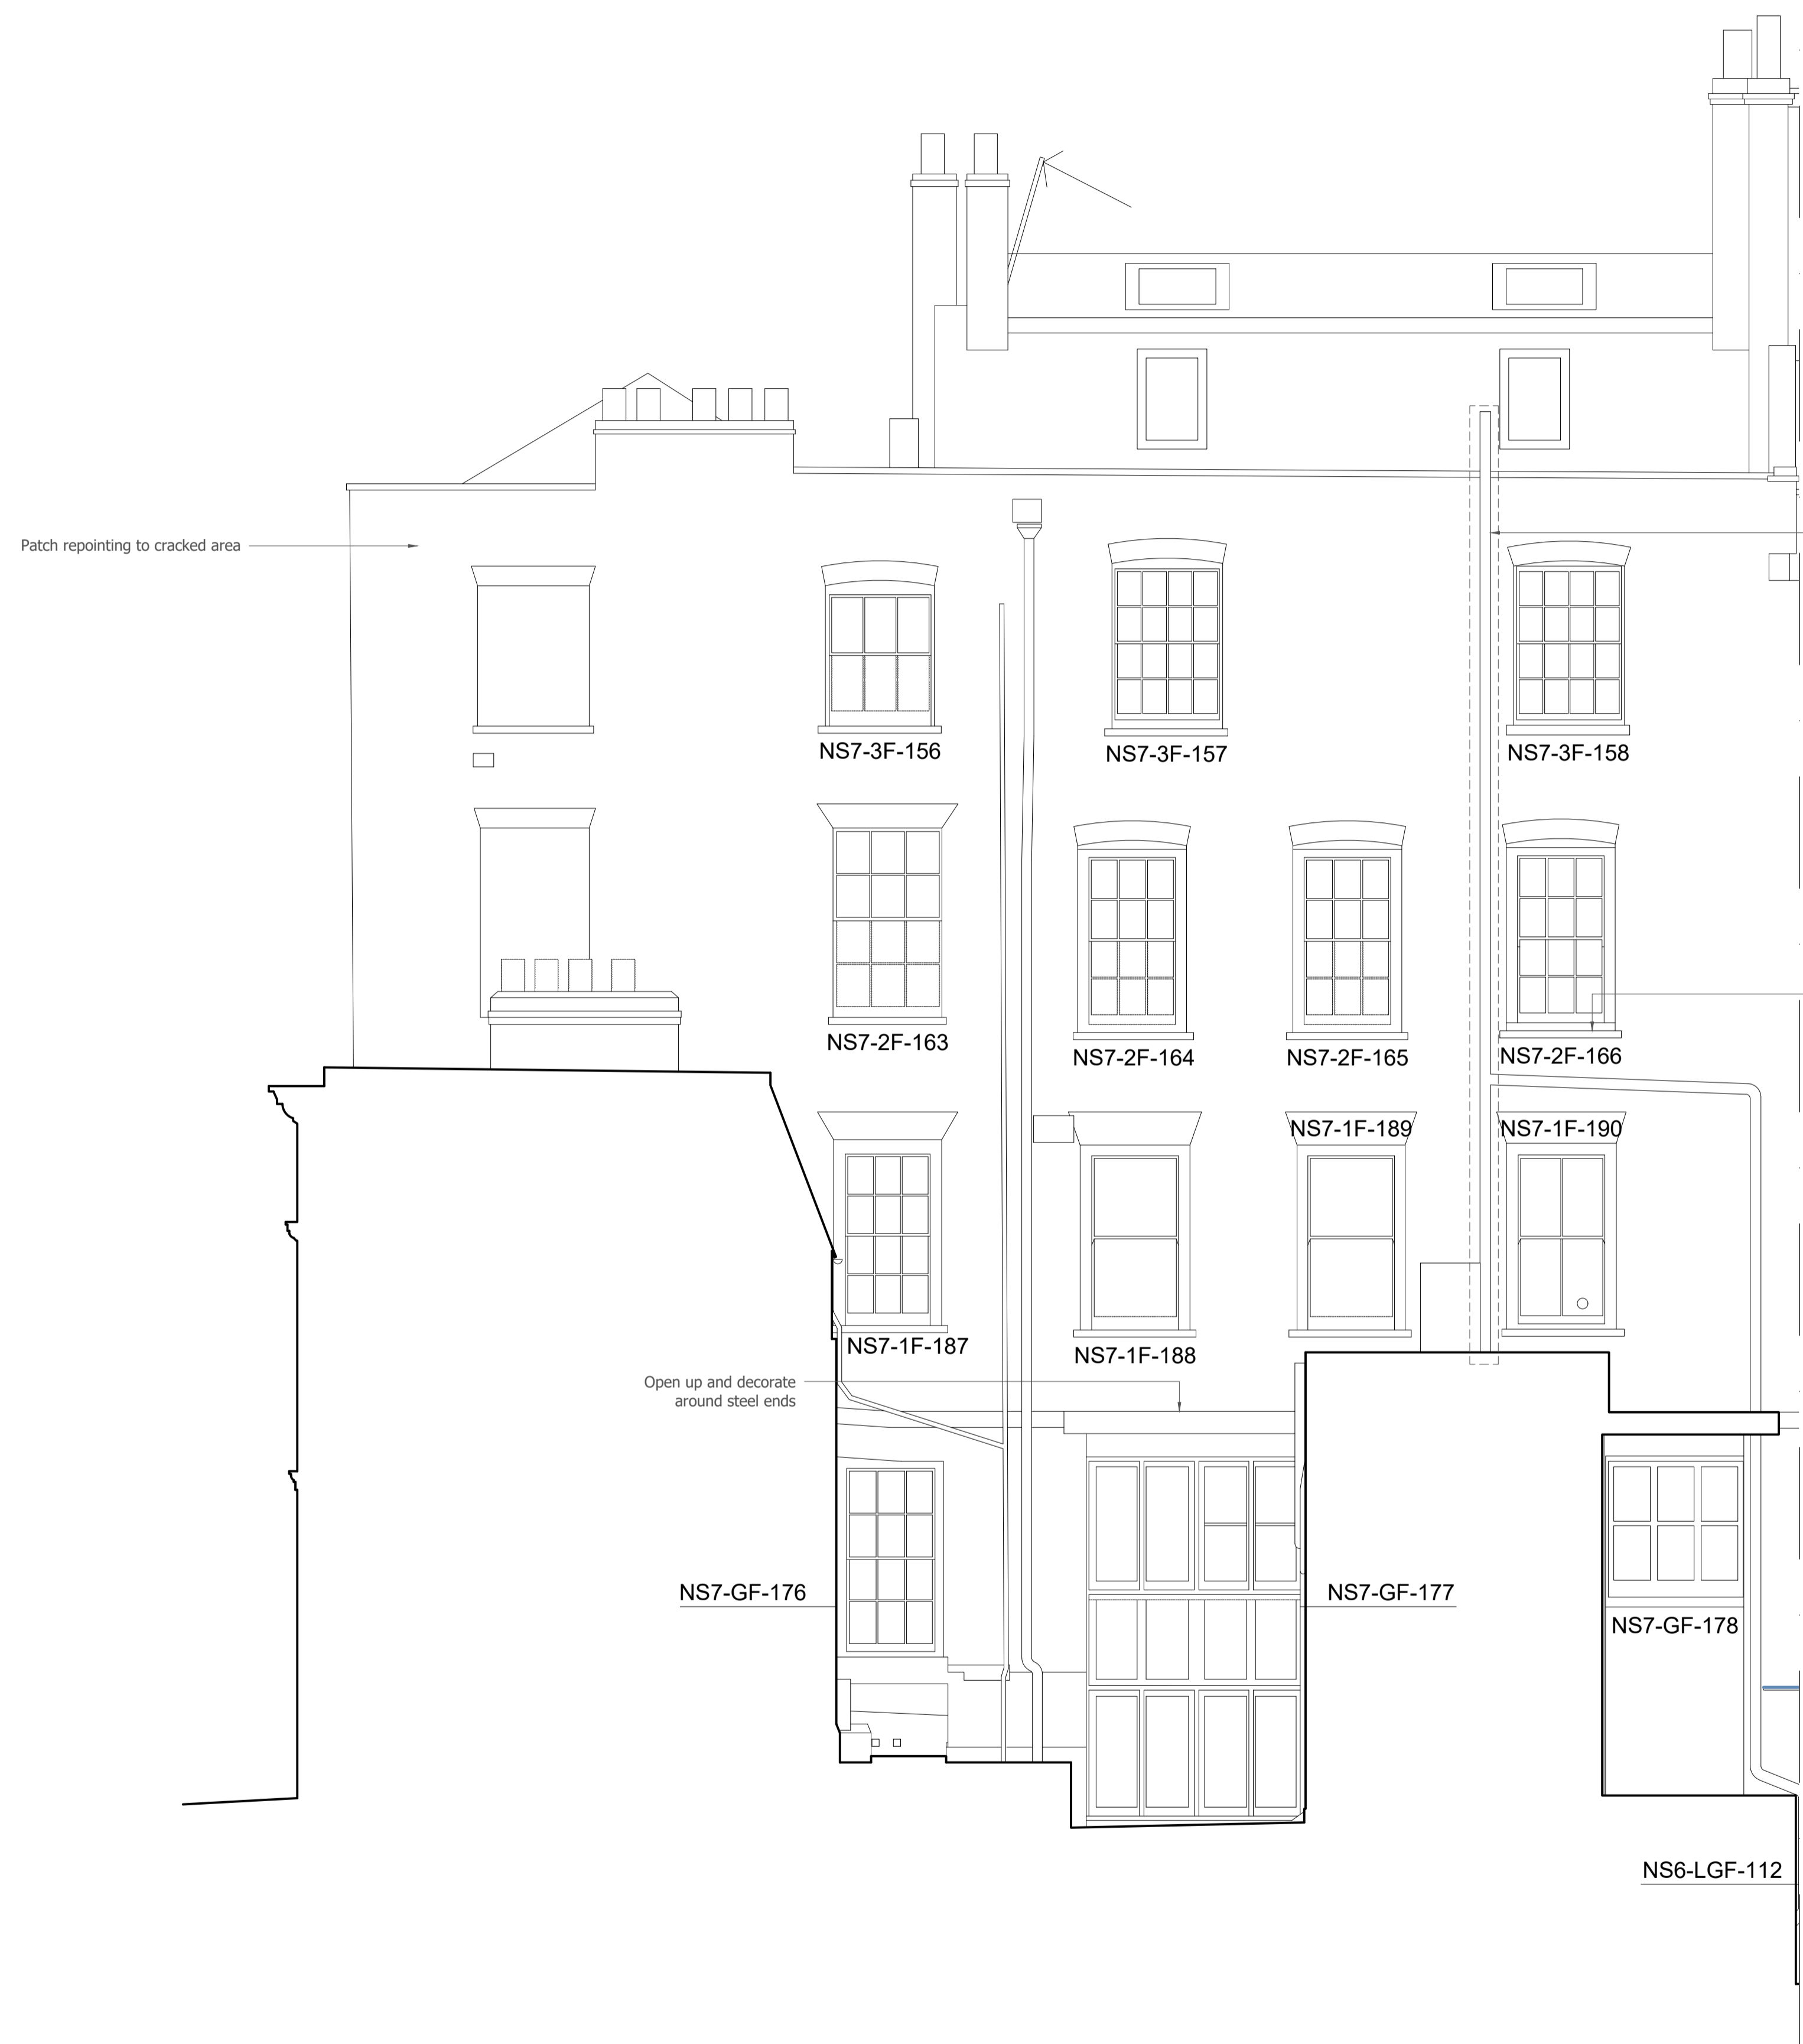
Brickwork is to be repointed where missing or failing. Cement mortars where failing will be replaced with a hydraulic lime mortar (NHL 2.0). Mortar mix to be agreed. Badly damaged or mortar repaired bricks are to be cut out and replaced with salvaged bricks sourced to match the existing. Assume 10% repointing unless described otherwise. All masonry lightly Thermatech cleaned. Air bricks cleaned of paint to maximise ventilation and then redecorated.

Gauged brick string courses  
Thermatech cleaned and badly decayed bricks, inappropriate cement mortar repairs, unstable areas and cement pointing removed.  
Replacement new gauged bricks installed with lime putty pointing.

New lead drip in Code 5 lengths not exceeding 1200mm

Existing lead drip renewed in Code 5 lengths not exceeding 1200mm.

New mortar fillet – NHL 5.0.

All cast-iron and lead downpipes and cast iron soil pipes require redecoration. Colour: Black to match the existing.

Shutters to be overhauled and repaired with scarf repairs. Racked shutters to be dismantled and reglued. All joinery to be thoroughly prepared and redecorated. New lead cover flashing to top rail.

Fractured and badly decayed gauged brickwork or mortar repairs to window heads to be cut out and replaced on a brick-by-brick basis. Washed out joints repointed with a non-hydraulic lime putty.

Stone window cills Thermatech cleaned and where necessary poulticed to remove extensive deposits. Mortar repairs to localised damage. All windows overhauled with scarf joinery repairs to decayed sections. Putty replaced where missing, detaching or cracked. All joinery redecorated. Draught-proofing seals and strips surface fixed to the existing windows.

New stone cills or indent repairs to stone cills.

New tiled cills.

All railings to Areas, bridges and steps to be rubbed down and repainted. Decayed ends opened up, painted and releaded. Localised damaged stonework to the bridge and plinths require a combination of pieced-in or mortar repairs. Open joints between paving slabs and steps to be repointed (NHL 5.0).

Basement Areas - Paving lifted and relaid to falls to existing channels and gully positions. New stone sourced to match existing when badly fractured or missing.

Basement Area walls - Decayed bricks and cement mortar repairs are to be repaired with salvaged bricks to match the originals. Wall surfaces cleaned of loose paint and relime-washed. Scarf repairs to existing doors and redecoration.
