New Square No.7 1:50
Rear West Elevation PROPOSED

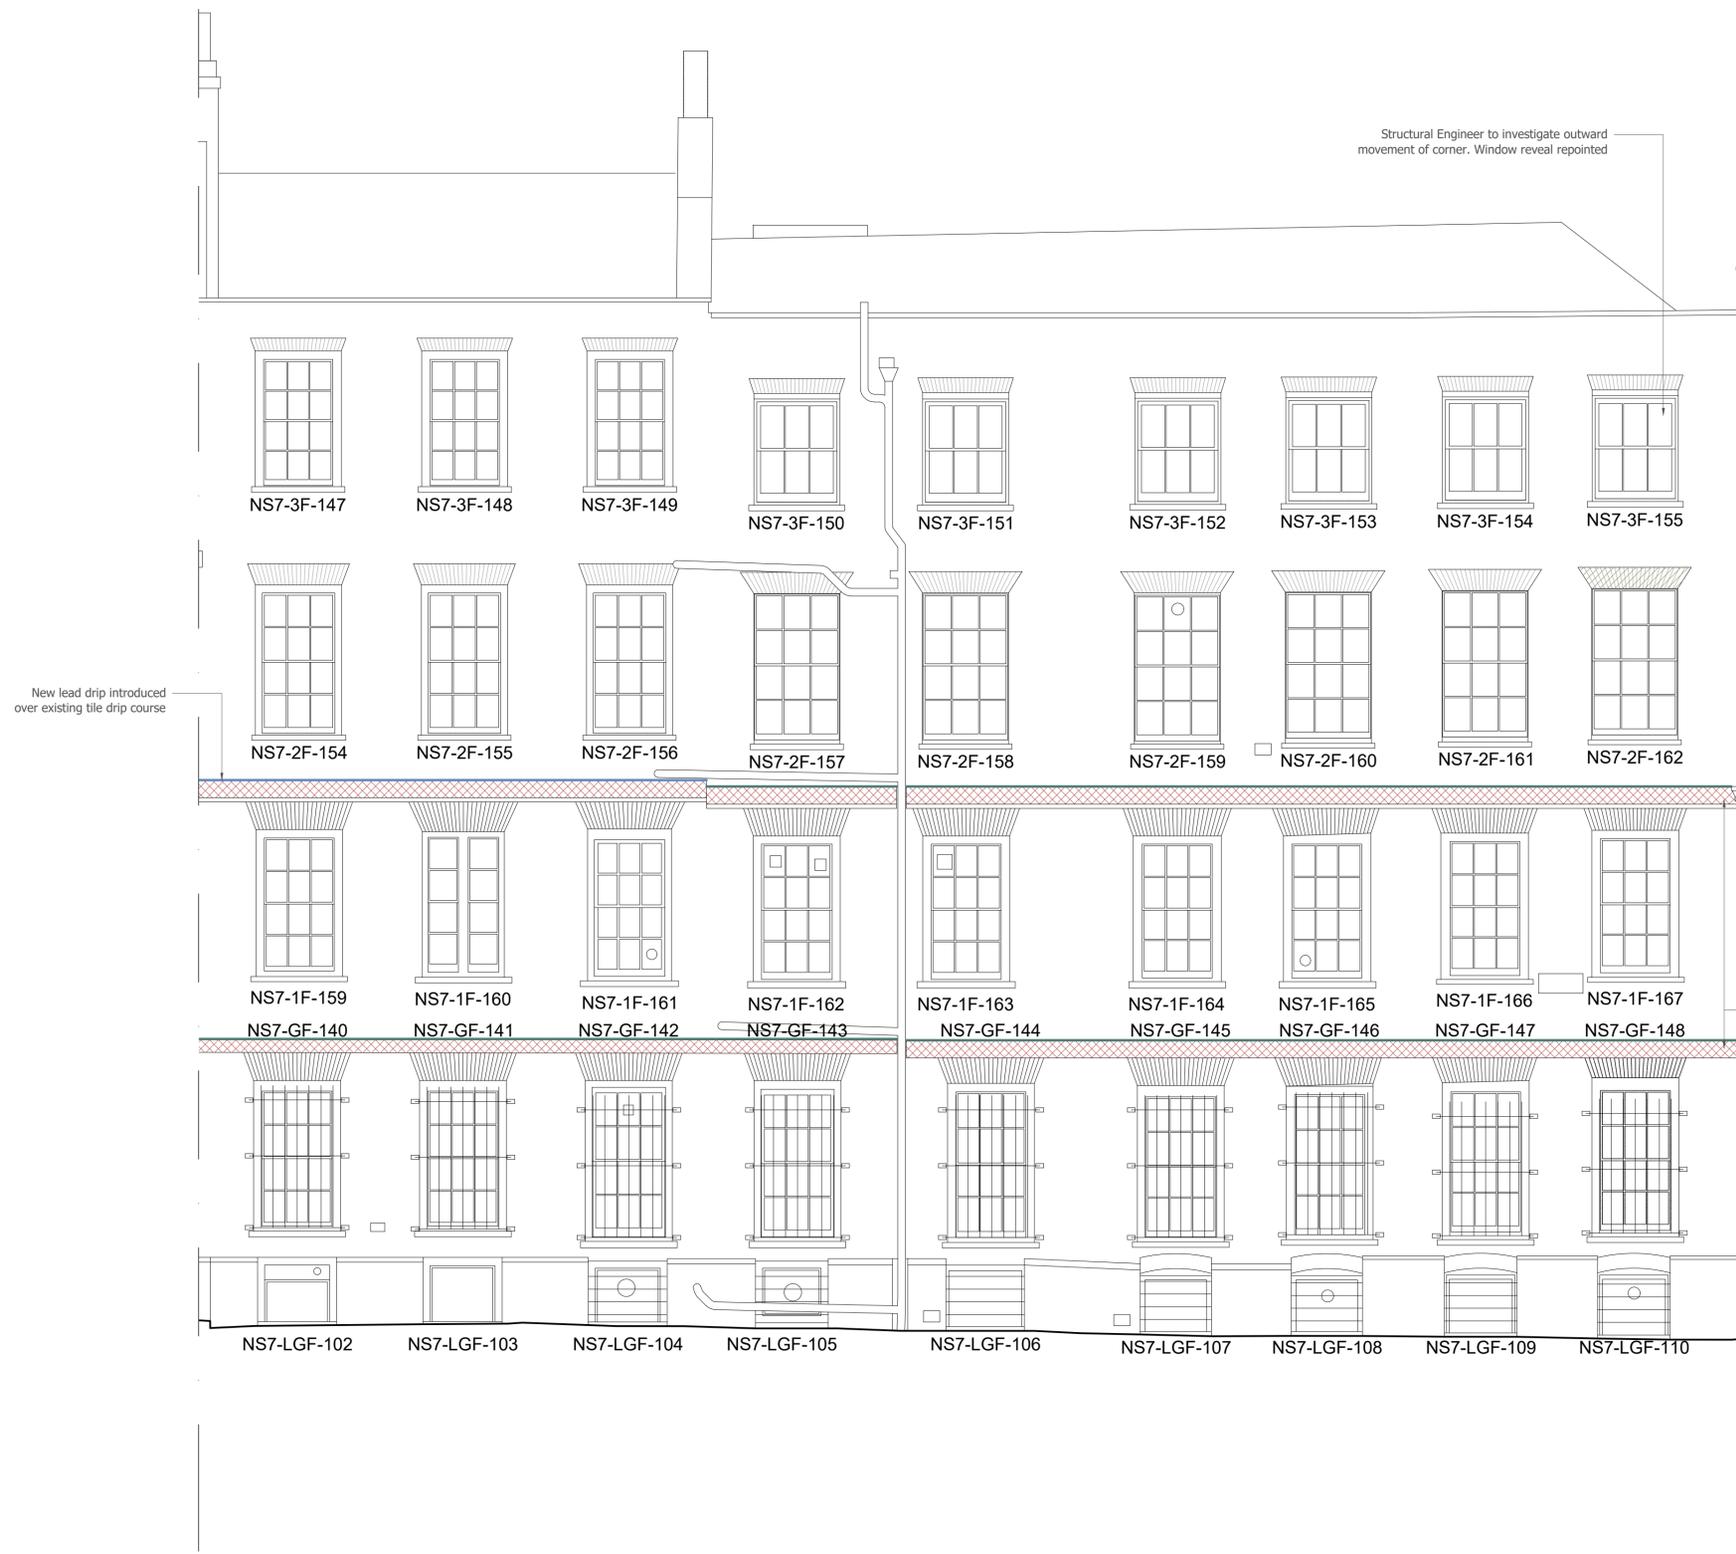
Brickwork is to be repointed where missing or failing. Cement mortars where failing will be replaced with a hydraulic lime mortar (NHL 2.0). Mortar mix to be agreed. Badly damaged or mortar repaired bricks are to be cut out and replaced with salvaged bricks sourced to match the existing. Assume 10% repointing unless described otherwise. All masonry lightly Thermatech cleaned. Air bricks cleaned of paint to maximise ventilation and then redecorated.

Gauged brick string courses
Thermatech cleaned and badly decayed bricks, inappropriate cement mortar repairs, unstable areas and cement pointing removed.
Replacement new gauged bricks installed with lime putty pointing.

New lead drip in Code 5 lengths not exceeding 1200mm

Existing lead drip renewed in Code 5 lengths not exceeding 1200mm.

New mortar fillet - NHL 5.0.

All cast-iron and lead downpipes and cast iron soil pipes require redecoration. Colour: Black to match the existing.

Shutters to be overhauled and repaired with scarf repairs. Racked shutters to be dismantled and reglued. All joinery to be thoroughly prepared and redecorated. New lead cover flashing to top rail.

Fractured and badly decayed gauged brickwork or mortar repairs to window heads to be cut out and replaced on a brick-by-brick basis. Washed out joints repointed with a non-hydraulic lime putty.

Stone window cills Thermatech cleaned and where necessary poulticed to remove extensive deposits. Mortar repairs to localised damage. All windows overhauled with scarf joinery repairs to decayed sections. Putty replaced where missing, detaching or cracked. All joinery redecorated. Draught-proofing seals and strips surface fixed to the existing windows.

New stone cills or indent repairs to stone cills.

New tiled cills.

All railings to Areas, bridges and steps to be rubbed down and repainted. Decayed ends opened up, painted and releaded. Localised damaged stonework to the bridge and plinths require a combination of pieced-in or mortar repairs. Open joints between paving slabs and steps to be repointed (NHL 5.0).

Basement Areas - Paving lifted and relaid to falls to existing channels and gully positions. New stone sourced to match existing when badly fractured or missing.

French Drain installed immediately in front of the building at basement level and concealed beneath the paving.

Basement Area walls - Decayed bricks and cement mortar repairs are to be repaired with salvaged bricks to match the originals. Wall surfaces cleaned of loose paint and relime-washed. Scarf repairs to existing doors and redecoration.
