No.53 Carey Street 1:50
Mews Front South Elevation PROPOSED

No.55 Carey Street 1:50
Mews Rear North Elevation PROPOSED

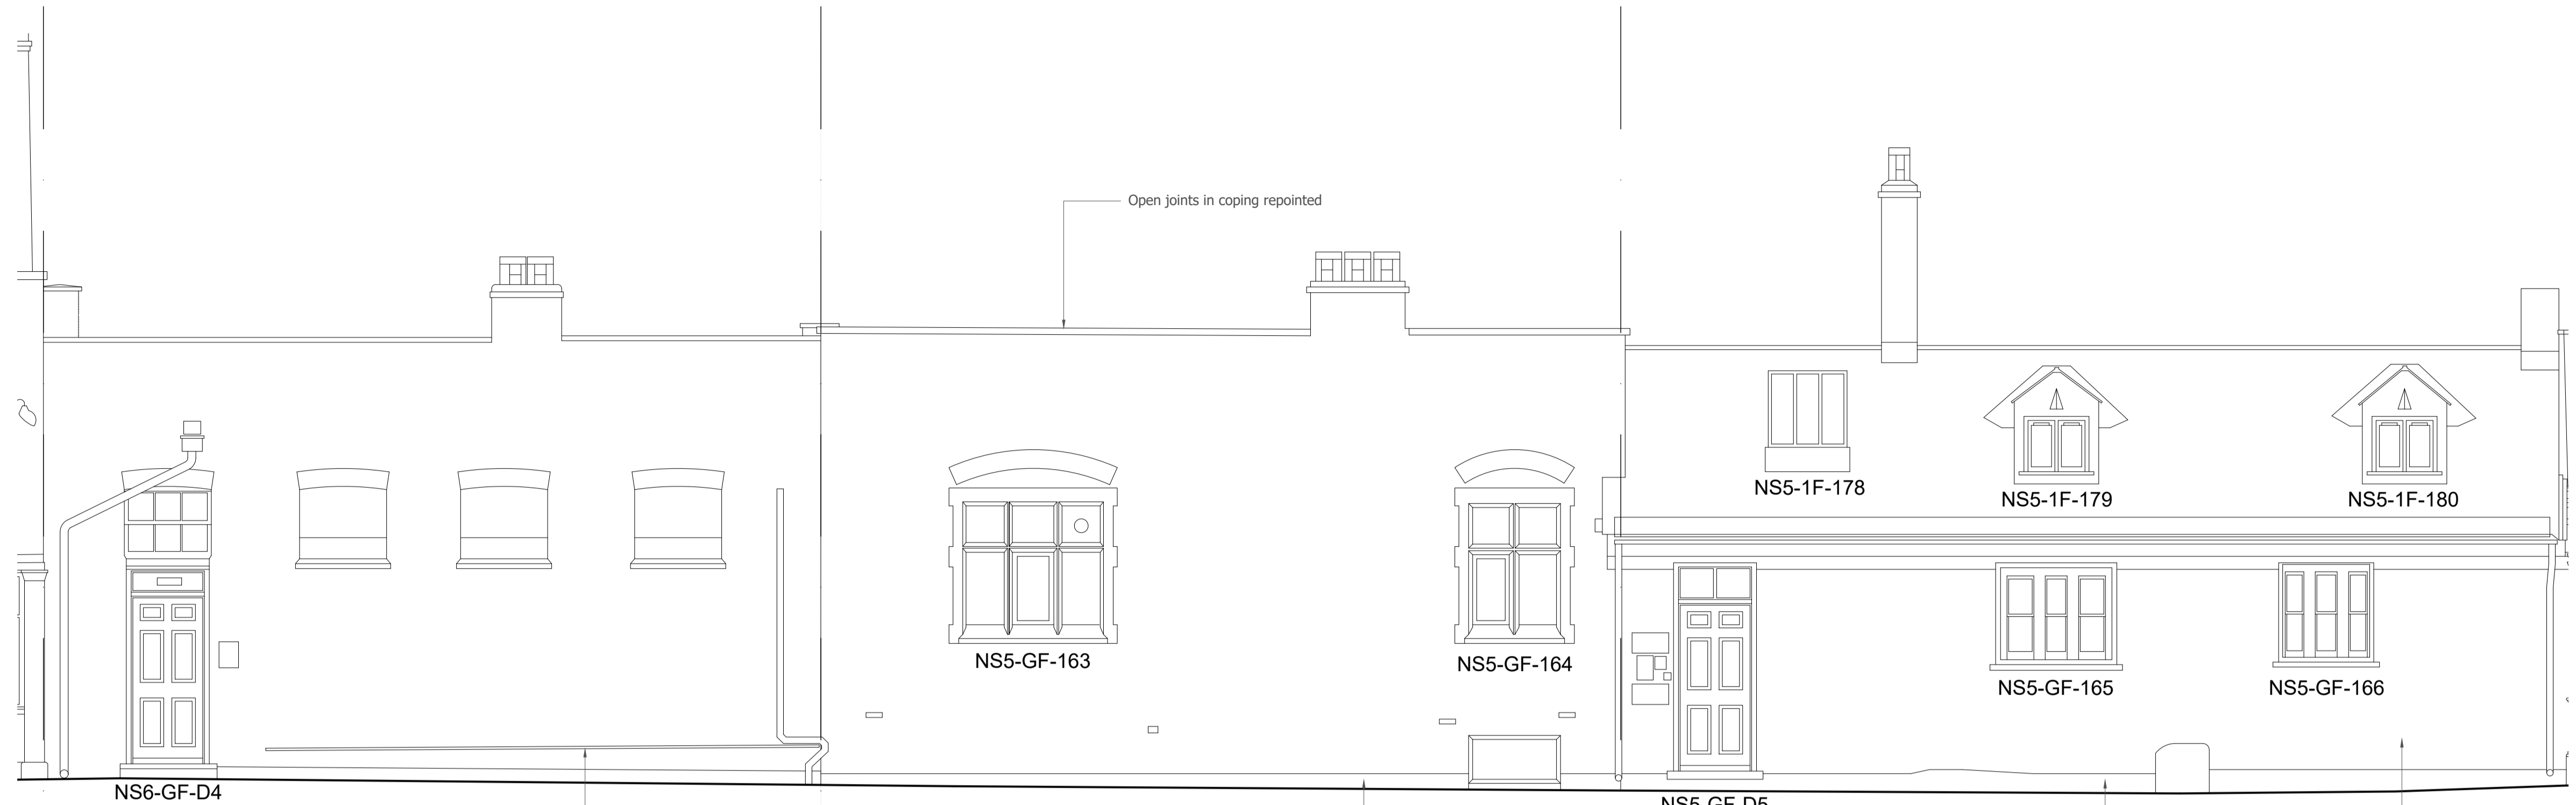
No.54 Carey Street 1:50
Mews Front South Elevation PROPOSED

No.55 Carey Street 1:50
Mews Front South Elevation PROPOSED

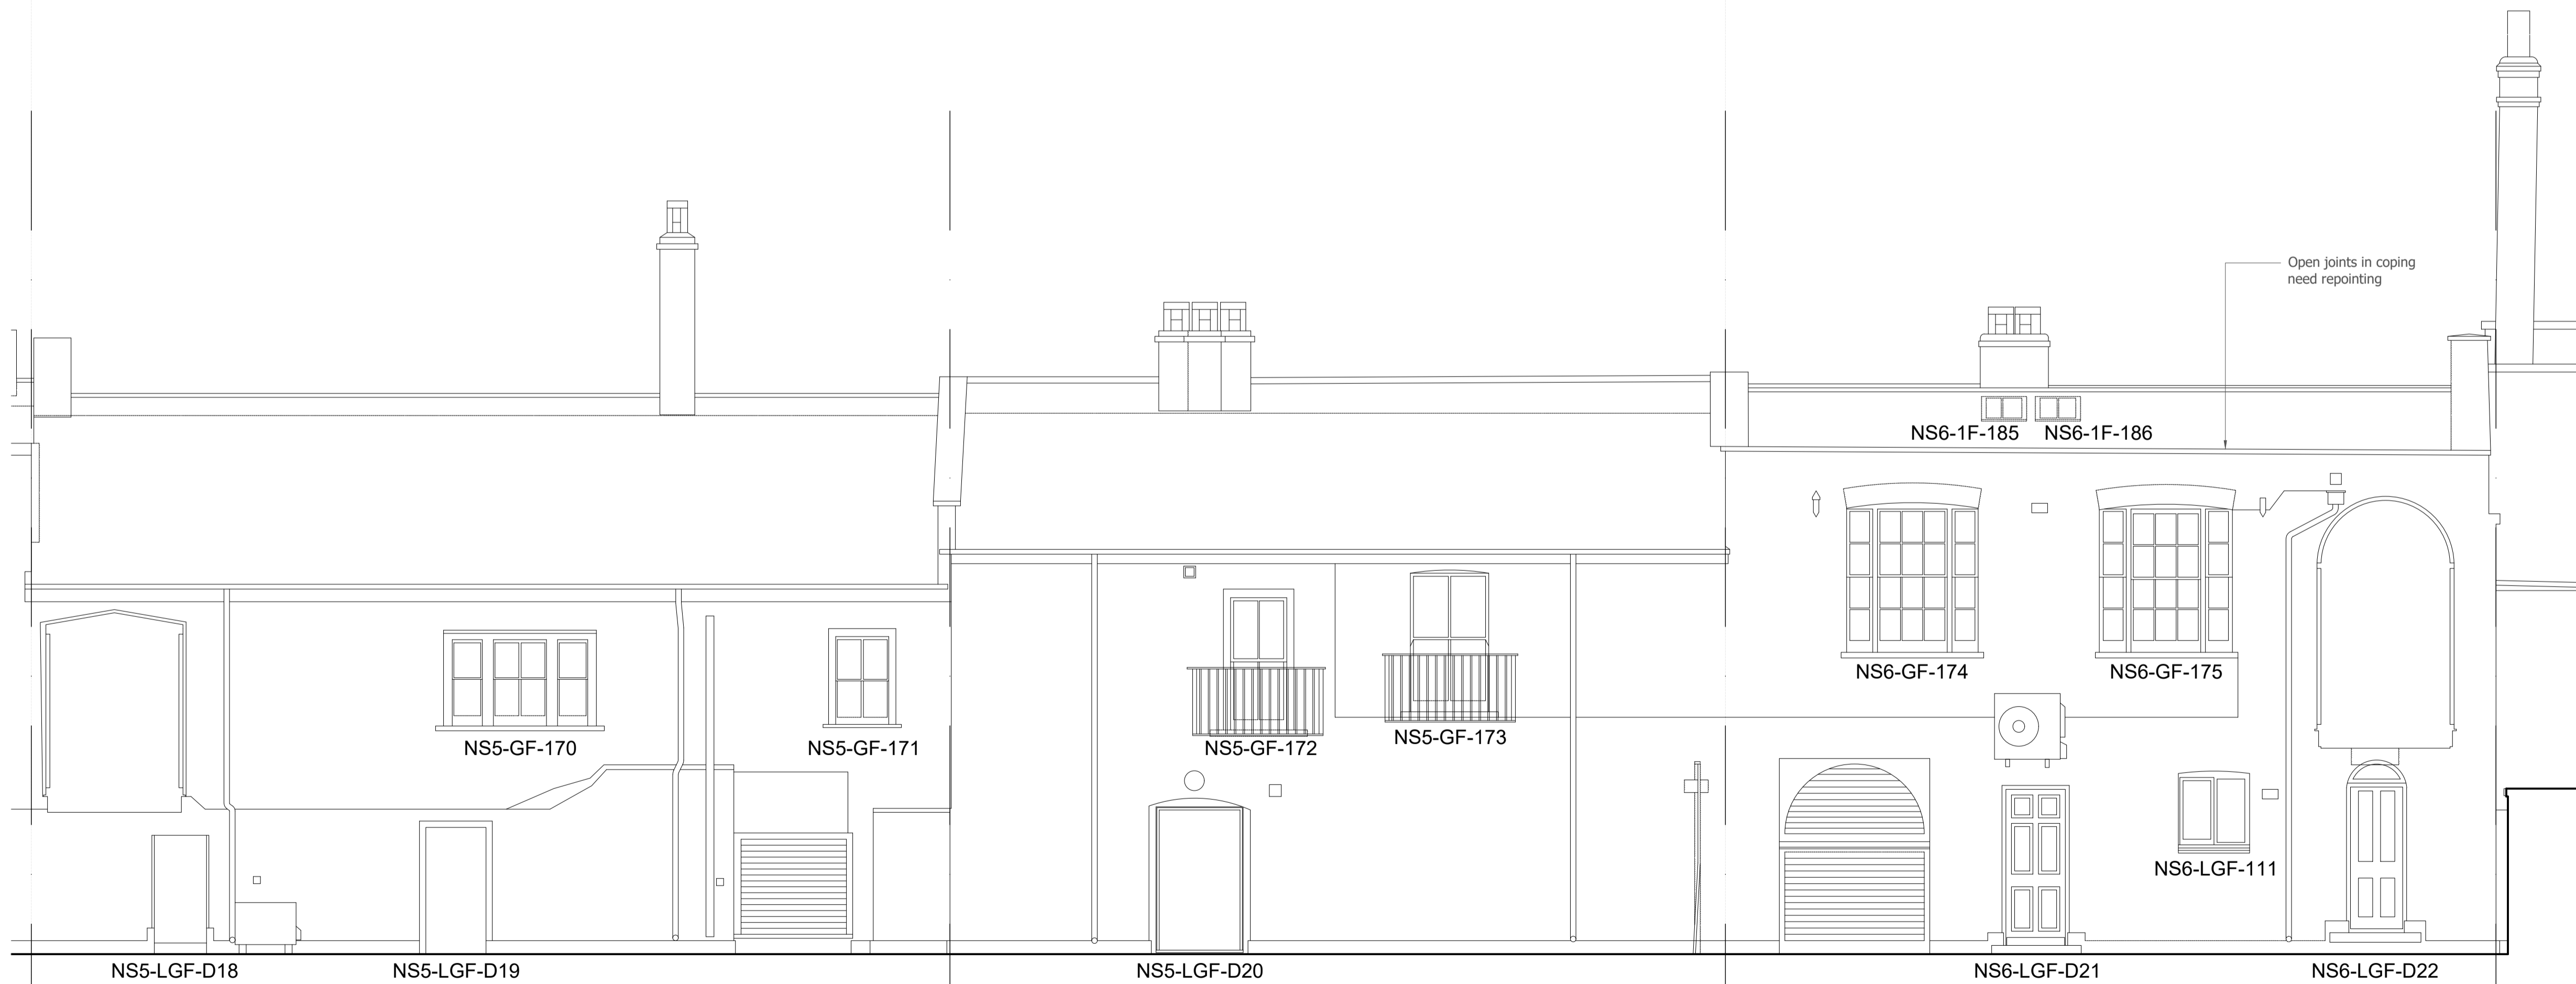
No.54 Carey Street 1:50
Mews Rear North Elevation PROPOSED
