**Thomas More House 1:50**  
West Elevation PROPOSED

**Thomas More House 1:50**  
South Elevation PROPOSED

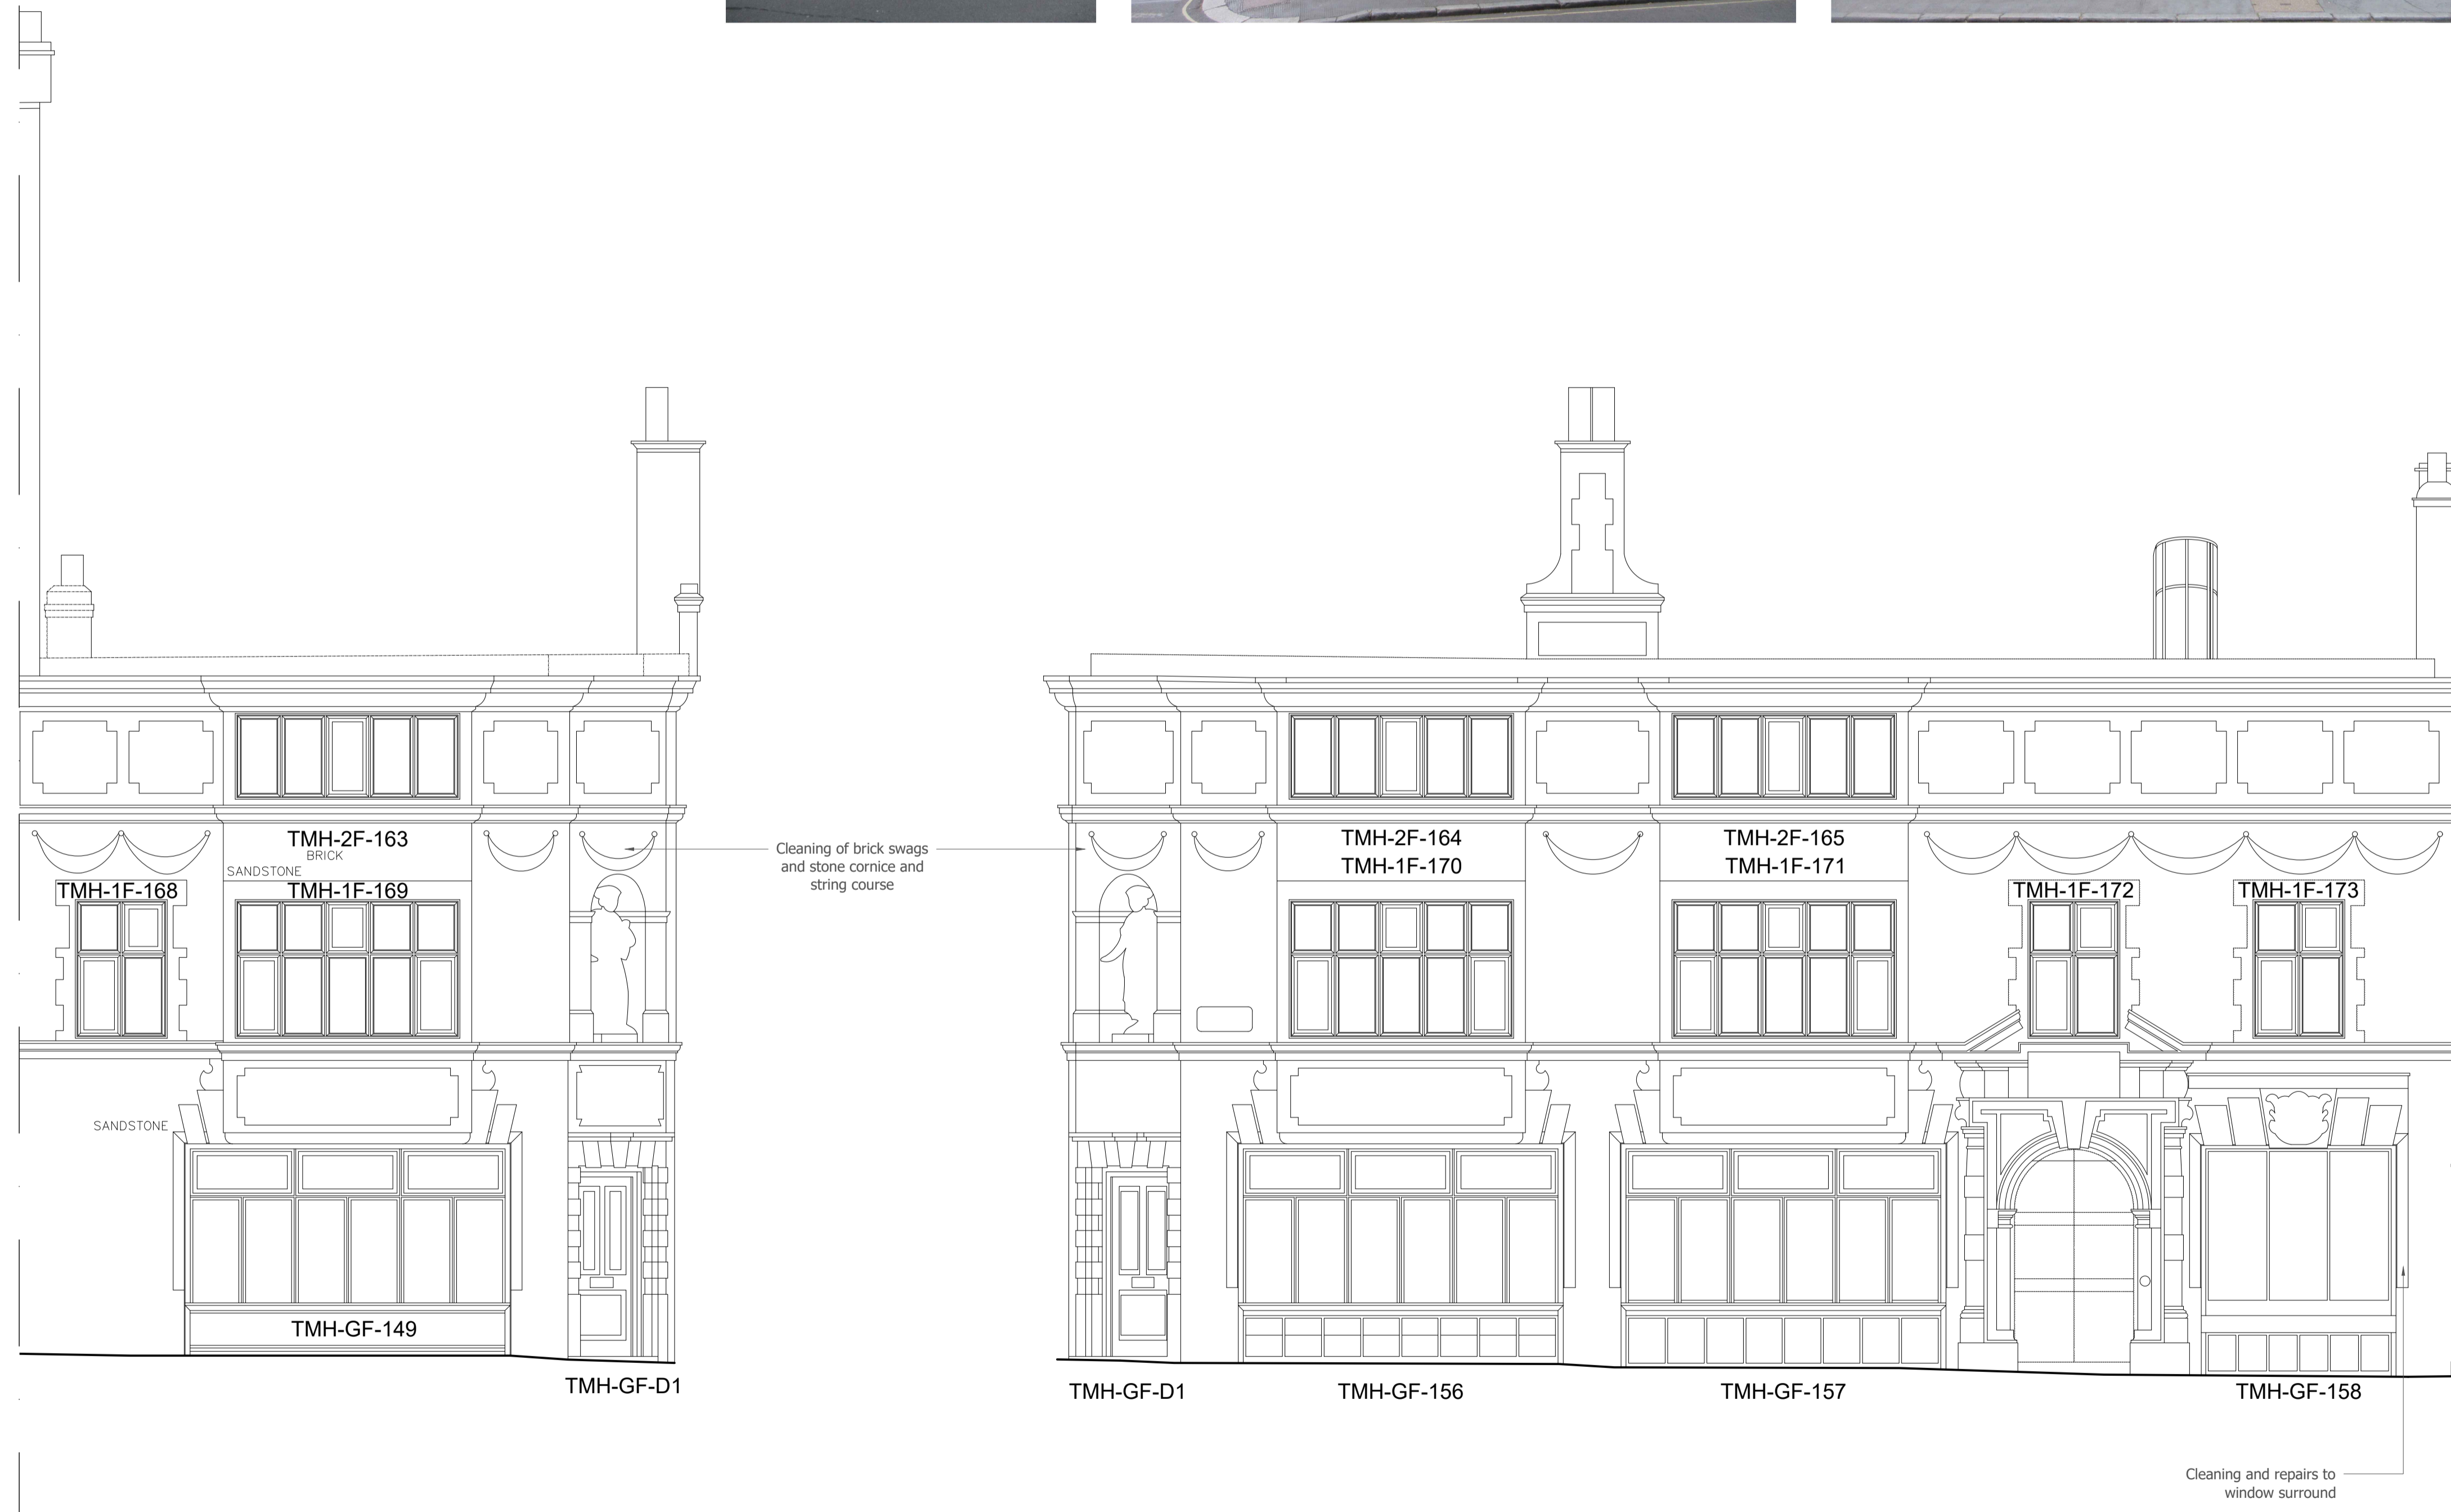
Brickwork is to be repointed where missing or falling. Cement mortars where falling will be replaced with a hydraulic lime mortar (NHL 2.0). Mortar mix to be agreed. Badly damaged or mortar repaired bricks are to be cut out and replaced with salvaged bricks sourced to match the existing. Assume 10% repointing unless described otherwise. All masonry lightly Thermatech cleaned. Air bricks cleaned of paint to maximise ventilation and then redecorated.

Gauged brick string courses  
Thermatech cleaned and badly decayed bricks, inappropriate cement mortar repairs, unstable areas and cement pointing removed.  
Replacement new gauged bricks installed with lime putty pointing.

Shutters to be overhauled and repaired with scarf repairs. Racked shutters to be dismantled and reglued. All joinery to be thoroughly prepared and redecorated. New lead cover flashing to top rail.

Fractured and badly decayed gauged brickwork or mortar repairs to window heads to be cut out and replaced on a brick-by-brick basis. Washed out joints repointed with a non-hydraulic lime putty.

Stone window cills Thermatech cleaned and where necessary poulticed to remove extensive deposits. Mortar repairs to localised damage. All windows overhauled with scarf joinery repairs to decayed sections. Putty replaced where missing, detaching or cracked. All joinery redecorated. Draught-proofing seals and strips surface fixed to the existing windows.

All railings to Areas, bridges and steps to be rubbed down and repainted. Decayed ends opened up, painted and releaded. Localised damaged stonework to the bridge and plinths require a combination of pieced-in or mortar repairs. Open joints between paving slabs and steps to be repointed (NHL 5.0).

Basement Areas - Paving lifted and relaid to falls to existing channels and gully positions. New stone sourced to match existing when badly fractured or missing.

French Drain installed immediately in front of the building at basement level and concealed beneath the paving.

Basement Area walls - Decayed bricks and cement mortar repairs are to be repaired with salvaged bricks to match the originals. Wall surfaces cleaned of loose paint and relime washed. Scarf repairs to existing doors and redecoration.
