New Square No.8 1:50 Front East Elevation PROPOSED

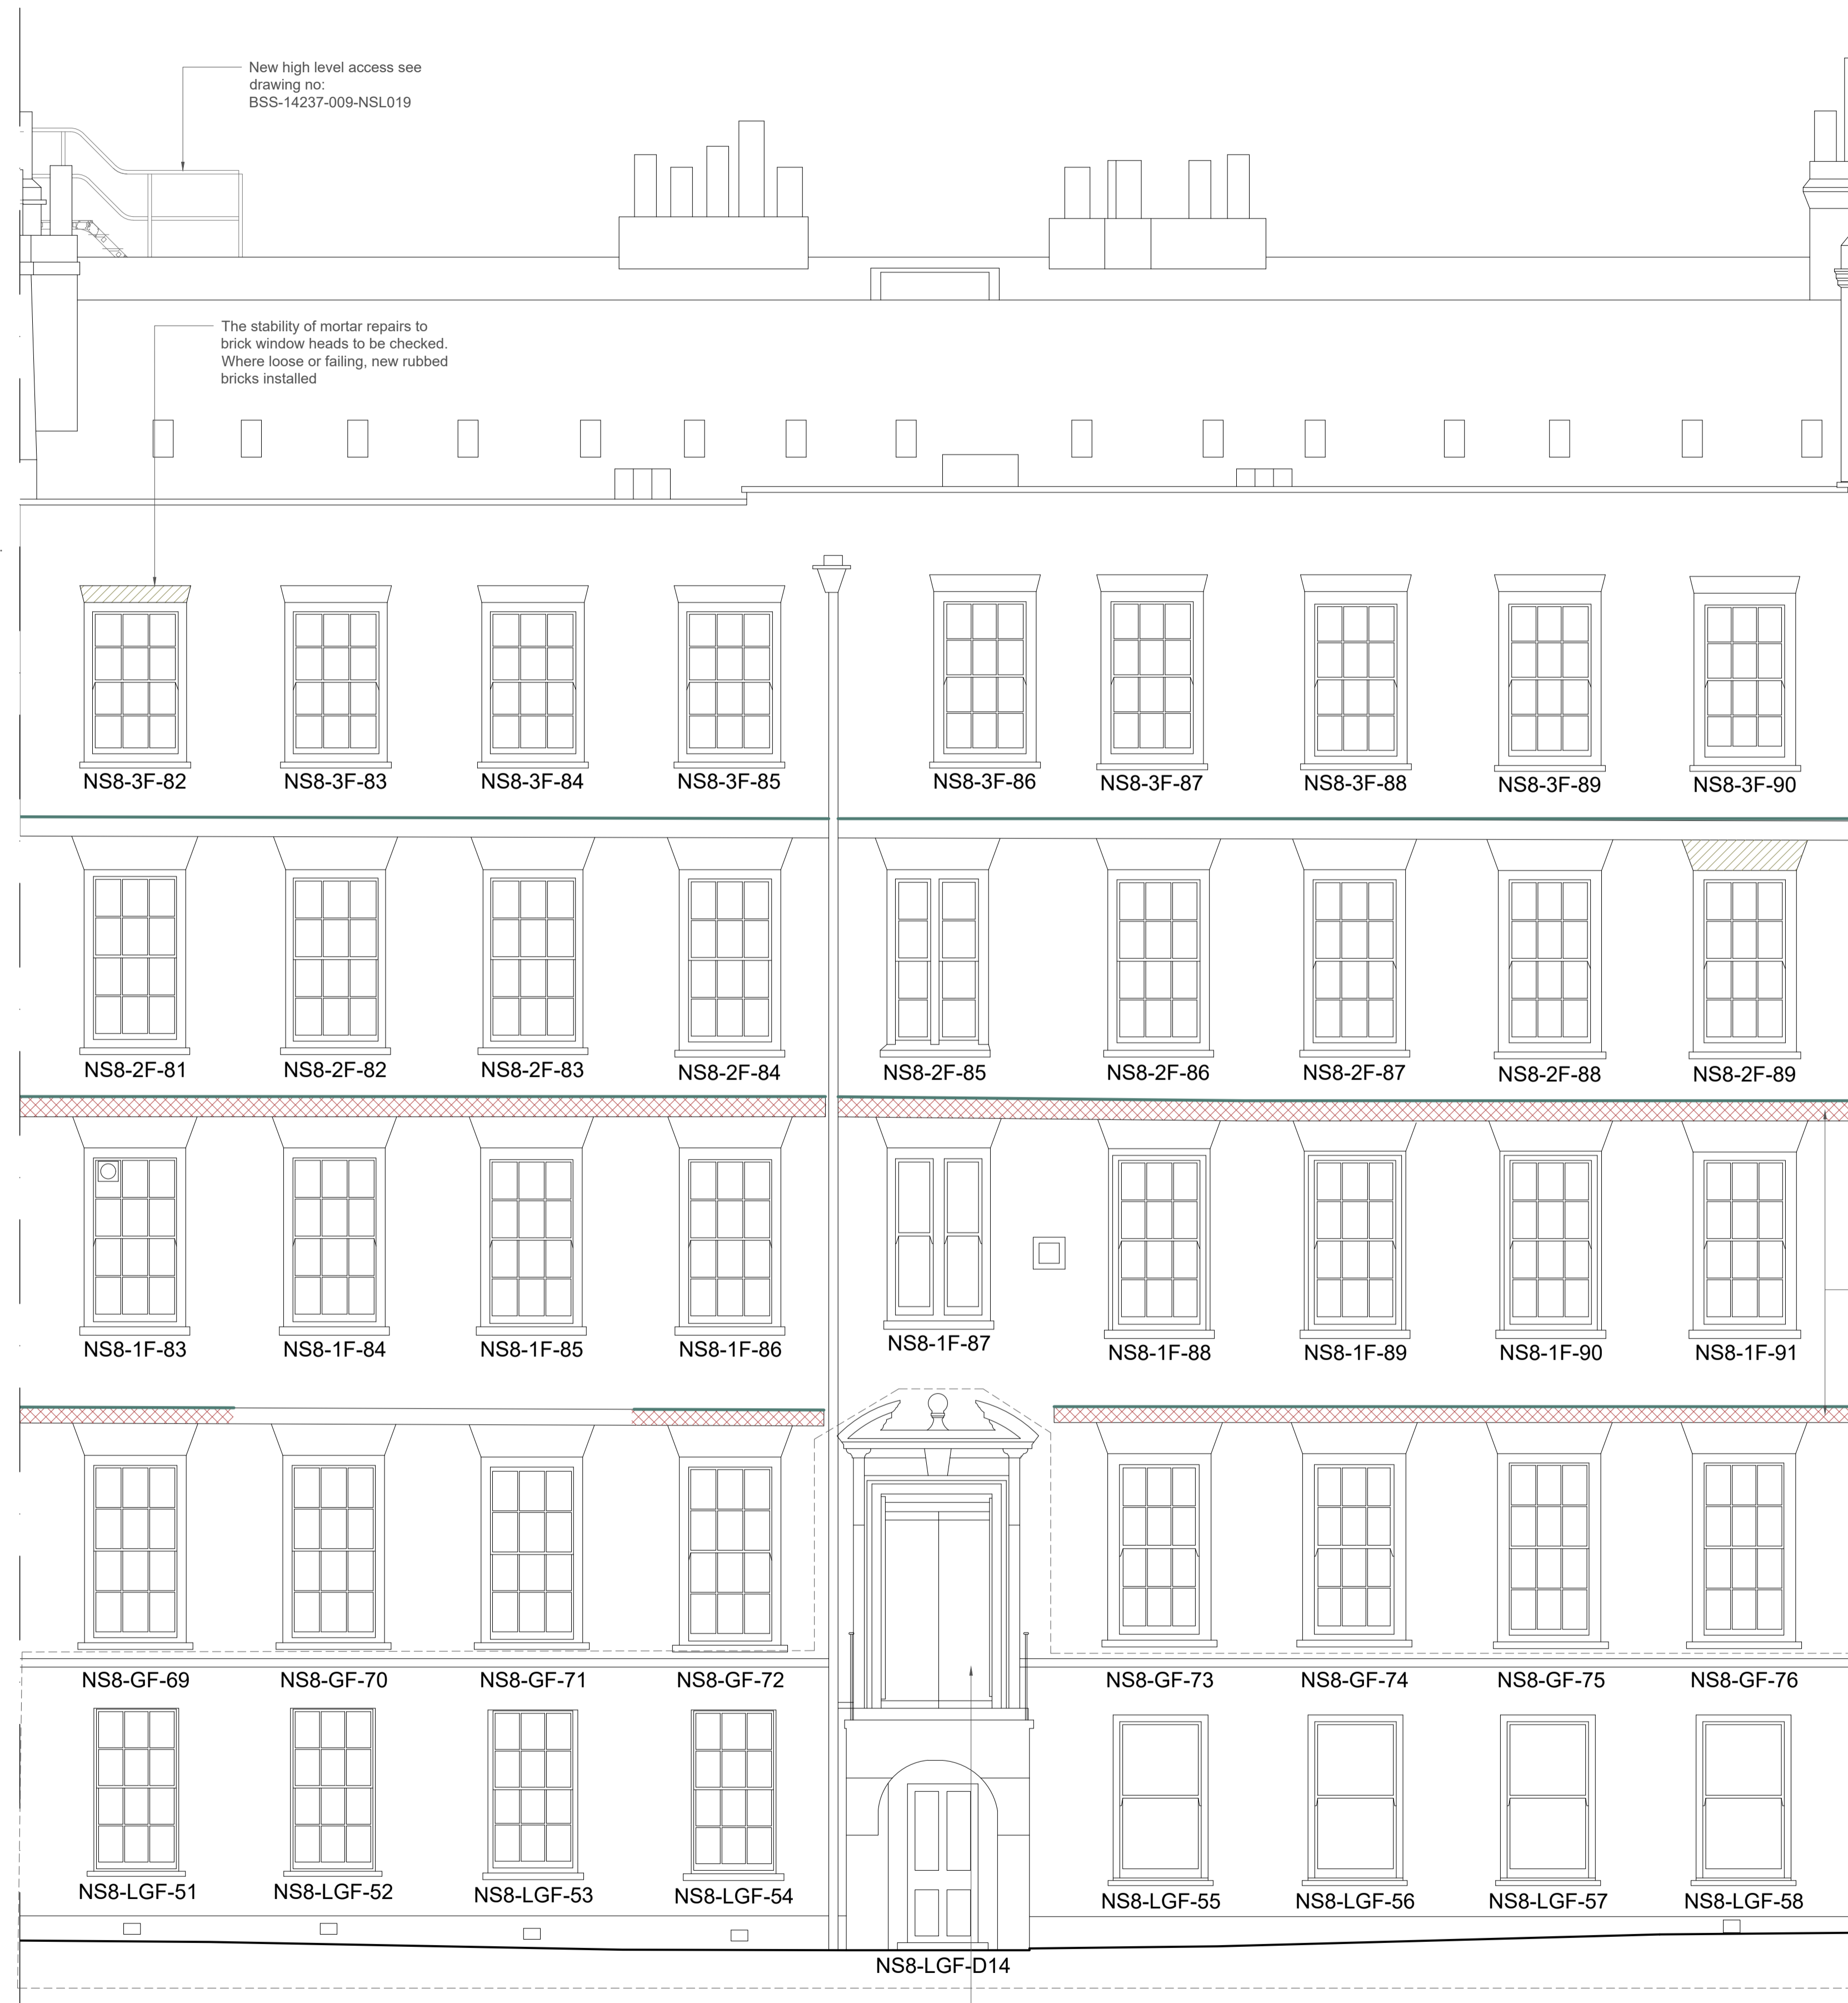
Open joints need repointing (NHL 5.0)

Railing repairs and redecoration. Pieced-in stone repair to damaged stone

Entrance door and stone surround repaired

Brick string course cleaned, decayed bricks cut out, mortar repairs cut and new gauged bricks inserted

Brickwork is to be repointed where missing or falling. Cement mortars where failing will be replaced with a hydraulic lime mortar (NHL 2.0). Mortar mix to be agreed. Badly damaged or mortar repaired bricks are to be cut out and replaced with salvaged bricks sourced to match the existing. Assume 10% repointing unless described otherwise. All masonry lightly Thermatech cleaned. Air bricks cleaned of paint to maximise ventilation and then redecorated.

Gauged brick string courses Thermatech cleaned and badly decayed bricks, inappropriate cement mortar repairs, unstable areas and cement pointing removed. Replacement new gauged bricks installed with lime putty pointing.

Shutters to be overhauled and repaired with scarf repairs. Racked shutters to be dismantled and reglued. All joinery to be thoroughly prepared and redecorated. New lead cover flashing to top rail.

Fractured and badly decayed gauged brickwork or mortar repairs to window heads to be cut out and replaced on a brick-by-brick basis. Washed out joints repointed with a non-hydraulic lime putty.

Stone window cills Thermatech cleaned and where necessary poulticed to remove extensive deposits. Mortar repairs to localised damage. All windows overhauled with scarf joinery repairs to decayed sections. Putty replaced where missing, detaching or cracked. All joinery redecorated. Draught-proofing seals and strips surface fixed to the existing windows.

All railings to Areas, bridges and steps to be rubbed down and repainted. Decayed ends opened up, painted and releaded. Localised damaged stonework to the bridge and plinths require a combination of pieced-in or mortar repairs. Open joints between paving slabs and steps to be repointed (NHL 5.0).
