Design, Access and Heritage Statement for
Fabric repairs and new access equipment

LINCOLN'S INN – New Square Nos 1-11a, Thomas More Chambers and Nos 53, 54 & 55 Carey Street

0400 – LONDON, LINCOLN’S INN – New Square

Design, Access and Heritage Statement

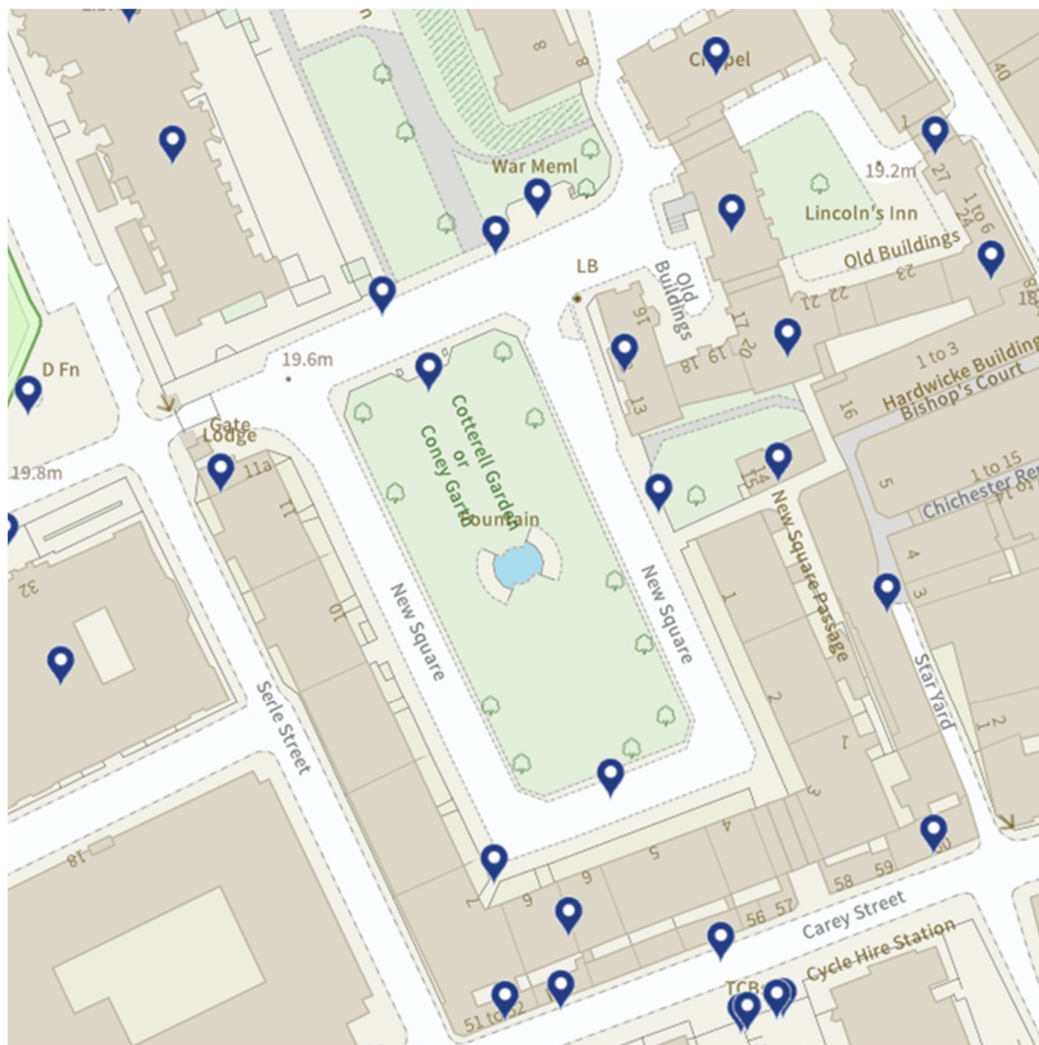
- 2.1. New Square in Lincoln's Inn was built between 1891 and 1697 on Fickett's Field and Nos 1-11 form a continuous terrace that wraps around three sides of the square. Nos 1-11 are collectively Grade II* listed.
- 2.2. Nos 1, 2 & 3 are located at the southern end of the east side; Nos 4-6 define the main southern elevation of the square and include a carriageway through to Carey Street. No 7 is located in the southwest corner and Nos 8-11 define the west elevation of the square. Close-by, there are a number of other Listed Buildings. An extract from Historic England's listed buildings map shows the square and each of the listed structures identified with a blue tab.
