Hero Granger-Taylor's comments on the document

'Heritage Agreement Method Statement (HAMS - monitoring and conservation management of ground movement due to below ground construction at 22 Park Village East - ADP-ESCT-02', SCS Railways document number 1MCo3-SCJ-EV-MST-SSo1_SLo3-000015.

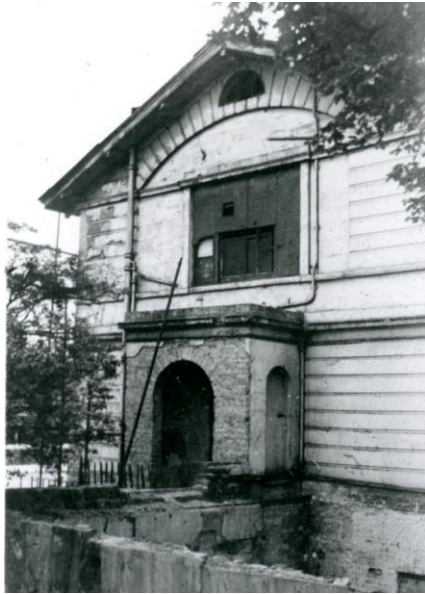
A series of photos in HG-T's possession, source not recorded but perhaps copied from the Crown Estate archive, show 22 PVE just as post-war repair work was beginning in c.1948. In the first photo, here, the scaffolding is already in place on the East facade and one pole leans against the porch:

This photo confirms that no walls were blown away and that the worst damage was to the porch and the Victorian extension, seen roofless in the foreground. From a structural viewpoint, neither of these were part of the principal building.

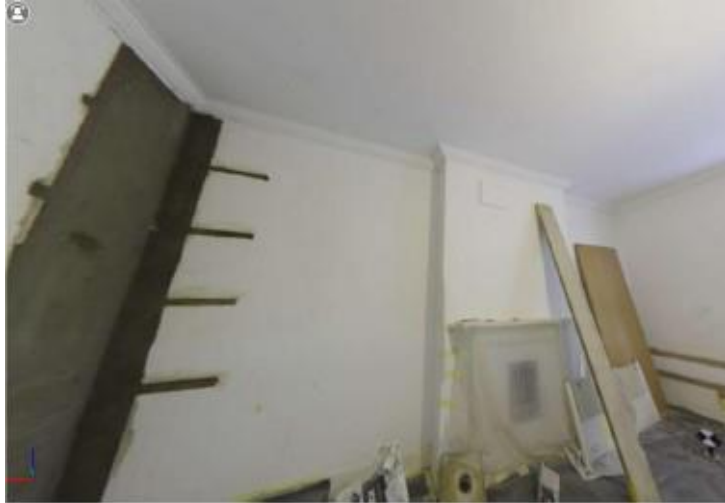
It is hard to comprehend why there is no mention of the insurance work when the relevant documents have been shared with SCS Railways/HS2 Ltd and the work itself took place in plain sight. There is also ample evidence of it in the photographs included in the SCS Railways document ‘22 Park Village East Investigation Surveys Scope Document, Document no.: 1MC03-SCJ-EN-NOT-SS01_SL03-000001’, dated 3 October 2022. Here, for example, in Fig.8, a wide angle photo shows plastered-over reinforcements at the corner of the first floor principal bedroom, where an internal wall joins the party wall with 24 PVE:

The 2012 damage to the building was characterised in both houses by long vertical cracks, particularly at the junctions of walls. There was also, at least at 22 Park Village East, some evidence of actual subsidence in the form of diagonal cracks at the corners of windows on the garden side. This subsidiary damage might have been caused by trees. But it seems unlikely that trees, or one particular tree, directly caused the vertical cracks which were distributed through the house, though predominantly in the half closest to 24 PVE. The ash tree referred to at 5.3.2 is actually some distance away, in the forecourt of 26 PVE.

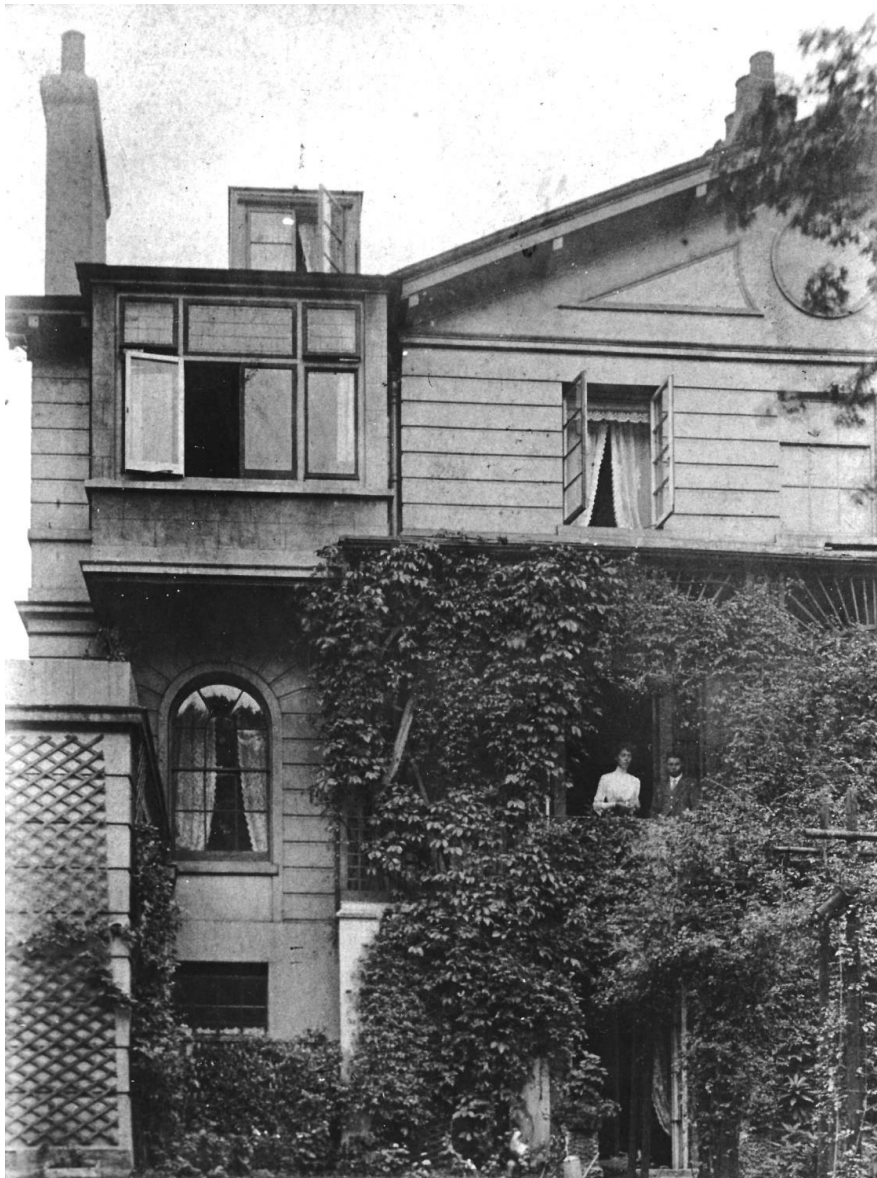
The earliest known image of the house is the photograph of the garden side of the house taken in 1910 for the Montague-Smith family (one of four photos given to HG-T by a descendant, apparently taken on the occasion of the engagement of the daughter of the family).

This image is of the west elevation, the garden side of the house, and records a number of features no longer surviving:

- i) the elaborate upper trellised upper part of the balcony and which was doubtless part of the original design. This trellised part of the balcony and its roof are also recorded in the 1941 National Buildings Record drawing and must have been survived up to this time. A photo taken from the canal towpath, probably also during the war, shows this upper part of the balcony still in situ but 'blacked out'. A decision was made by the Crown Estate not to replace it as part of the post-war restorations, no doubt on grounds of cost.

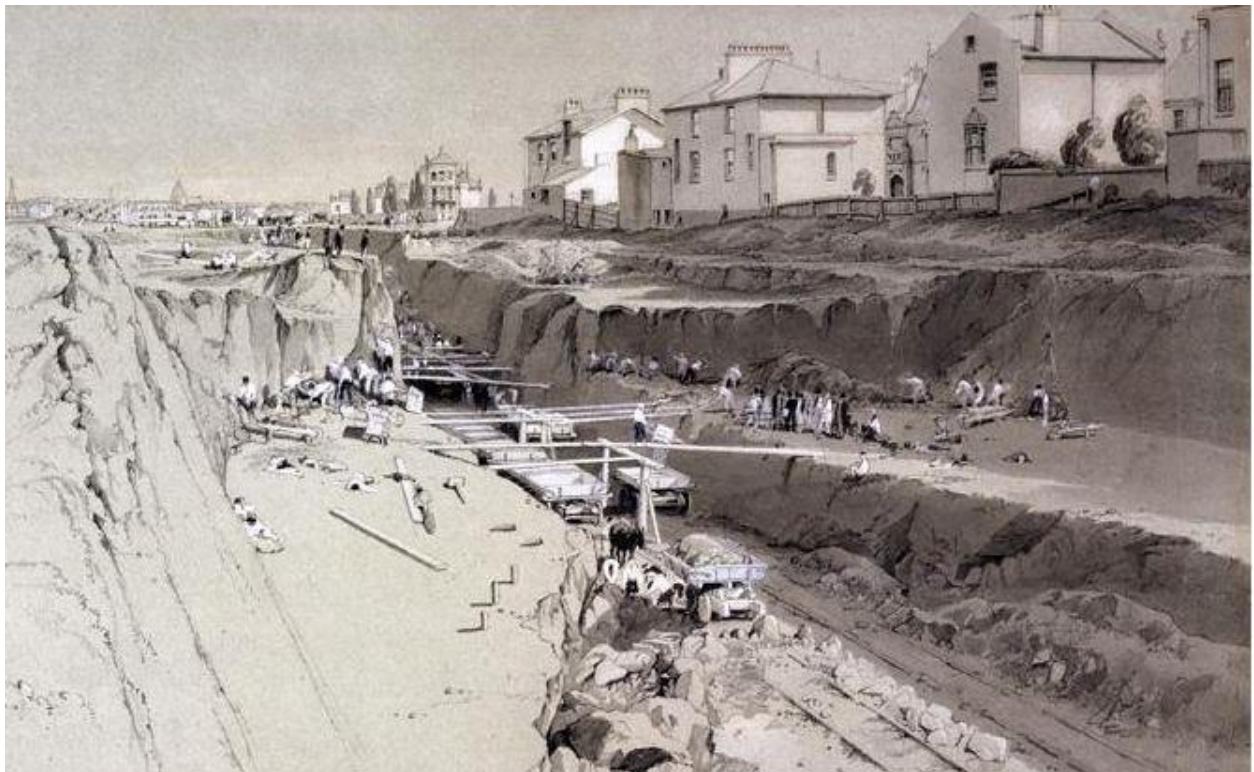
The now-demolished houses on the east side of PVE, built after those on the west side, were always smaller and plainer and on much smaller plots. This can be seen in the excellently detailed 1836 drawing by J.C.Bourne, as here:

The drawing shows the excavation of Robert Stephenson's railway cutting underway, and the backs of 9 to 17 Park Village East, according to the post 1871 numbering (7-9 and 13-15 were semi-detached). The masonry wall at the back of no.9, on the extreme right, evidently correctly marks the boundary between the Crown and Southampton Estates. (National Railway Museum)
