# The Heath & Hampstead Society

**Planning Ref:** 2024/5203/P  
**Address:** 31 Willoughby Road London NW3  
**Case Officer:** Henry Yeung  
**Date:** 8<sup>th</sup> January 2025

We wish to object to this planning application for its risk to flooding. In addition to the inadequately addressed matters concerning protection of the listed buildings and retaining wall revealed by the neighbours in Willow Cottages and by their expert Phil Smith of GCG, this project would also add further to the risk of flooding; not only to immediate neighbours, but also to the South End Flood Zone and other properties 'downstream' of this part of the river Fleet catchment area. This is counter to the NPPF and the Emerging Hampstead Neighbourhood Plan.

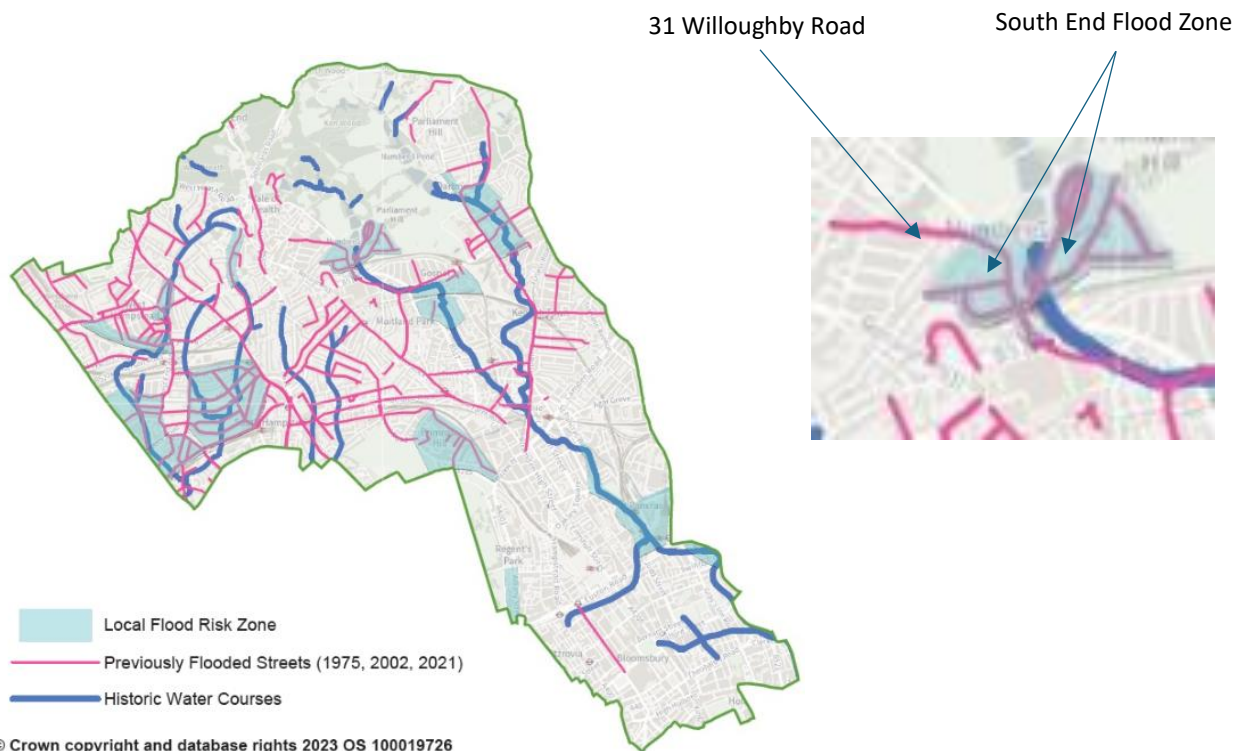
### Camden Draft Local Plan Map 10: Areas of Historical Flooding in Camden and Local Flood Risk Zones

‘Areas at risk of flooding’ in the NPPF are described as included all flood zones, including Flood Zones 1 which has critical drainage problems and which has been notified to the local planning authority by the Environment Agency, as stated in the Technical Guidance to the NPPF: Flood Risk March 2012) where ‘flood risk’ is defined as **‘risk from all sources of flooding - including from rivers and the sea, directly from rainfall on the ground surface and rising groundwater, overwhelmed sewers and drainage systems, etc’** and in the Planning Practice Guidance from March 2014 as (para 4.1.6) ‘the combination of the probability and potential consequences of flooding. Areas at risk of flooding are those **at risk from any source, now or in the future.**’ These can be seen in the following maps:

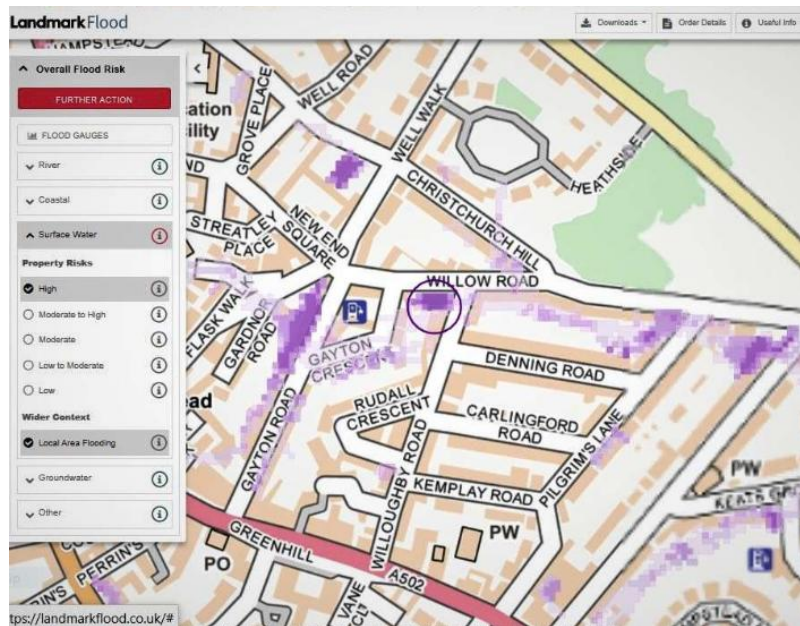
Landmark Flood Report No 241664144-1 (2024)  
Willow Cottages objection, addendum document  
Purple=areas of High Risk surface water flooding
