Subject: Planning Application 2025/0226/T

Chester Terrace Gardens - retaining wall repair and reconstruction proposals

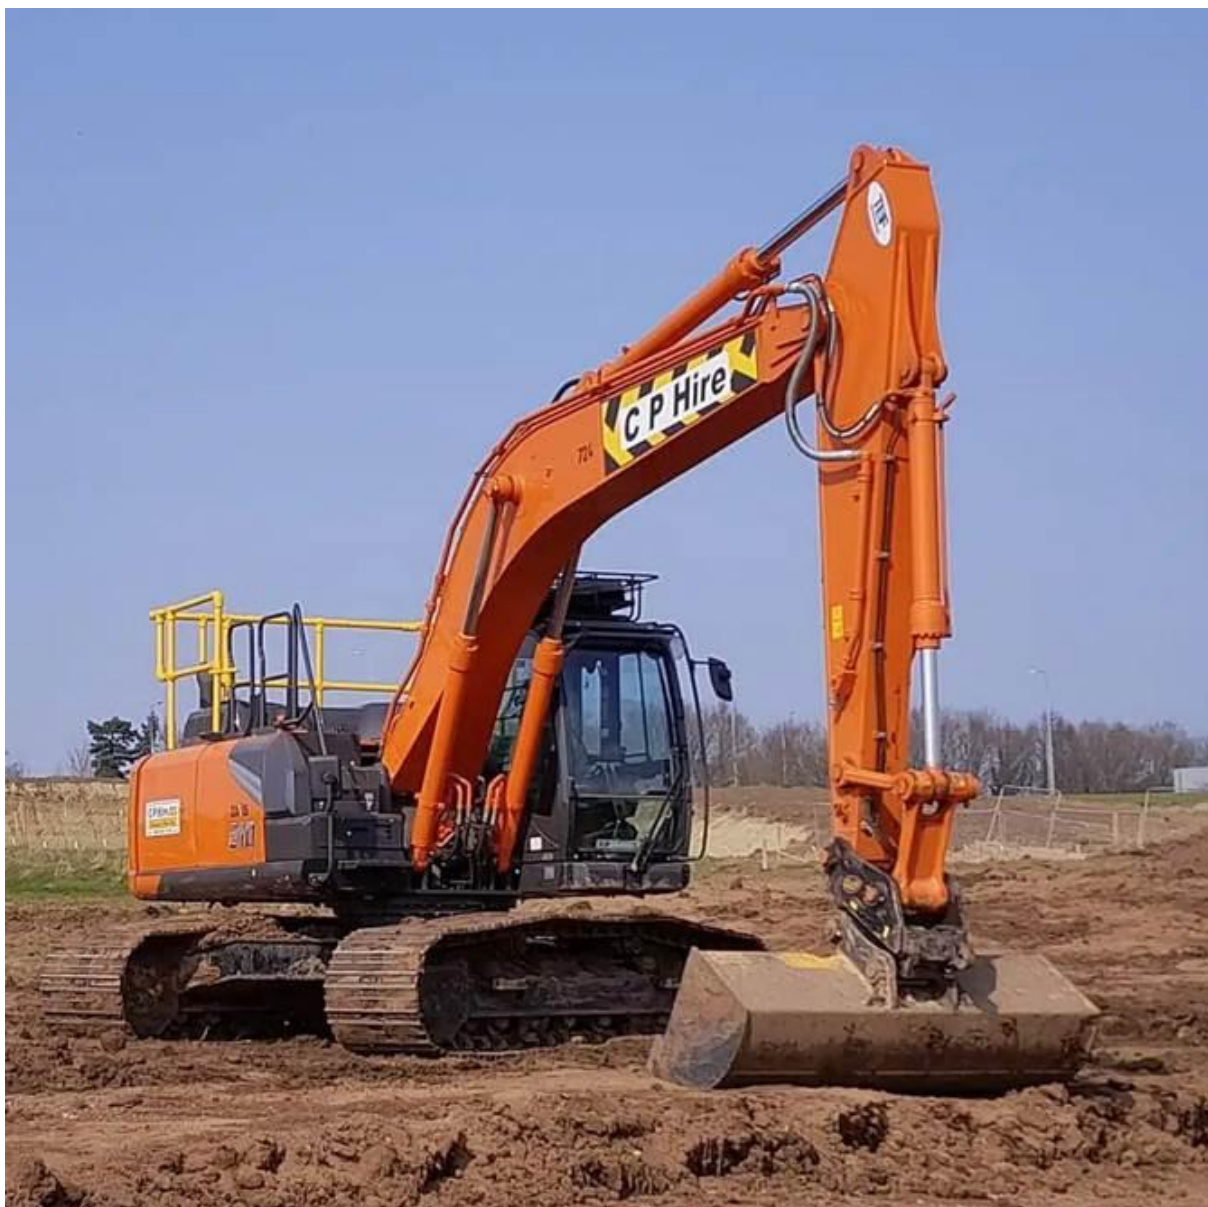
1. We wish to formally oppose the planning application reference 2025/0226/T, listed on January 20th 2025 & notified to us this morning.
2. The proposed works on the trees in Chester Terrace Gardens are to enable the unnecessary use of a huge 21 tonne excavator (photo above) for the proposed minor works planned in Chester Terrace Gardens (the rebuilding of just 1/3 of the retaining wall).

6. The independent, tangible evidence shows that using a 21 Tonne excavator is totally unnecessary.
7. Attached also is a copy of the report by TZG, another structural engineer, which further corroborates the Price & Myers' analysis.

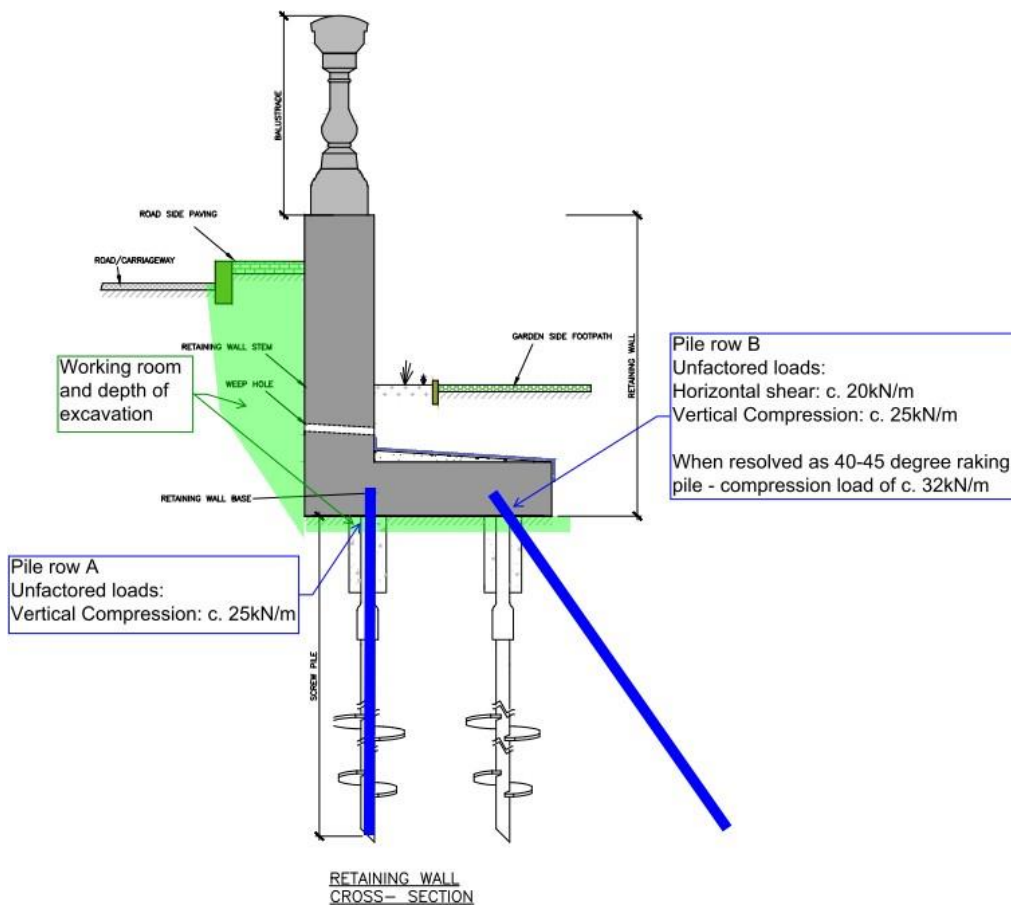
Proposed alternative piling arrangement, with approximate piles loads

Notably, the method statement suggests that a "21 tonne excavator" is required to install the steel screw piles that will support the new L-shaped reinforced concrete (RC) retaining wall. This would presumably necessitate the destruction of all the mature trees and shrubs in the vicinity. HPM's drawings do not note the required capacities for the piles, however our own calculations show that (all loads here are unfactored) vertical compression loads of around 25kN/m, to each of the two rows of piles, and horizontal shear loads of around 20kN/m, to the outer pile row, are needed to resist the applied forces. If the outer pile row is installed at a 40-45 degree rake from vertical, resolving the forces removes the shear load and it puts the pile essentially in pure compression (and so leaves a far more structurally efficient arrangement), with a load capacity of around 32kN/m required. This arrangement is as shown in the sketch below, with proposed pile rows shown in blue.

Given that screw piles can typically be installed at approximately 500mm centre spacing before adverse group action needs to be considered, it is certainly not unreasonable to assume that screw piles could be installed at 1m centre spacing along each row. This would result in piles needing to take unfactored compression loads in the order of 25-35kN. Having spoken to some screw pile specialists, including Target Fixings (website: <https://targetfixings.co.uk/products/heli-pile/>) it is clear that piles achieving such loads in the London Clay assumed to exist on the site can readily be installed using hand held equipment, for example a 63kg pneumatic driver, and at the 45 degree rake indicated in the sketch above given the available working room. Even if the piles needed to be installed using a 1.5 tonne mini-excavator to get the required torque to reach the necessary capacity, this would still likely be possible with minimal destruction of the local mature flora. The currently proposed use of a 21 tonne excavator to install the piles therefore seems needlessly excessive, destructive, and expensive, for such modest loads that are only, after all, generated from supporting what is a relatively low level retaining wall.

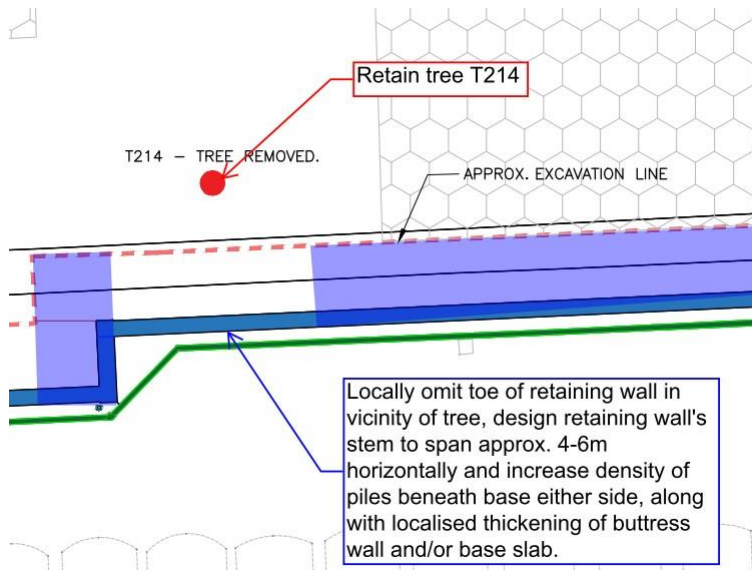
Tree T214 - near Wall 2 - proposed alternative retaining wall arrangement

Whilst it is acknowledged that any flora immediately adjacent to where the sections of wall will be replaced will need to be removed, it does appear that an alternative structural arrangement could be pursued local to trees marked T214 and T217 and so not require their removal. Please refer to the two sketches below, which are mark ups of HPM drawing 24509-82 rev P1, showing

the basic principle. The sketches show the toe/base of the retaining wall locally being left out for a 4-6m length of wall in the vicinity of the trees, therefore meaning that the tree roots would remain relatively undisturbed. The new 450mm thick RC retaining wall stem appears to already be thick enough to span this distance horizontally, but it, or the buttressing wall and/or base at either end, could be increased in size if necessary. The density of piles beneath the toe of the retaining wall would also need to be increased at either end, but a detailed analysis of the arrangement and refinement of loads should prove it feasible.

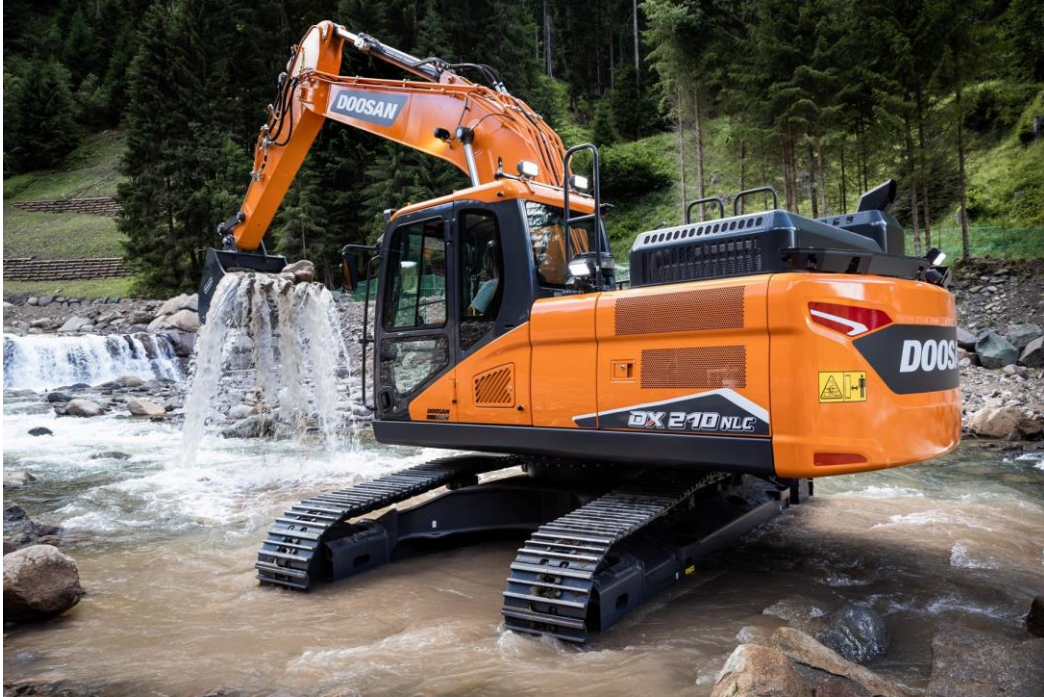
Fig 1 – Top (21 Tonne Excavator)

HPM's Method Statement shows a 21 Tonne Excavator being required to install the piles. For reference (see Image 1) which shows a typical 21 Tonne Excavator. I do not consider such a machine is necessary to install piles or excavate the foundation. Piles may be installed using much smaller machinery – some proprietary piling systems can be installed by hand (see Image 2). Using much smaller hand-installed systems would enable the piles to be installed around trees and their roots.
