# 1MC03 Main Works – Contract Lot S1

## HERITAGE AGREEMENT METHOD STATEMENT (HAMS)-MONITORING AND CONSERVATION MANAGEMENT OF GROUND MOVEMENTS DUE TO BELOW GROUND CONSTRUCTION AT 14 PARK VILLAGE EAST - APD-ESCT-01

Document no: 1MC03-SCJ-EV-MST-SS01\_SL03-000013

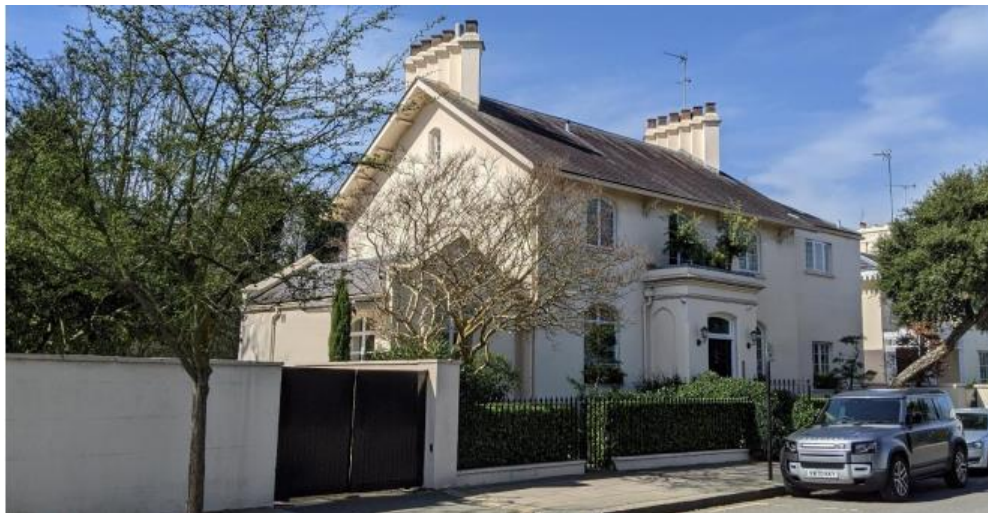
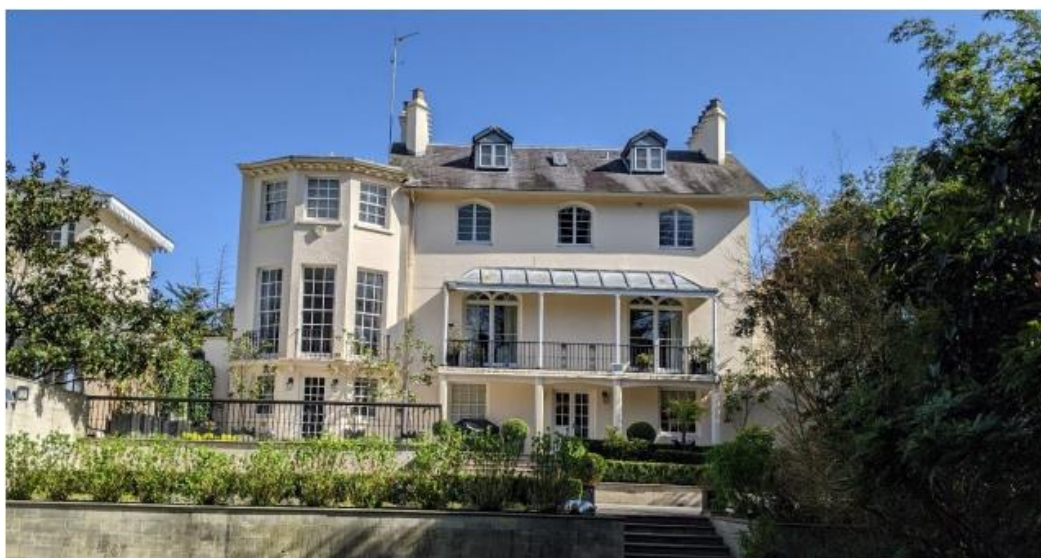
Figure 2 14 Park Village East front and rear elevations

4.1.1 14 Park Village East is one of the detached residential villas laid out between 1824 and 1832 to John Nash's Regent's Park village suburb design (Figure 2). A 3-storey extension to the northwest elevation of the building and a single storey extension at upper ground on the southeast elevation are likely to be post-1950 reconstruction. A 2005 listed building consent permitted a lower ground floor infill connection to 12 Park Village East and the garden boundary between 12 and 14 Park village East has been partially removed.

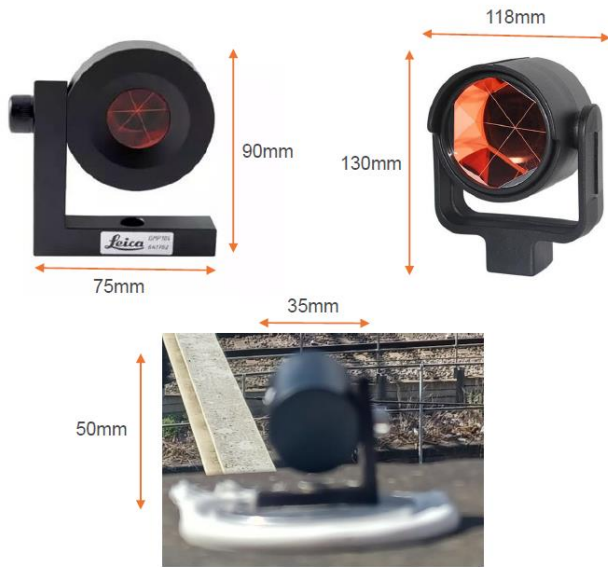
Figure 7 Typical 3D prism

7.5.2 3 D prisms, crack monitors, laser distometers, and ground surface levelling studs will measure movements affecting the key building components and adjoining ground surfaces. The devices illustrated (Figures 7 & 8) are typical examples, but specific instruments used may vary according to situation.

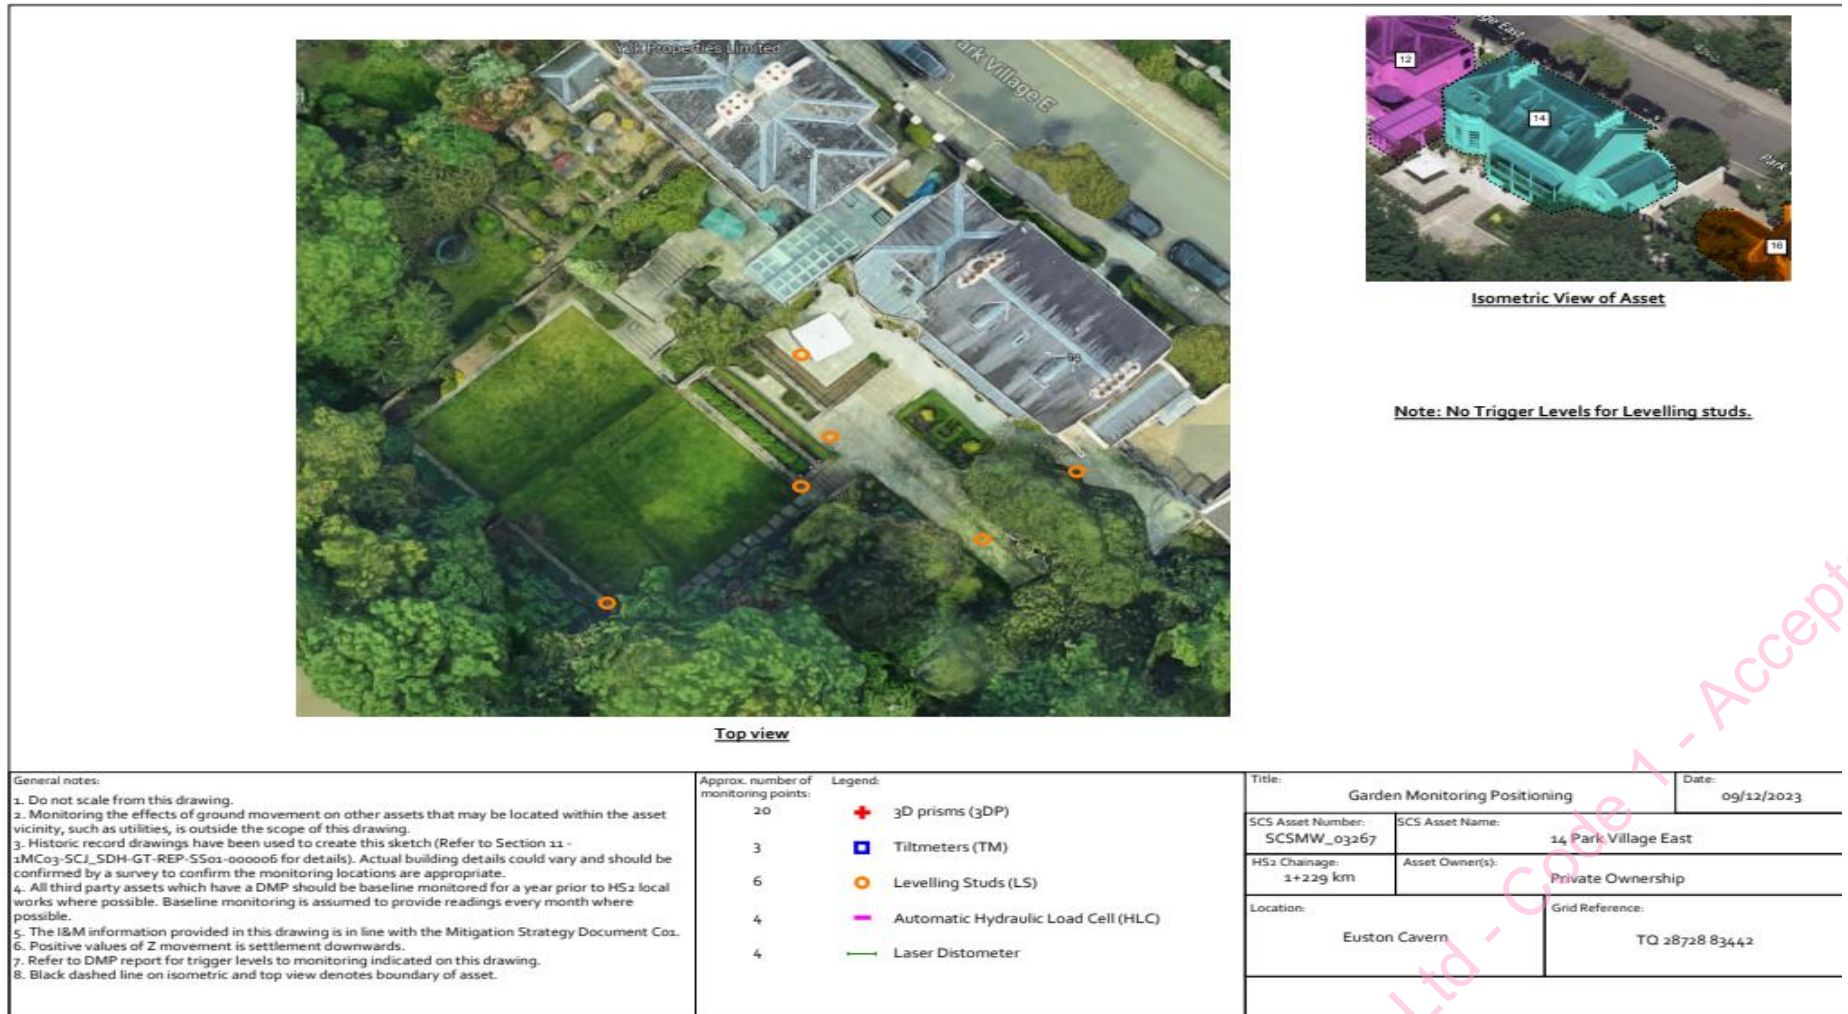
# **11 Appendix A – Instrumentation Design Drawings (as proposed in SCSjv Designers Monitoring Plan - 10 12 14 16 26 28 Park Village East Asset Protection Area East - Euston Throat West Buildings Package 1 - APD-ESCT-01 Document no: 1MCo3-SCJ\_SDH-GT-REP-SSo1-000012)**

- 7.5.9 Settlement of the rear gardens within the influence zone of the HS2 works is to be monitored by means of precise levelling studs, generally at 5m centres. Indicative positions have been indicated in Appendix A Instrumentation Design Drawings.
- 7.5.10 This will extend to the historic rear retaining wall to the canal.
