1MC03 Main Works – Contract Lot S1

HERITAGE AGREEMENT METHOD STATEMENT (HAMS)-MONITORING AND CONSERVATION MANAGEMENT OF GROUND MOVEMENTS DUE TO BELOW GROUND CONSTRUCTION AT 16 PARK VILLAGE EAST - APD-ESCT-01

Document no: 1MC03-SCJ-EV-MST-SS01_SL03-000014

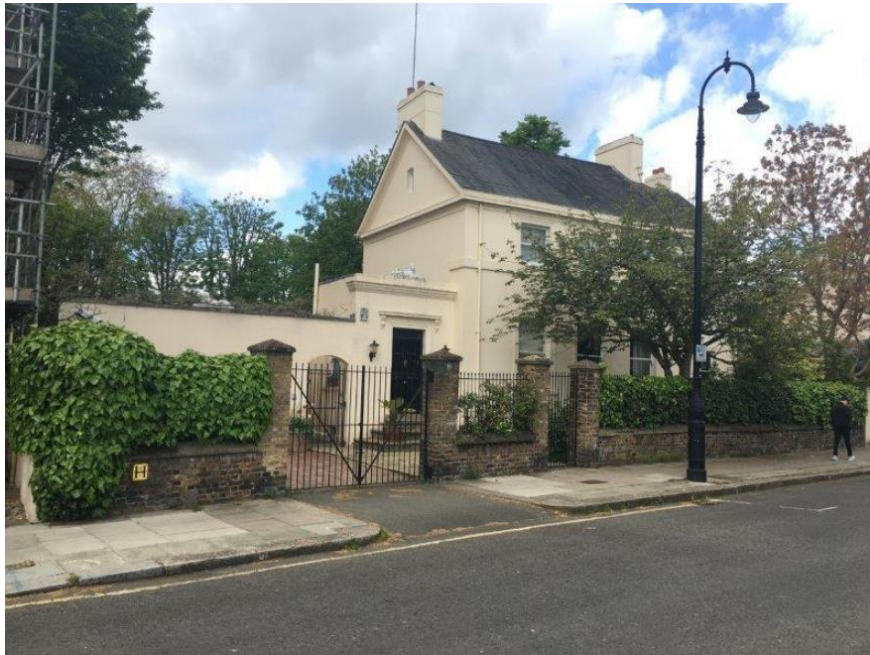
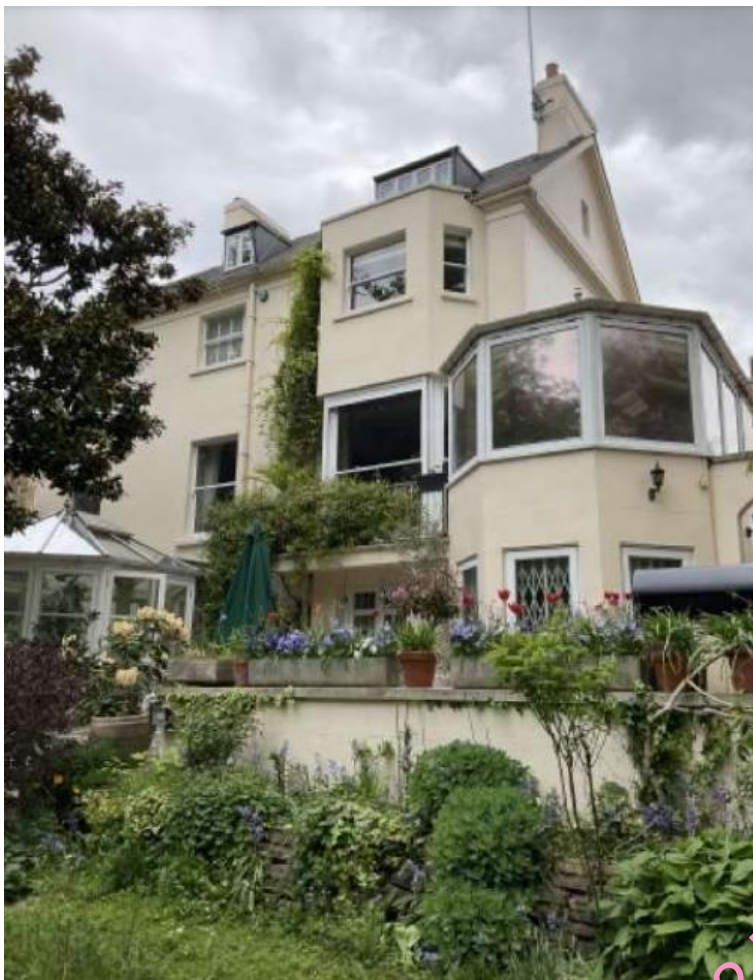
Figure 2 16 Park Village East front and rear elevations

4.1.1 16 Park Village East is one of the 3-storey detached residential villas laid out between 1824 and 1832 to John Nash's Regent's Park village suburb design (figure 2). All twelve surviving residential properties are jointly grade II* listed.
